# Emissions Service Action Code: 24EZ

Subject	Engine Control Module (ECM) Software					
Release Date	September 2, 2020					
Affected Vehicles	Country	Beginning Model Year	Ending Model Year	Vehicle	Vehicle Count	
	USA	2018	2018	PASSAT	37,878	
	CAN	2018	2018	PASSAT	2,614	
	<ul> <li>Check Campaigns/Actions screen in Elsa on the day of repair to verify that a VIN qualifies for repair under this action. Elsa is the <u>only</u> valid campaign inquiry &amp; verification source.</li> <li>Campaign status must show "open."</li> <li>If Elsa shows other open action(s), inform your customer so that the work can also be completed at the same time the vehicle is in the workshop for this campaign.</li> </ul>					
Problem Description	This action addresses an emissions system-related Engine-Off calculation error and improves the Oxygen Sensor Aging-Correction Factor. Neither concern has a direct impact to vehicle exhaust or evaporative emissions. However, either condition could affect proper operation of the Malfunction Indicator Lamp (MIL).

# **Repair Instruction**

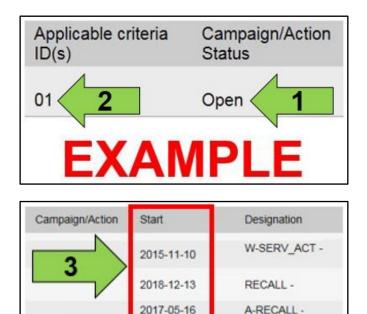
EXAMPLE

Enter the VIN in Elsa and proceed to the "Campaign/Action" screen.

On the date of repair, print this screen and keep a copy with the repair order.

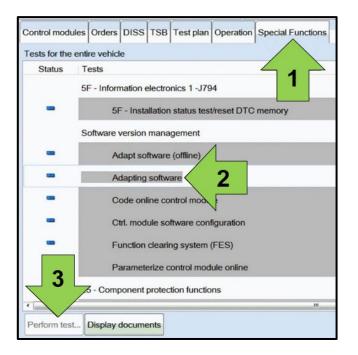
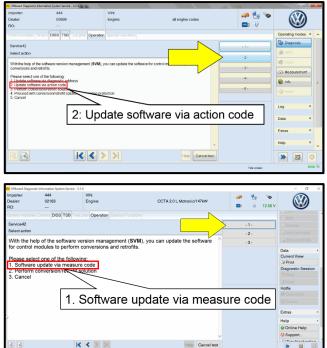
- Confirm that scan tool is communicating with the diagnostic head by USB <Green Arrow>.
  - If the Bluetooth symbol is shown <Red 0 Arrow> then disconnect the diagnostic head from the vehicle and reconnect the USB cable to the diagnostic head and then reattach to the vehicle.
- Upon ODIS startup, verify the "Diagnosis" operating mode is selected <as shown>.
- Once the GFF scan is complete, select "Special functions" <arrow 1>, then "Adapting software" <arrow 2>, then select "Perform test" <arrow 3>.
