GROUP ELE	MODEL 2021MY Seltos (SP2)
	NUMBER 210	DATE September 2020

TECHNICAL SERVICE BULLETIN

**SUBJECT: SERVICE ACTION: ICU OPERATION
LOGIC IMPROVEMENT (SA435)**

This bulletin provides the procedure to improve the logic of the Integrated Central Control Unit (ICU) on some 2021MY Seltos (SP2) vehicles, produced from November 20, 2019 through August 13, 2020, which may exhibit a parasitic draw during long-term storage, while the ICU is in Transportation Mode. To correct this concern, apply the improved logic to the ICU on vehicles in dealer stock only, using the KDS ECU Upgrade function as described in this bulletin. For confirmation that the latest reflash has been applied to a vehicle you are working on, verify the ROM ID using the table on page 3 of this bulletin. Before conducting the procedure, verify the vehicle is included in the list of affected VINs.

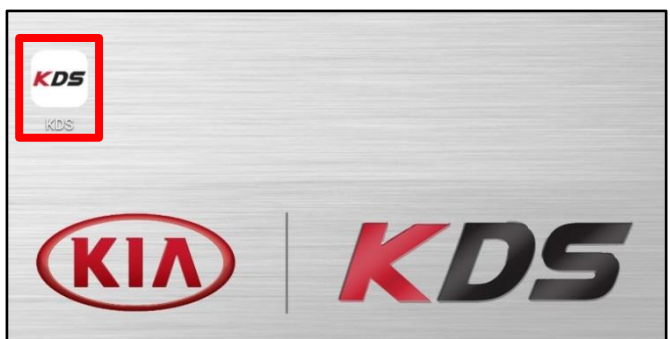
- 2. With the ignition ON, turn ON the KDS tablet. Select **KDS** from the home screen.
