Emissions Service Action

Code: 24GA

Subject Engine Control Module (ECM) Software

Release Date September 2, 2020

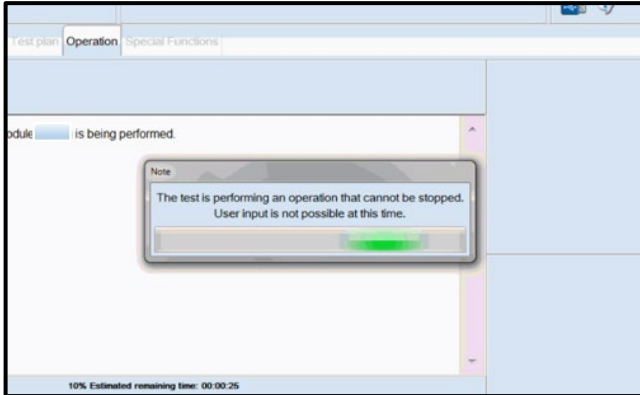
- Select Complete/Continue <arrow> after each operation is completed.

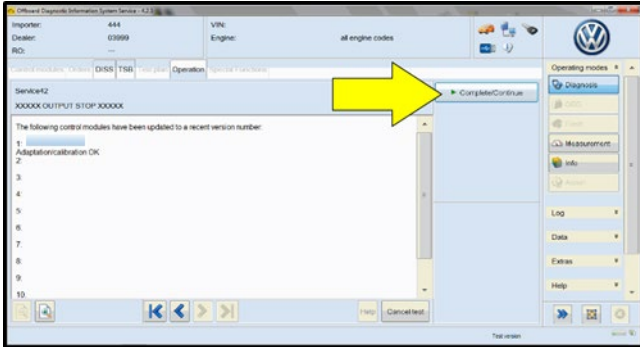
- When the SVM update is complete a confirmation message is displayed <as shown>.
- Select "Complete/Continue" <arrow>.

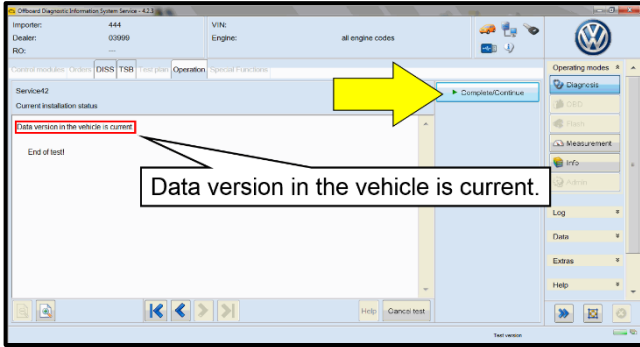
TIP

If the software in the vehicle is already current, a message may appear indicating this. If this occurs, complete the ODIS test plan and send the diagnostic protocol online.
