HYUNDAI Technical Service Bulletin	GROUP BODY ELECTRICAL	NUMBER 20-BE-009H-1
	DATE SEPTEMBER, 2020	MODEL(S) GENESIS (DH)
SUBJECT: MULTIFUNCTION SWITCH WARRANTY EXTENSION (TXXH), REPLACEMENT, AND SOFTWARE UPDATE

Description: This bulletin provides the warranty extension, service procedure to replace the left side of the multifunction switch assembly, and perform a software update. Certain vehicles may exhibit intermittent headlight flickering while driving with the light switch on AUTO light mode.

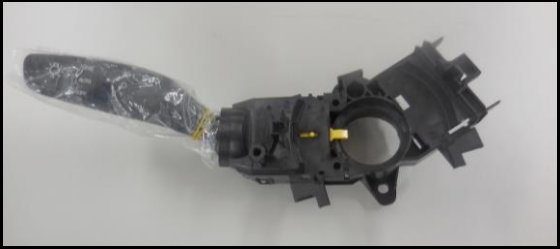
PART NAME	PART NUMBER	PART IMAGE
MULTIFUNCTION SWITCH ASSEMBLY (LH Side)	93410-B1400FFF

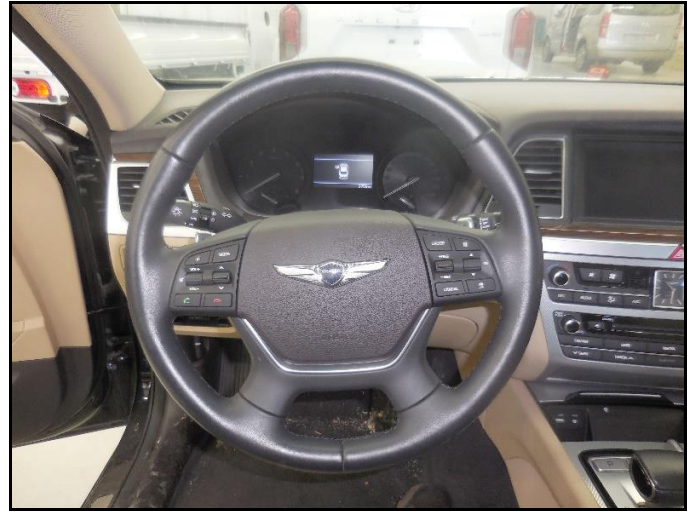
2. Turn the steering wheel to the upright position as shown in the reference picture.

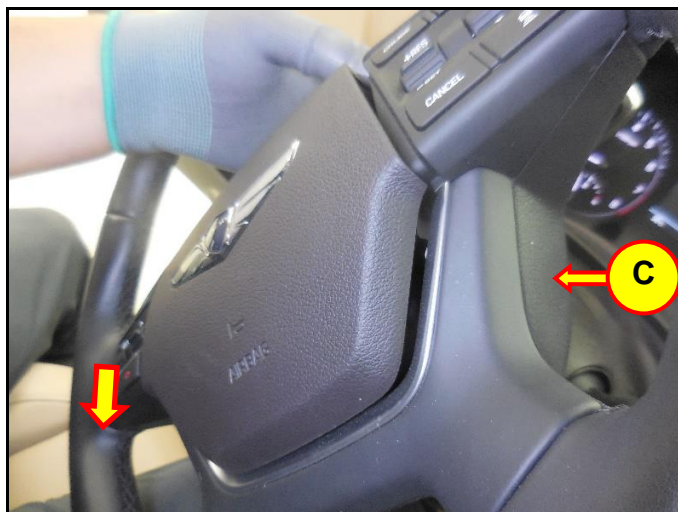
7. Turn the steering wheel counterclockwise until the driver airbag guide hole is lined up top.

Place a small flathead screwdriver into the guide hole (C), and gently bend it back to release the DAB spring.

When the spring is engaged, the right side of the DAB will slightly pop up.

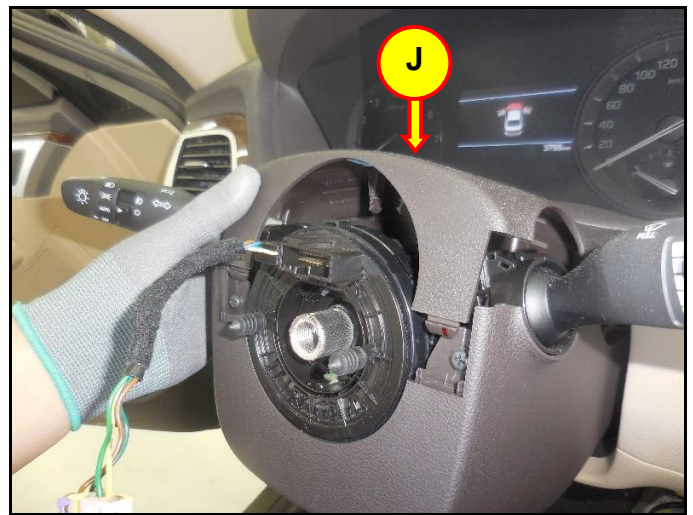
Insert the flathead screwdriver and pry upward.

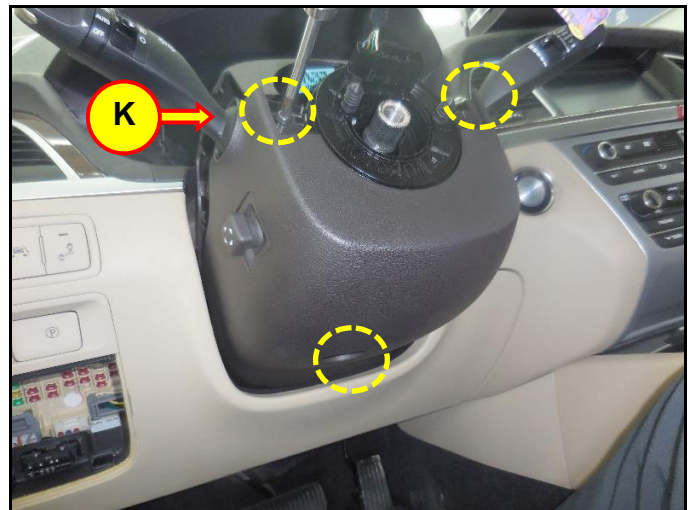
14. Use a Phillips screwdriver, and remove the column shaft lower cover fixing screws (K).

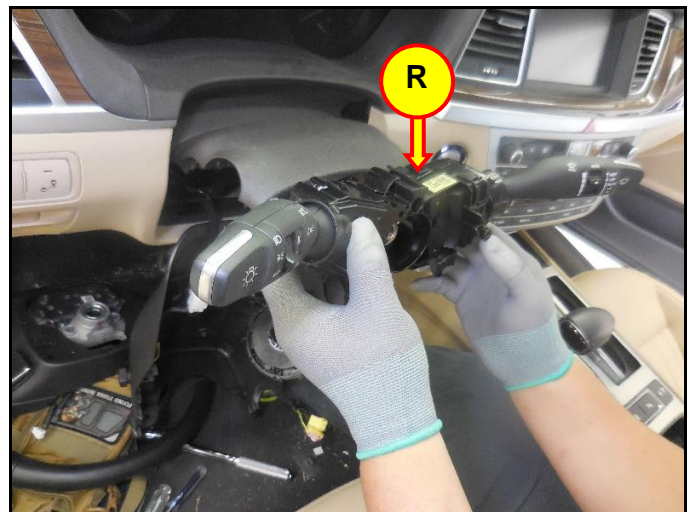
19. Remove the multifunction switch assembly (R).
