QUARANTINE NOTICE

Reference number:	QN-61-1429	Issued: 30 September, 2020
Subject:	Introduction of Apple CarPlay	
Model(s):	DBX	
VIN Range:	Refer to the separately published list of affected Vehicle Identification Numbers (VINs)	
Applicable to:	All	
Distribute to:	After Sales Manager Executive Manager Service Manager Sales Manager	Warranty Staff Technician(s) Parts Staff

Aston Martin is pleased to announce a new software for the Head Unit (HU) which includes the introduction of Apple CarPlay.

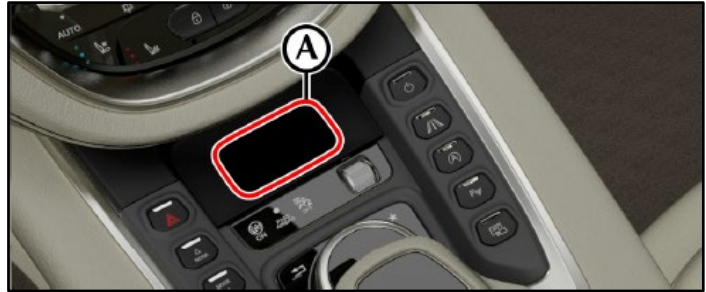
Figure 2

5. Place the vehicle key in the space (A). (refer to Figure 2).

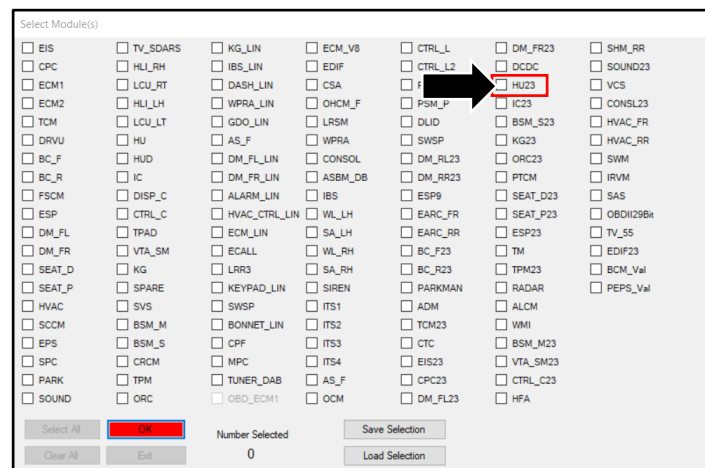
Figure 4

10. Select the “HU23” module then click the “OK” button (refer to Figure 4).

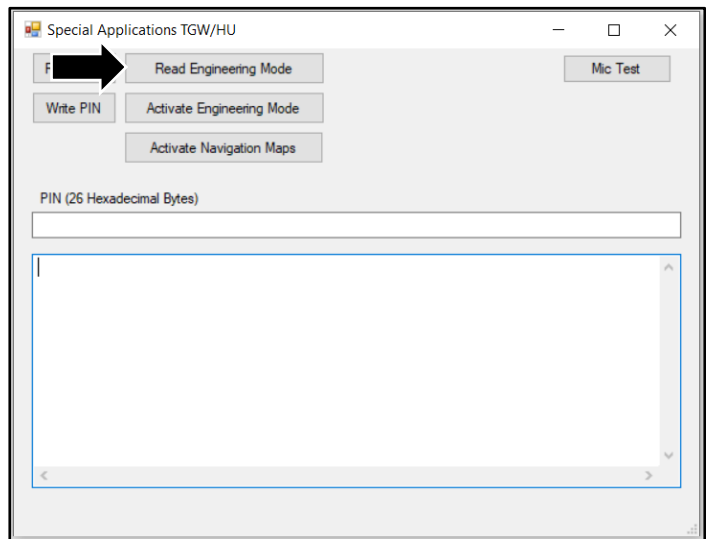
Figure 5

11. Select 'Read Engineering Mode' (refer to Figure 5).

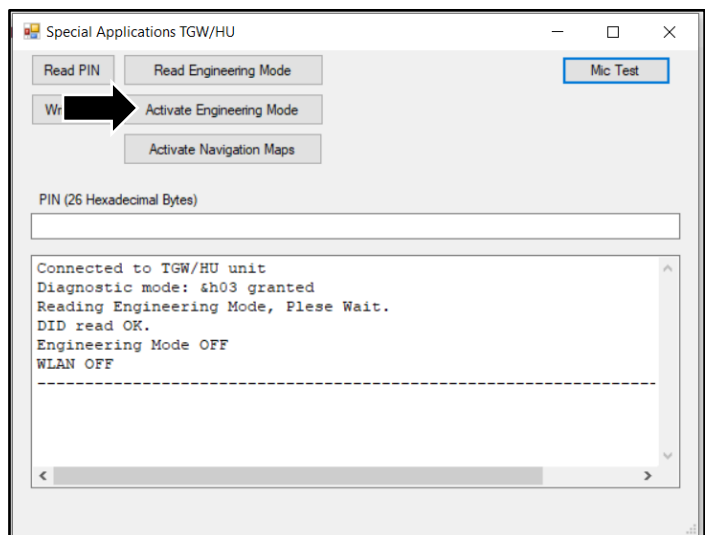
Figure 6

12. Select 'Activate Engineering Mode' (refer to Figure 6).

Note: The HU will start again.

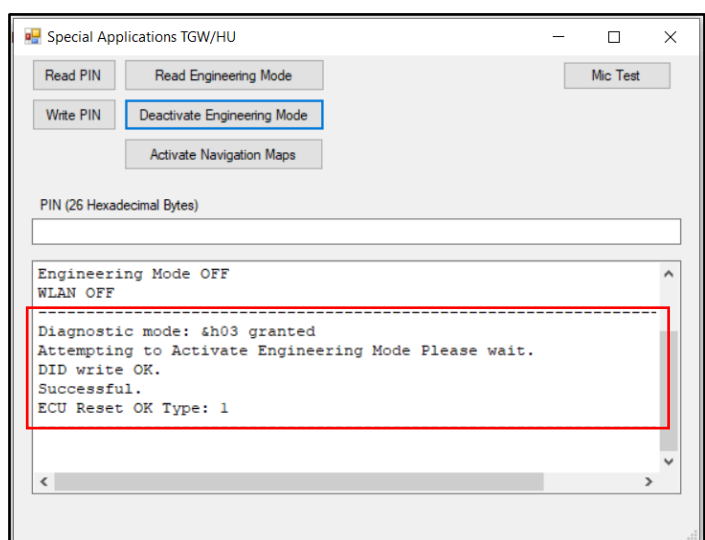
Figure 7

13. Check Engineering mode is active (refer to Figure 7).

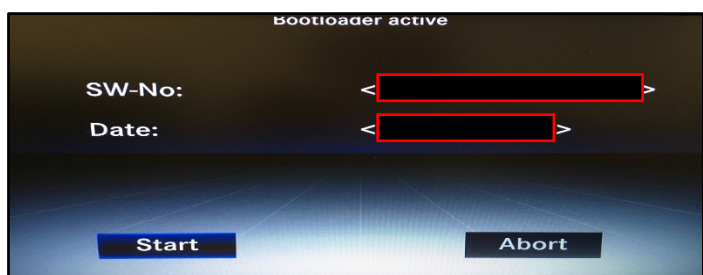
Figure 11

20. The HU will go into 'Bootloader active' mode. The software version number will be shown. (refer to Figure 11).

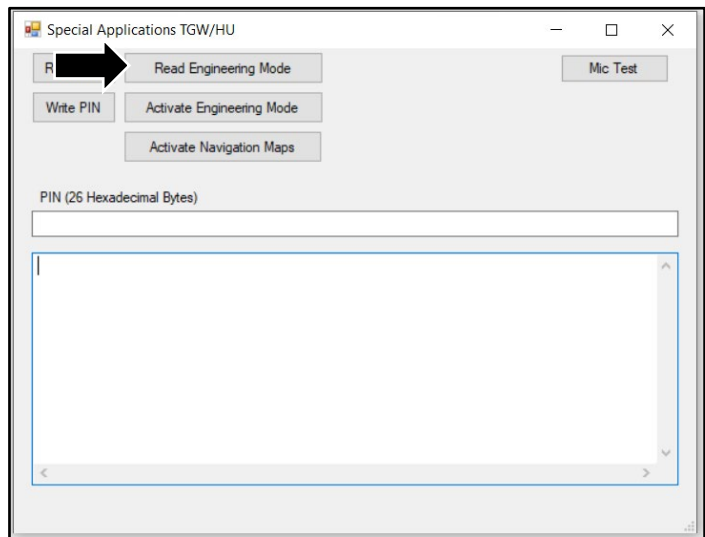
Figure 15

- 27. Select 'Read Engineering Mode' (refer to Figure 15).

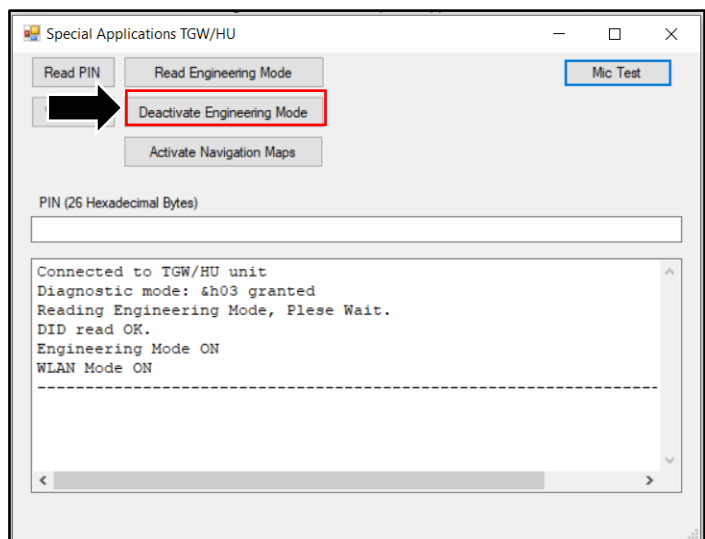
Figure 16

- 28. Select 'Deactivate Engineering Mode' (refer to Figure 16).

Note: The HU will start again.

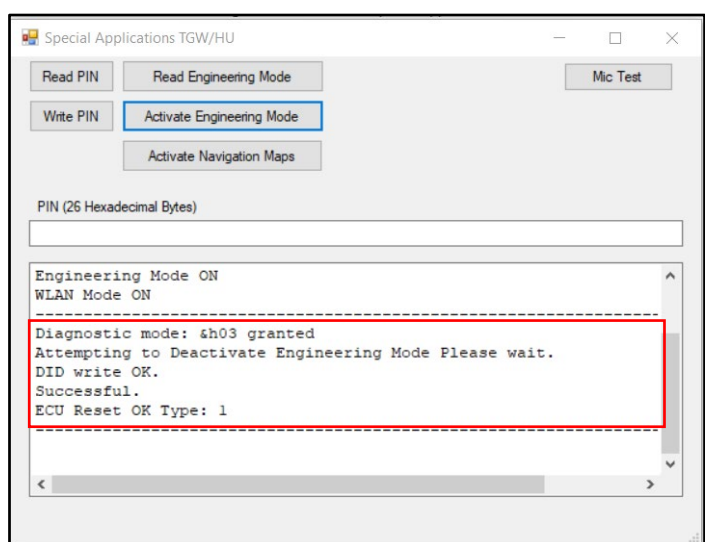
Figure 17

- 29. Check 'Engineering Mode' is off. (refer to Figure 17).
