Emissions Service Action

Code: 23BZ

Subject Engine Control Module (ECM) Software

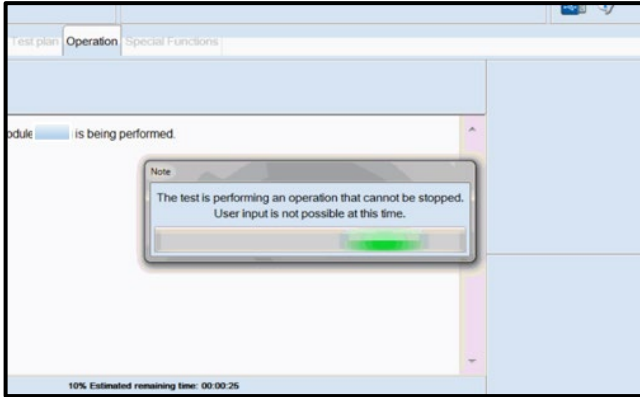
- Select "Accept" <arrow> and follow the on screen prompts.
- During the flash, this screen appears when each operation is performed:

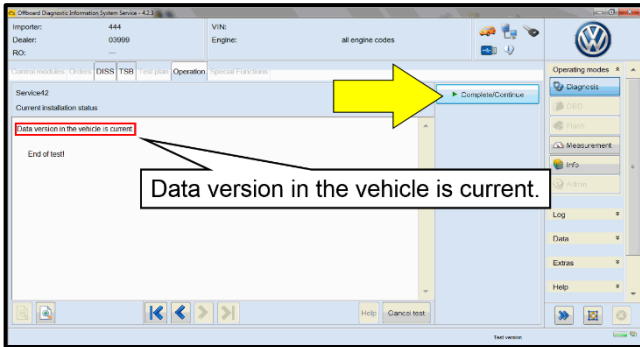
- When the SVM update is complete a confirmation message is displayed <as shown>.
- Select "Complete/Continue" <arrow>.
