October 15, 2020

MIL Comes On with DTC P0716

Supersedes 19-003, dated September 12, 2019; to revise the information highlighted in **yellow**.

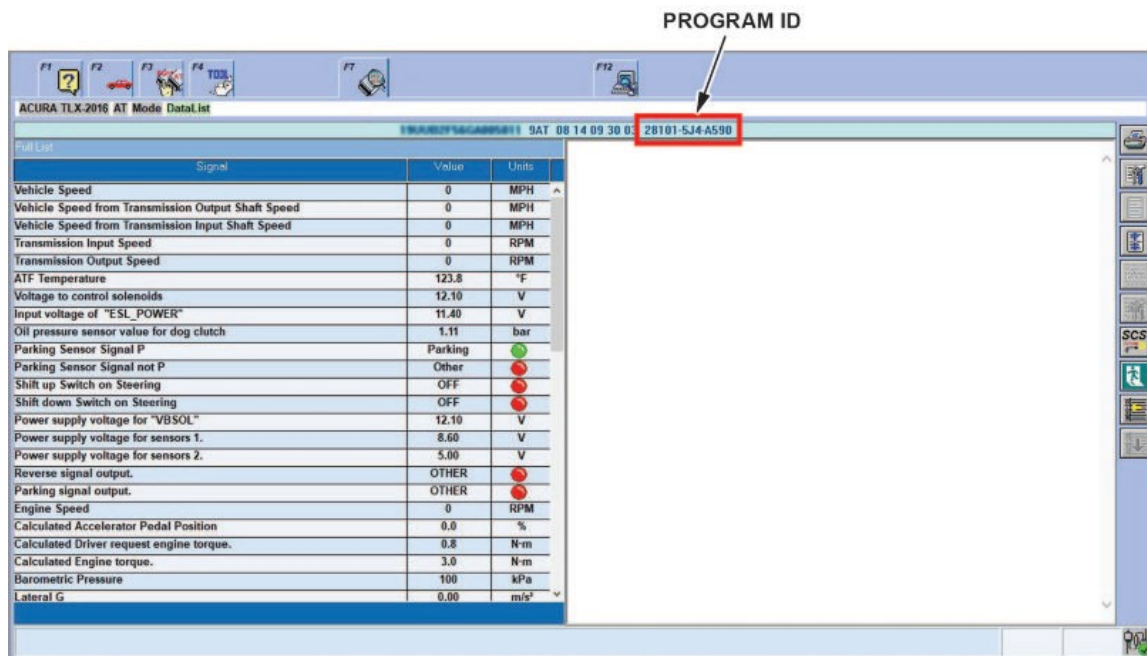
1. Turn the ignition to ON.
2. Connect the i-HDS, and go to the **A/T Data List**. Check if the software has been updated by comparing the Program ID with the table in SOFTWARE INFORMATION.

- If the Program ID shown matches the table, the vehicle has been updated and this service bulletin does not apply. Continue with normal system troubleshooting.
- If the Program ID shown does not match the table, the vehicle has not been updated. Go to step 3.

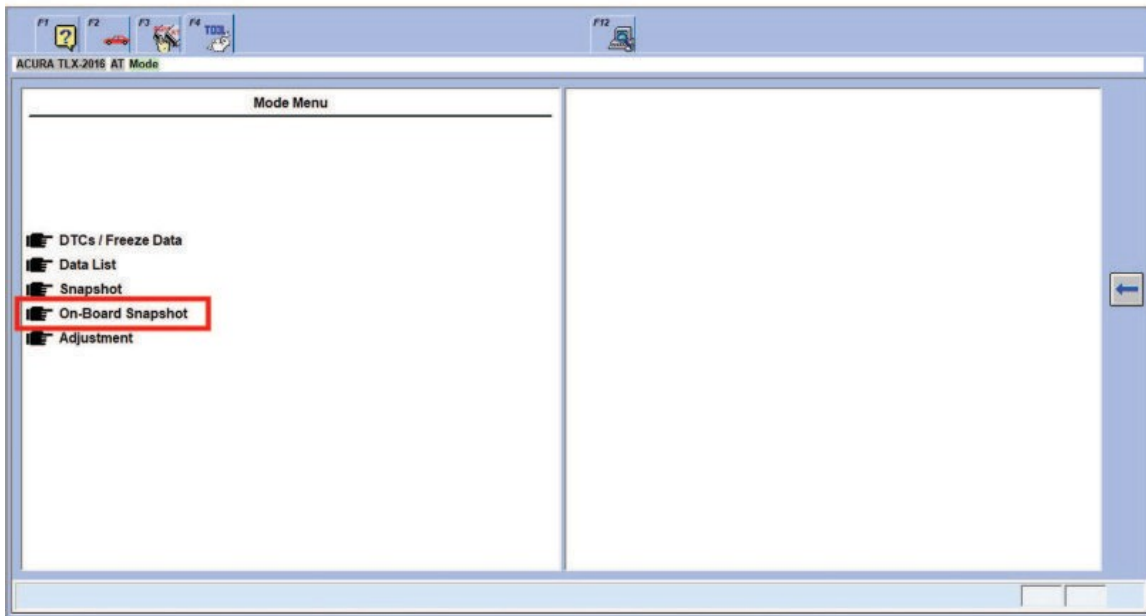
3. Select **Mode Menu**, then **On-Board Snapshot**.

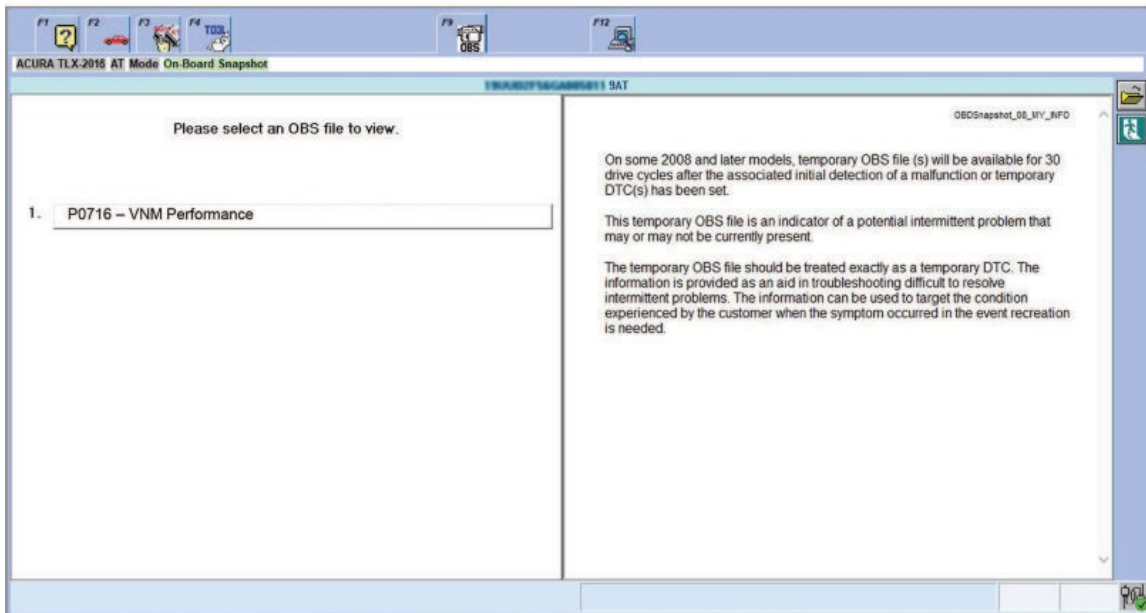
4. Select and view all available on-board snapshots for Automatic Transmission (EAT).

- If no on-board snapshots show P0716, this service bulletin does not apply. Continue with normal system troubleshooting.

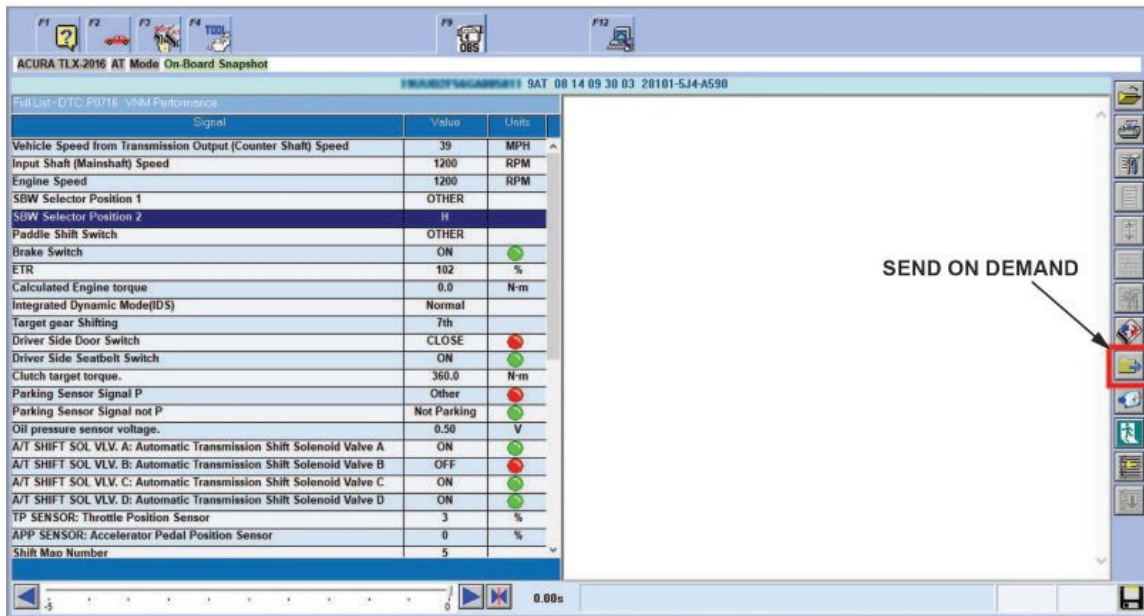
- If an on-board snapshot shows P0716, select **Send On Demand** to e-mail it to Tech Line, then go to step 5.
