Service Bulletin

Bulletin No.: 20-NA-176

Subject: Malfunction Indicator Lamp (MIL) Illuminated - DTCs P1338, P1339, P133A, P133B, P133C, P133D, P133E, P133F, P066A, P066B, P066C, P066D, P066E, P066F, P0671, P0672, P0673, P0674, P0675, P0676, P0677, P0678, P067A, P067B, P067C, P067D, P067E and/or P067F Set

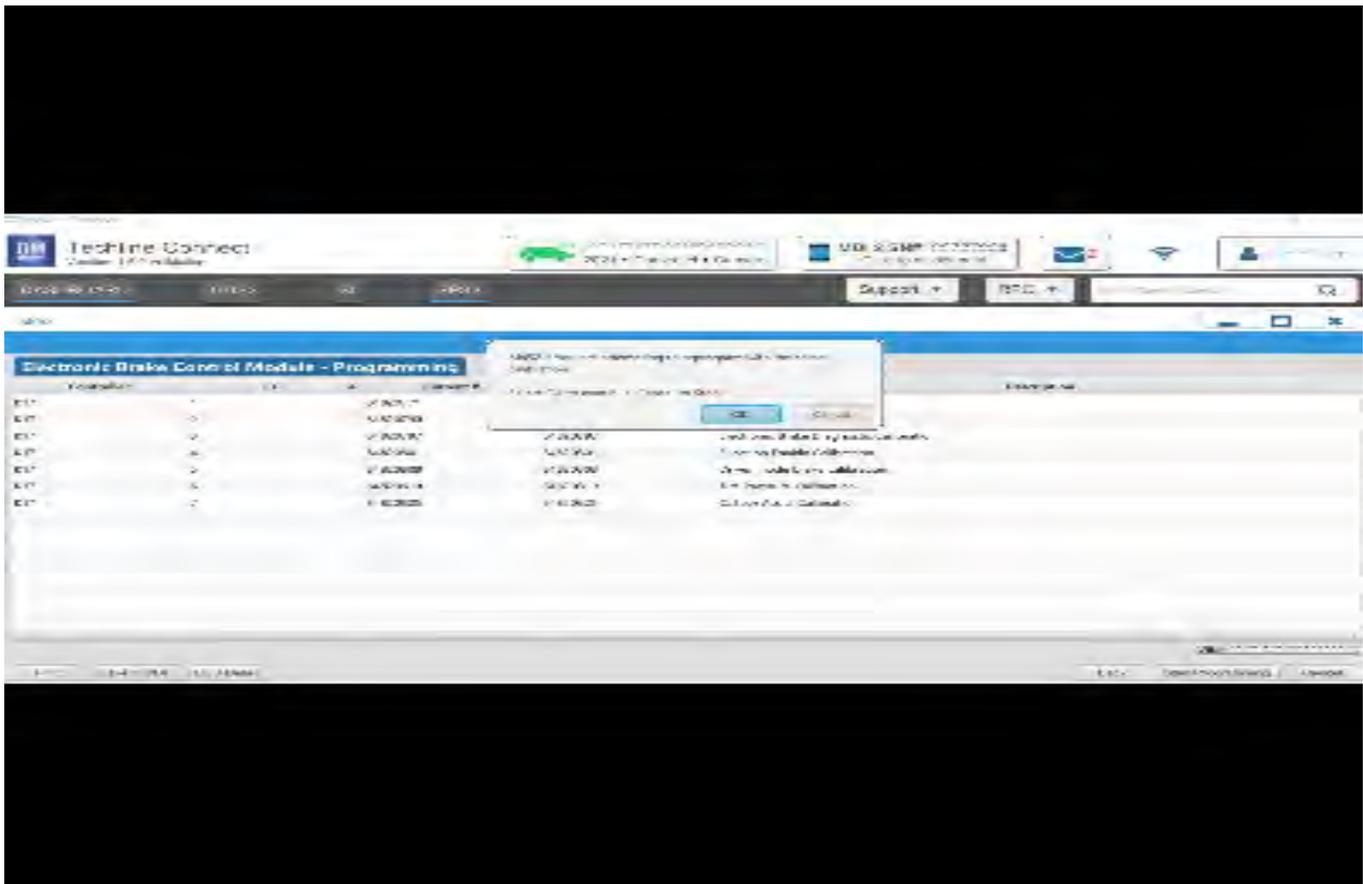
5431207

Important: Techline Connect and TIS2WEB screens shown above.

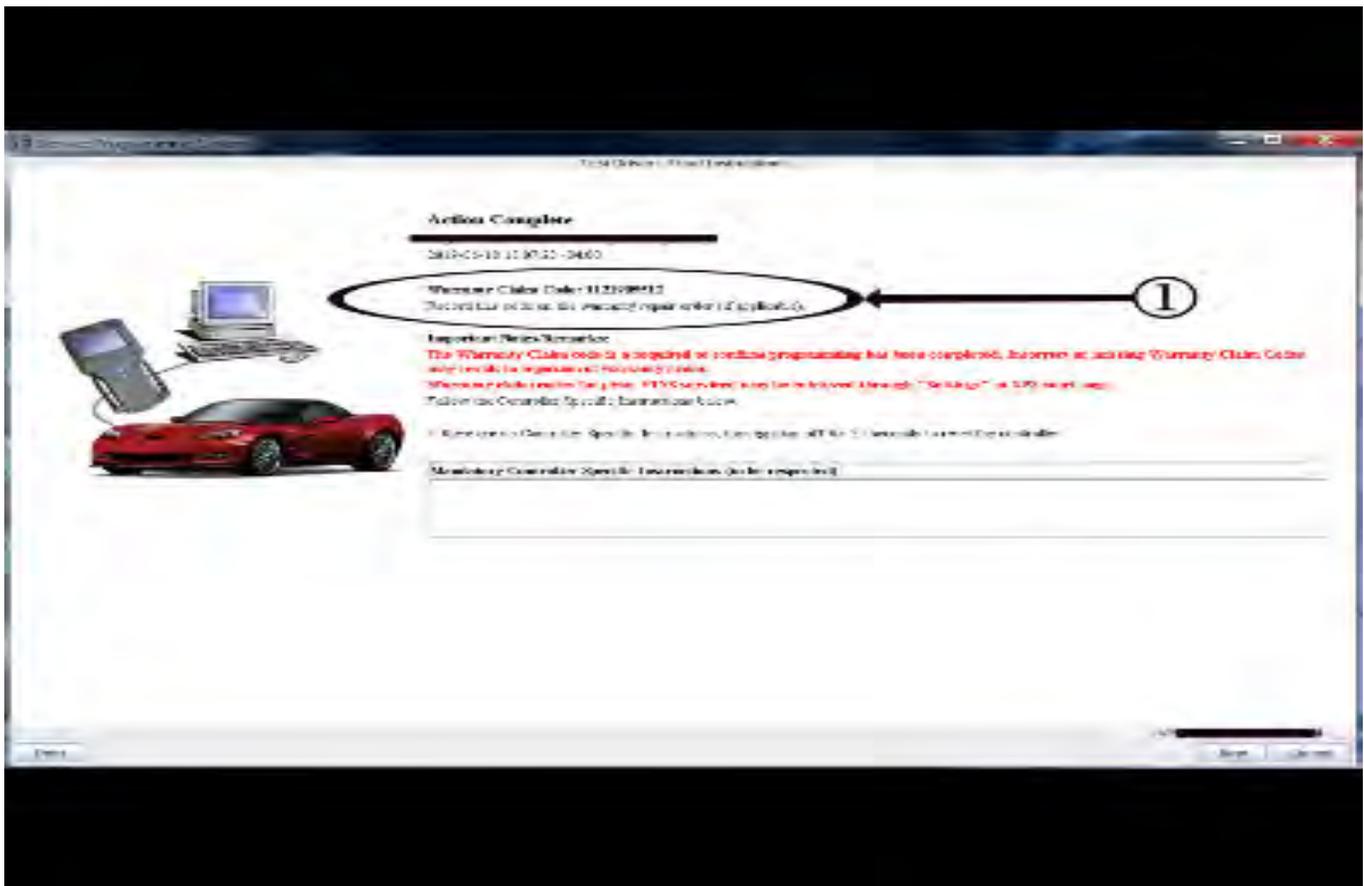
5431209

Important: To avoid warranty transaction rejections, you **MUST** record the warranty claim code provided on the SPS Warranty Claim Code (WCC) screen shown above on the job card. Refer to callout 1 above for the location of the WCC on the SPS screen
