# Navigation System Software Update (Pioneer)

**Service Category** Audio/Visual/Telematics

**Section** Navigation/Multi Info Display

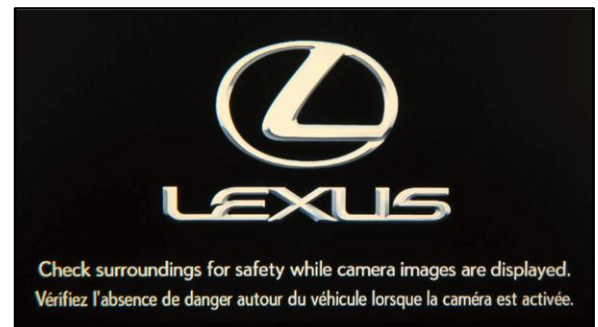
Figure 1.

1. Confirm the software version.
  - A. Start the engine. The Lexus emblem will be displayed on the navigation screen.

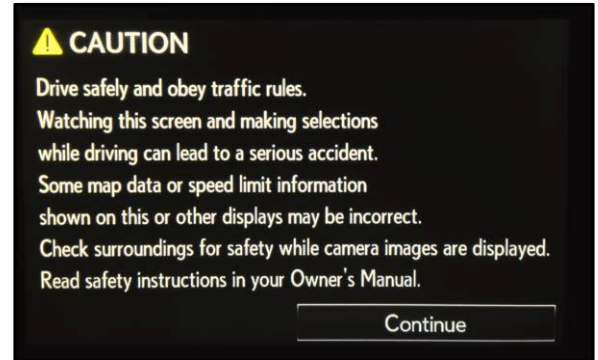
**Figure 2.**

- B. Wait for the display to switch to the Caution screen and select Continue.

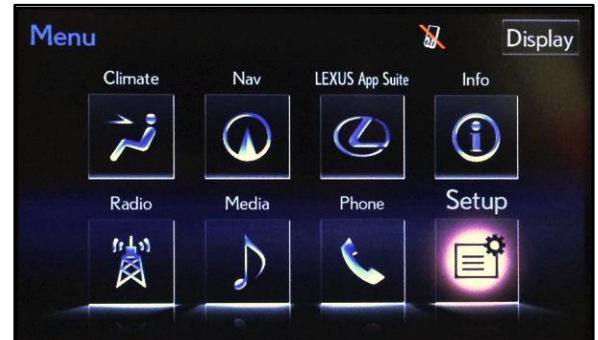
**Figure 3.**

- D. From the navigation menu, select Setup.

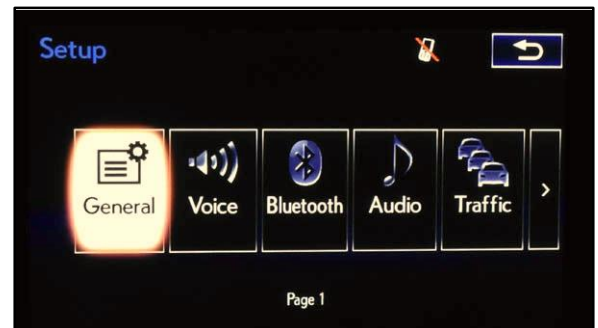
**Figure 4.**

- E. Select General.

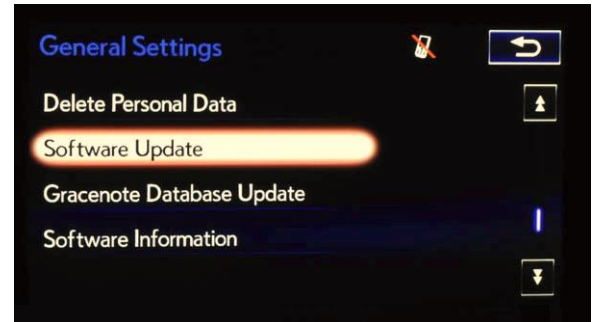
**Figure 5.**

F. Select Software Update.

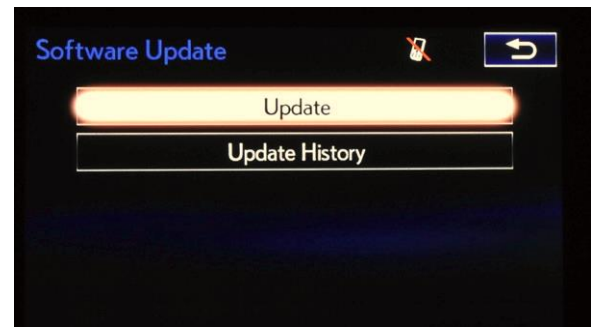
**Figure 6.**

G. Select Update.

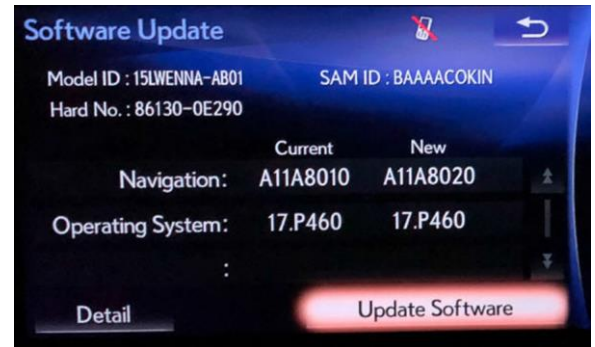
**Figure 7.**

2. Update software version.
  - A. Select Update Software.

Figure 7 refers to models with a 10.3-in. or a 12.3-in. screen.

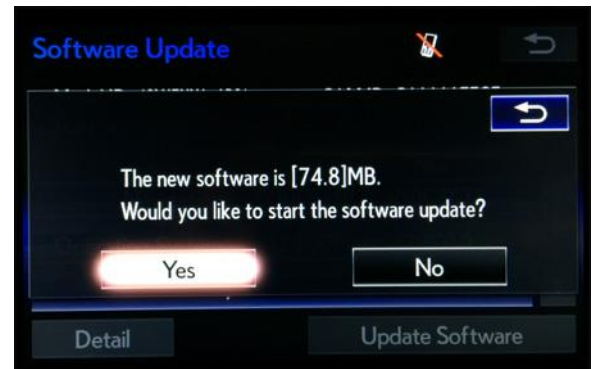
**Figure 8.**

- B. Select Yes.

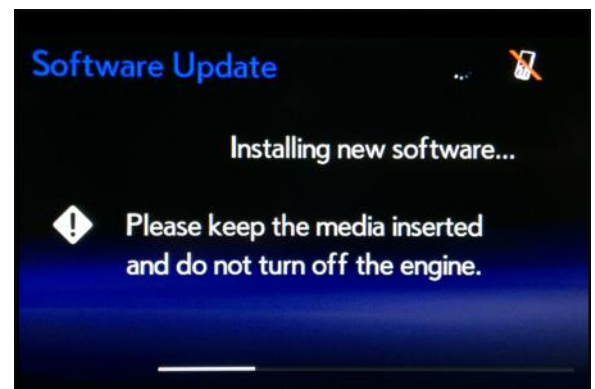
**Figure 9.**

- C. Wait for the software to install.

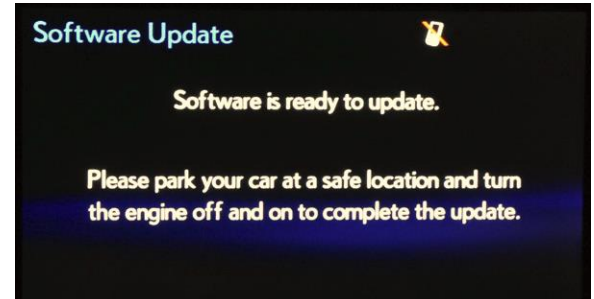
**Figure 10.**

- D. Cycle the ignition OFF and ON to complete the update.

After the ignition is turned OFF and ON the update will take several minutes to complete.

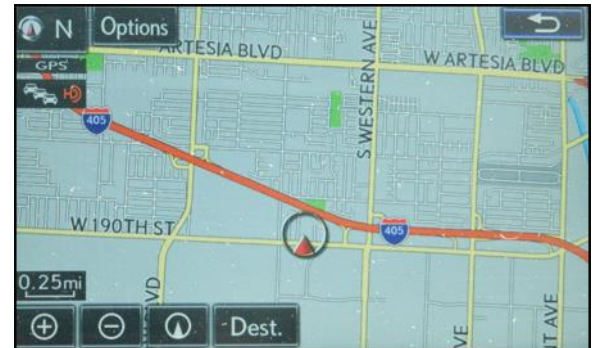
**Figure 11.**

- E. Do NOT remove the USB flash drive or turn OFF the ignition until the navigation screen is present.

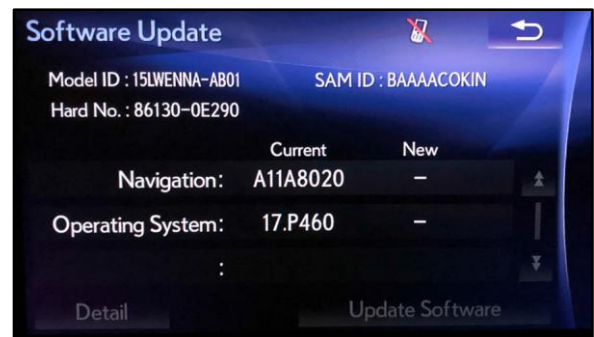
**Figure 12.**

- F. Confirm the current software version has been updated on the Software Update screen.

Figure 12 refers to models with a 10.3-in. or a 12.3-in. screen.
