GROUP Product Improvement	MODEL 2014-2016MY Soul (PS) w/Nu 2.0L GDI
	NUMBER PI2002B	DATE August 2020

PRODUCT IMPROVEMENT CAMPAIGN

SUBJECT: NU 2.0L GDI - KNOCK SENSOR DETECTION SYSTEM (KSDS) LOGIC IMPROVEMENT (PI2002B)

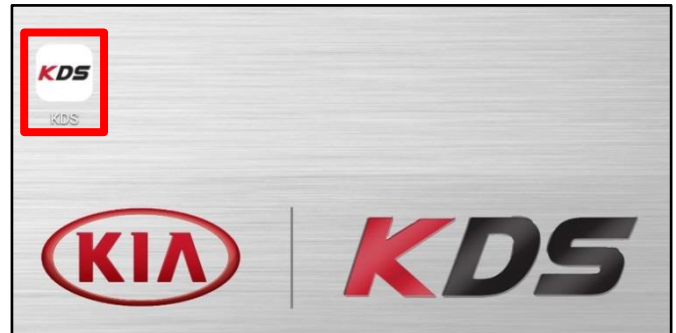
2. With the ignition ON, turn ON the KDS tablet. Select **KDS** from the home screen.

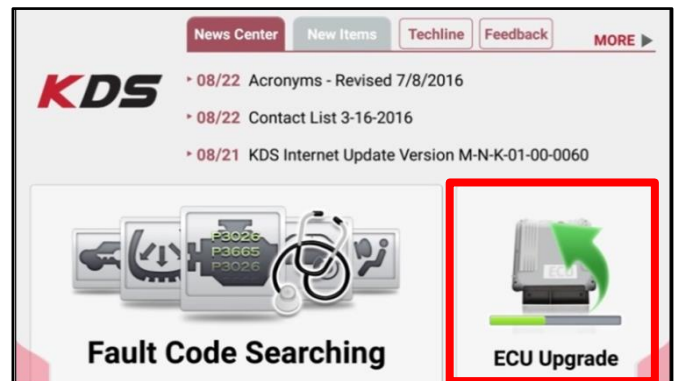
4. Select **ECU Upgrade**.

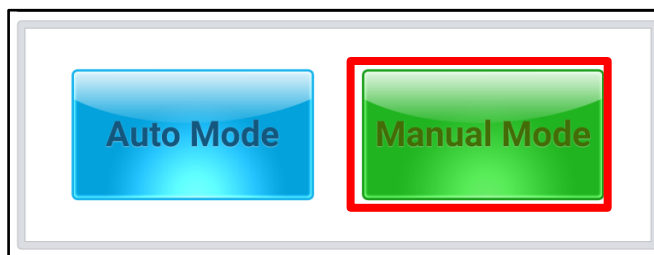
- Select **Manual Mode**.

Always follow the instructions given on the KDS for Manual mode. Refer to page 7 for passwords.

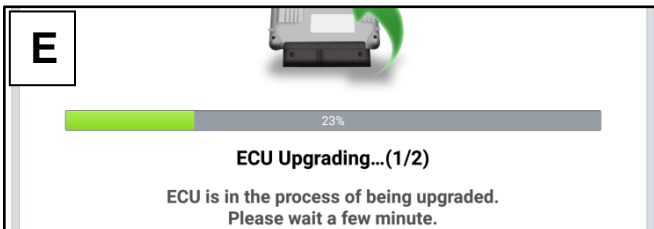
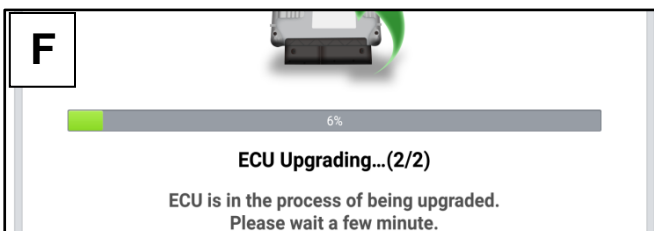
- The ECU upgrade will begin and the progress of the upgrade will appear on the bar graph. Upgrade part (1/2) (E) will download the upgrade event to the VCI-II. Upgrade part (2/2) (F) will upgrade the ECU.

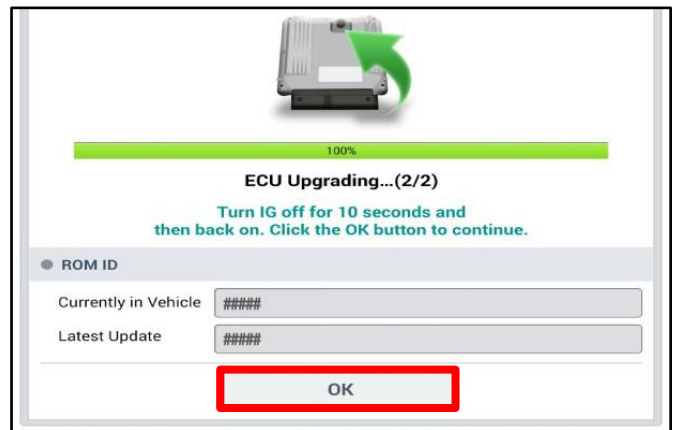
- When instructed on the KDS, turn the ignition **OFF** for ten (10) seconds then back on. Touch **OK** to continue.

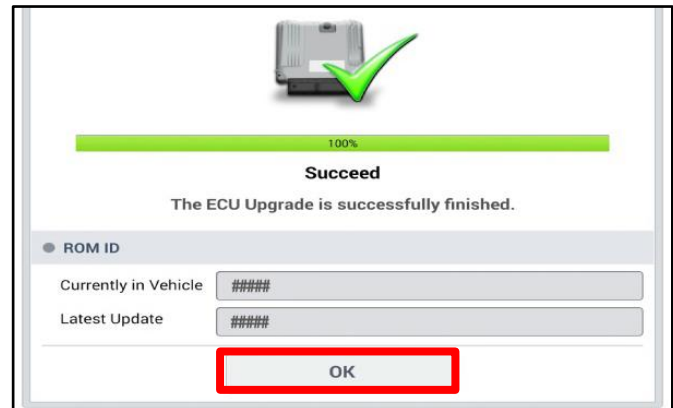
- Once the upgrade is complete, touch **OK** to finalize the procedure.

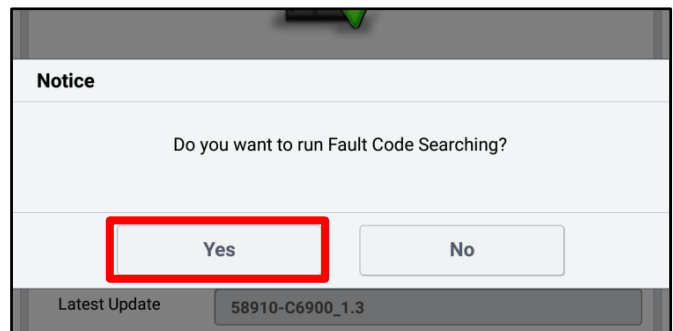
- When prompted, select **YES** to check for Diagnostic Trouble Codes (DTC) and erase any DTCs stored such as EPS, ESC, and TPMS that may have been set during the upgrade.
