Emissions Recall

Code: 24GB

Subject Engine and Transmission Control Module (ECM/TCM)

Release Date October 29, 2020

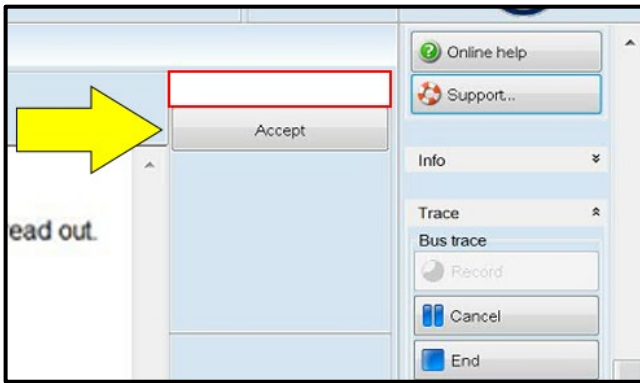
- Enter the corrective action code (SVM code) as listed below.

- Select "Accept" <arrow> and follow the on screen prompts.
- During the flash, this screen appears when each operation is performed:

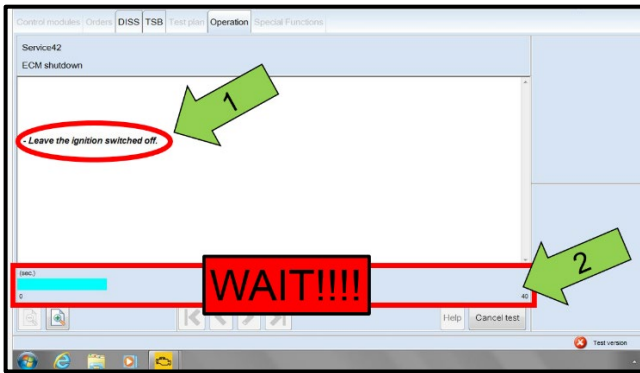
- It is **IMPERATIVE** that **ALL** of the ignition cycle on/off delay requests are fulfilled in their entirety during this flash process <arrow 1>.
- Failing to wait for the ignition on/off timing cycle to complete (progress bar and countdown timer <arrow 2>) before cycling the ignition on/off **MAY** damage a control module.
- Damage to control modules as a result of failing to wait the specified time displayed by the progress bar and countdown timer <arrow 2> are **NOT** covered under this action.

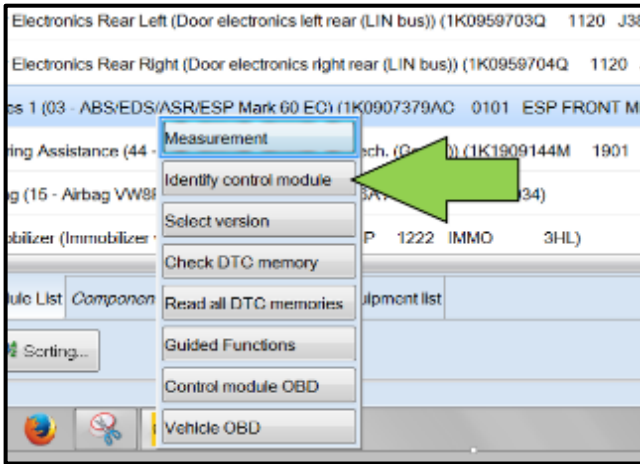
- After the software update is completed and before sending the GFF Log Online:
 - Select the “Control Module” tab.
 - Scroll down and right click on the module that was updated (0001 and 0002).
 - Select “Identify Control Module” <arrow>.

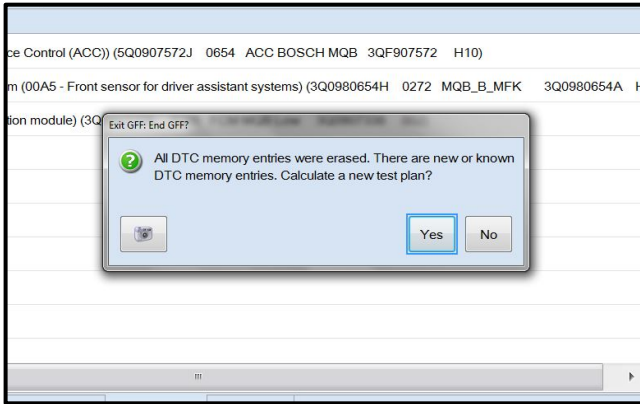
- Exit GFF and send diagnostic protocol online when prompted.
