MODEL
**2014-2016MY
Soul (PS)
w/Nu 2.0L GDI**

NUMBER
2002B (Rev 1, 10/28/2020)

SUBJECT: **NU 2.0L GDI - KNOCK SENSOR DETECTION SYSTEM
(KSDS) ECU UPGRADE (PI2002B)**

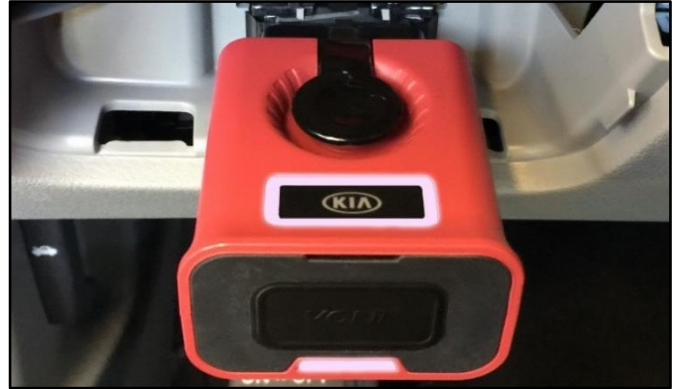
The ECU upgrade function on KDS operates wirelessly. It is not necessary to perform the upgrade via USB cable.

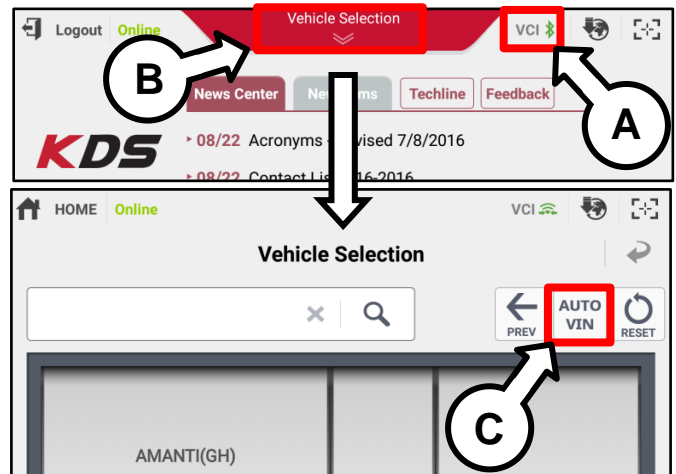
3. Confirm communication with VCI (A) and then configure the vehicle (B) using the **AUTO VIN** (C) feature.

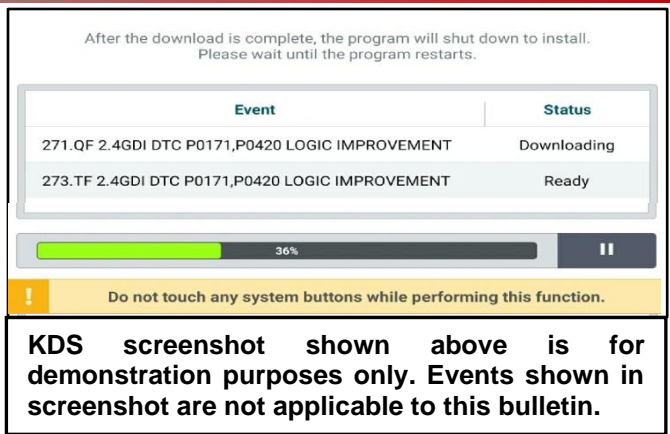
- The KDS will check the server for recently uploaded Events and then automatically download **Upgrade Event #508**.

*** NOTICE**
 The vehicle must be identified in Vehicle Selection to download an Event for that vehicle.

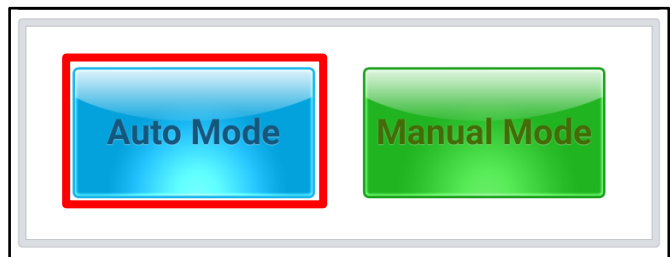
- Select **Auto Mode**.

CAUTION
 Do NOT attempt to perform a Manual Mode upgrade UNLESS Auto Mode fails. Always follow the instructions given on the KDS in either Auto or Manual mode.

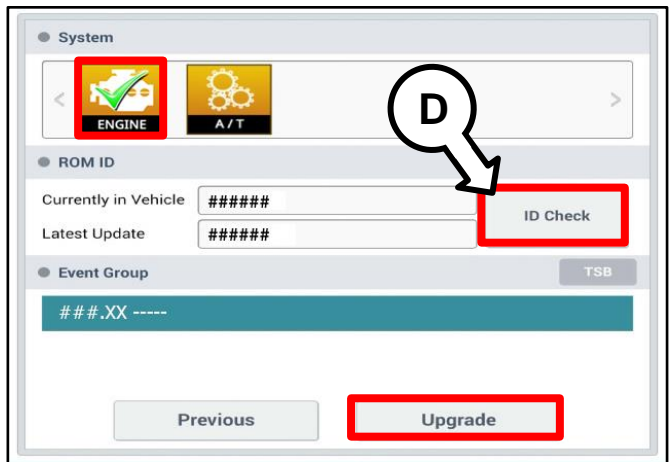
- Select the **ENGINE** system under the System selection menu.

Touch **ID Check** (D) and confirm that the latest update is available.

Select **Upgrade Event #508** and select **Upgrade** to continue.

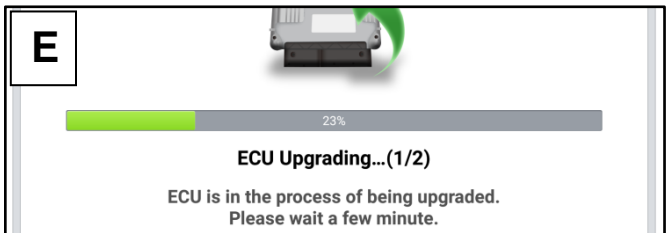
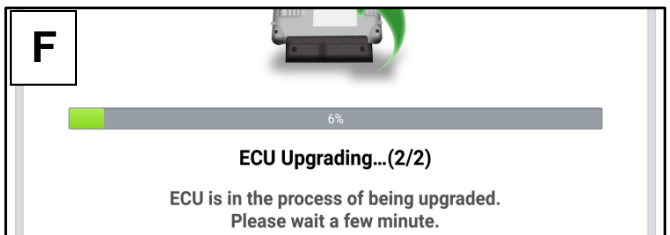
- The ECU upgrade will begin and the progress of the upgrade will appear on the bar graph. Upgrade part (1/2) (E) will download the upgrade event to the VCI-II. Upgrade part (2/2) (F) will upgrade the ECU.

CAUTION
 Do not touch the system buttons (like 'Back', 'Home', 'etc.') while performing ECU Upgrade.

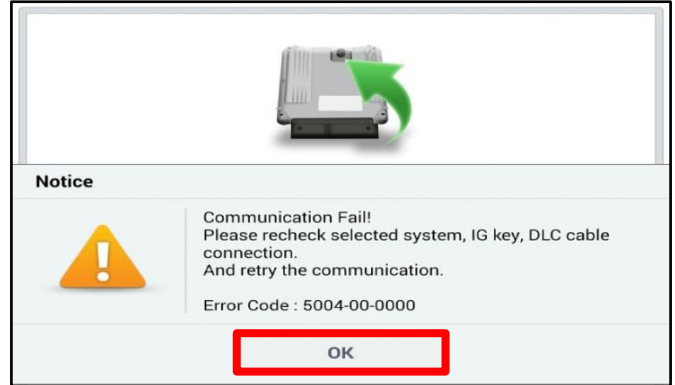
9. If a “Communication Fail” screen appears, verify that the VCI-II and KDS are communicating properly. Touch **OK** and restart the procedure from step 4.

If an error notice continues to appear or if the upgrade cannot be performed, DO NOT disconnect the KDS/VCI-II. Contact GIT America Help Desk at (888) 542-4371 or Techline.

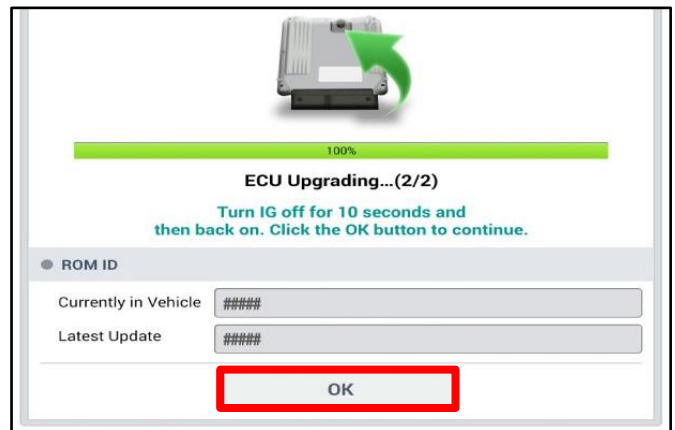
10. When instructed on the KDS, turn the ignition **OFF** for ten (10) seconds then back on. Touch **OK** to continue.

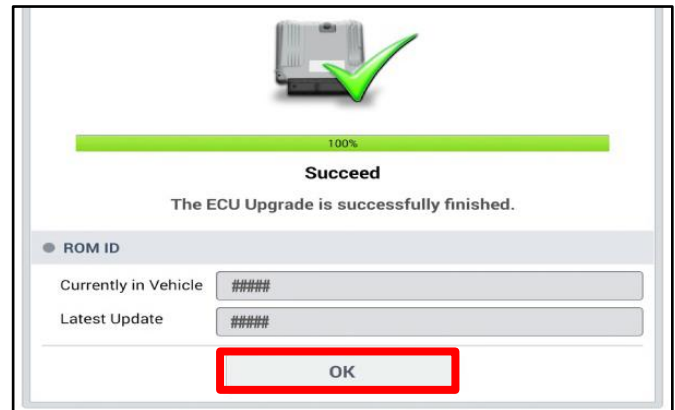
11. Once the upgrade is complete, touch **OK** to finalize the procedure.

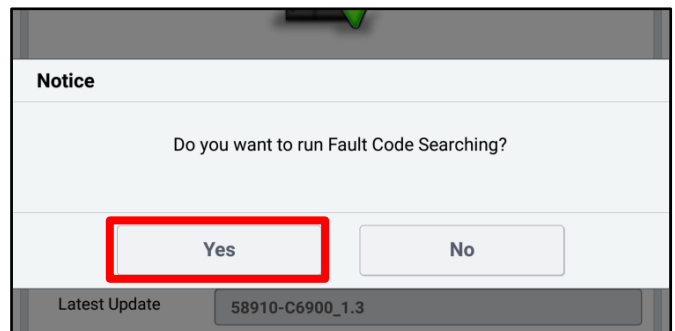
12. When prompted, select **YES** to check for Diagnostic Trouble Codes (DTC) and erase any DTCs stored such as EPS, ESC, and TPMS that may have been set during the upgrade.
