# **Service Alert**

CONNECTED VEHICLE SYMPTOM TROUBLESHOOTING

Service Alert No.: SA-031/20

2019-2021 Mazda3 2020-2021 CX-30 2021 CX-5 2021 CX-9

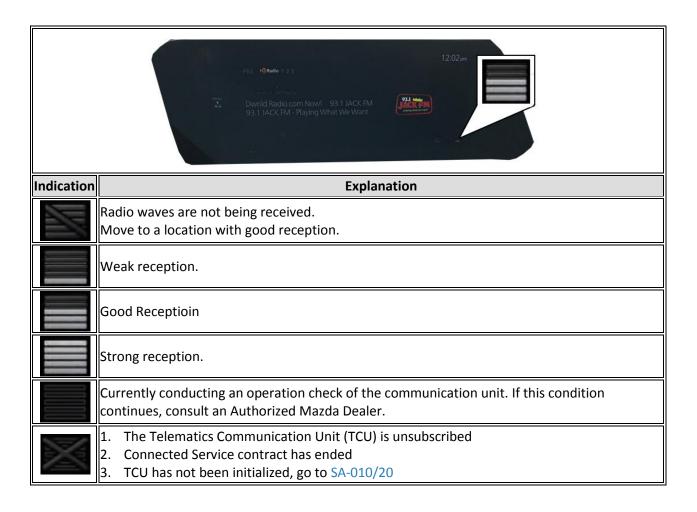
Confirm the customer's phone and vehicle have good to strong reception during the concern as shown in the table below.

- If the reception is weak, move the vehicle to a location where the reception is good to strong as shown in the table, then try to get the Authorization Code and/or operate the remote functions before proceeding to the Repair Procedure if there is still an issue.
- If the reception is good to strong, proceed to the Repair Procedure.
