LTB01248NAS2

TECHNICAL BULLETIN

Electronic Park Brake (EPB) Warning Lamp Illuminated and 'Park Brake needs Calibration' Message Displayed

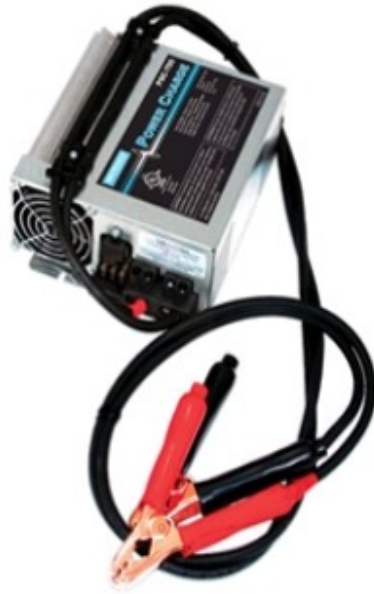
E192494

Jaguar Land Rover-approved
Midtronics battery power supply

- A Jaguar Land Rover-approved Midtronics battery power supply must be connected to the vehicle startup battery.
- All ignition ON/OFF requests MUST be performed; failure to do these steps may cause damage to vehicle control modules.

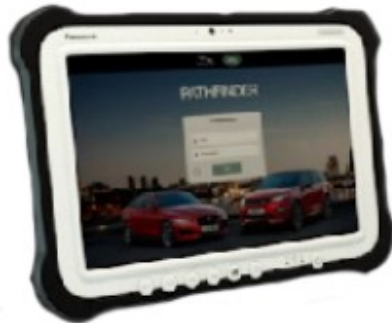
E208514

Jaguar Land Rover-approved
diagnostic equipment with
latest PATHFINDER software
