Symptom: Brakes - Error Message "Brake System Fault" Appears: Re-programming PSM Control Unit (SY 160/19)

Model line: **Macan (95B)**

Subject: **PSM control unit**

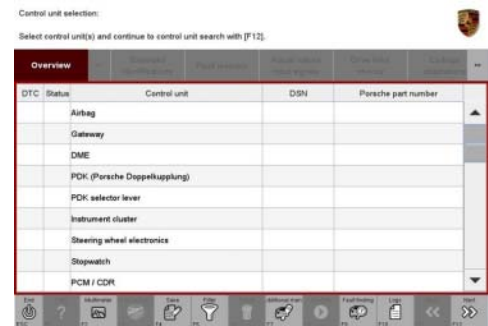
Control unit selection

2.2 Once the PSM control unit has been found and is displayed in the overview, select the **'Maintenance/repairs'** menu.
