WLH1 - Re-Programming DME and PDK Control Unit (Workshop Campaign)

Vehicle Type: **Panamera 4S (971)**
Panamera 4S Executive (971)

Subject: **DME and PDK control unit**

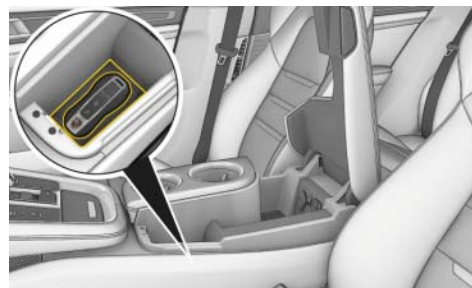
Driver's key in storage compartment

2 Place the driver's key with the back facing down in the front left storage compartment in the center console ⇒ *Driver's key in storage compartment*. This will guarantee an uninterrupted radio link between the vehicle and the driver's key.
