Service Action

Code: 96H1

Subject Lane Assist System Software

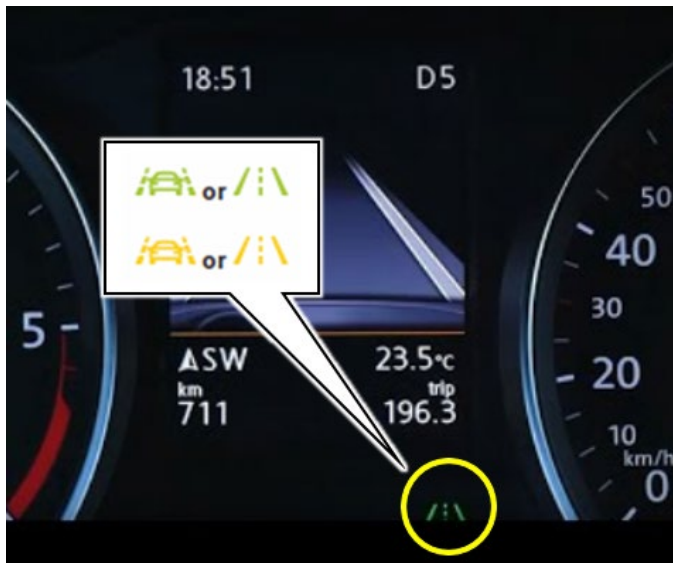
- Perform software configuration for the *Front sensor For Driver Assistance System* to address missing driver assist icons in the instrument cluster.

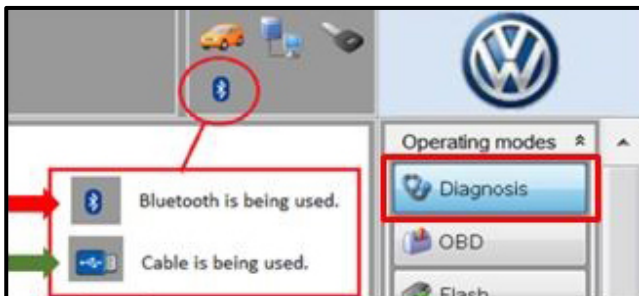
- Confirm that scan tool is communicating with the diagnostic head by USB <Green Arrow>.
 - If the Bluetooth symbol is shown <Red Arrow> then disconnect the diagnostic head from the vehicle and reconnect the USB cable to the diagnostic head and then reattach to the vehicle.
- Upon ODIS startup, verify the "Diagnosis" operating mode is selected <as shown>.
