## QUARANTINE NOTICE

Reference number:	QN-00-1426	Issued: 16 October, 2020
Subject:	Active Park Assist Software Update	
Model(s):	DBX	
VIN Range:	Refer to the separately published list of affected Vehicle Identification Numbers (VINs)	
Applicable to:	All Dealers	
Distribute to:	After Sales Manager Executive Manager Service Manager Sales Manager	Warranty Staff Technician(s) Parts Staff

Aston Martin has released a software update to the active park assist to give a smoother vehicle movement when the system is in operation.

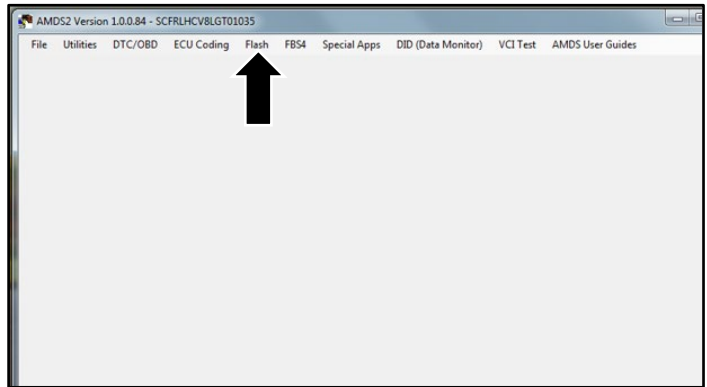
Figure 1

4. Select "Flash" (refer to Figure 1).

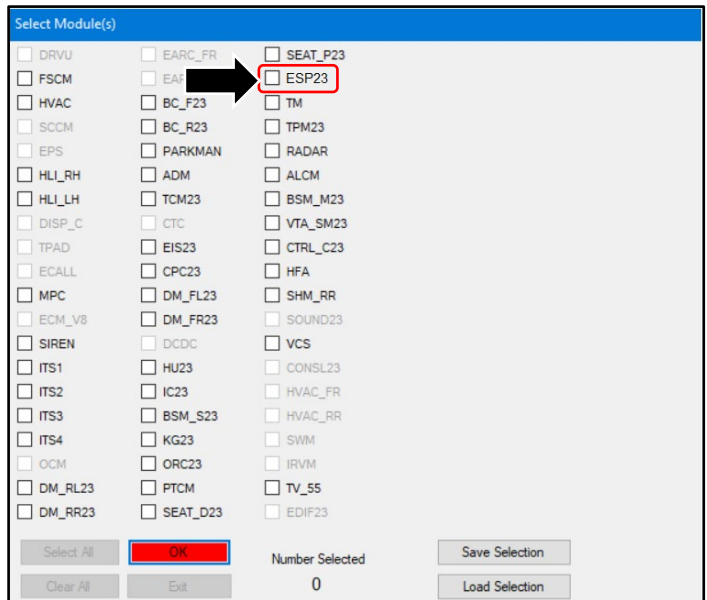
Figure 2

5. Select the "ESP23" module then click the "OK" button (refer to Figure 2).

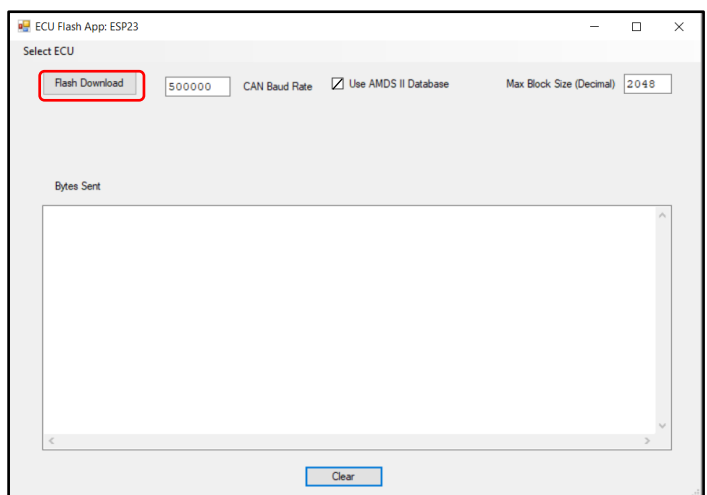
Figure 3

6. Click the "Flash Download" button (refer to Figure 3).

**Note: The update is complete when you can read "Post-programming sequence completed OK. VCI Disconnected. DRVU reset OK" in the display.**

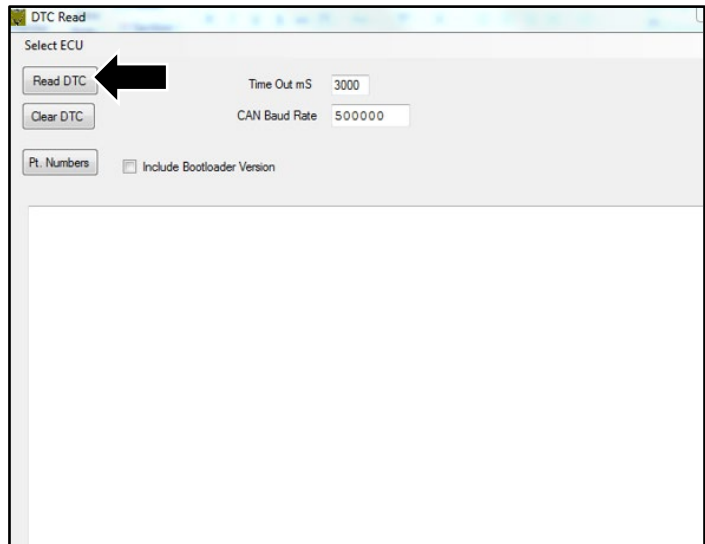
Figure 5

9. In the “DTC Read” window, click the ‘Read DTC’ button, (refer to Figure 5).

- 10. Make sure there are no diagnostic trouble codes (DTCs) stored for the ESP23 Module.
- 11. Open the door to make sure the ignition turns off, then close the door again.
- 12. Set the ignition to on but do not start the engine.
- 13. Do a check for DTCs.
- 14. Disconnect the VCI from the vehicle and shut down AMDS 2.0.
- 15. Set the ignition to OFF.
