Release Date	11/03/2020	Technical Service Bulletin	
90P4 UPDATE

Audi
Gateway Software Update – (NVLW)

Criteria	Technical Background
01	The internal time in the gateway may run asynchronously. As a result, requests automatically become invalid after approx. 60 minutes and are rejected. This means that the Audi connect vehicle-specific services can no longer be run.

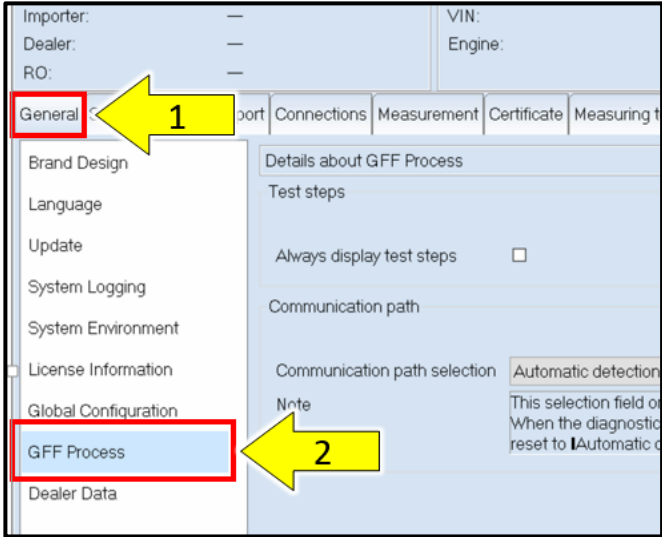
- From the “General” tab <arrow 1>, select “GFF Process” <arrow 2>.

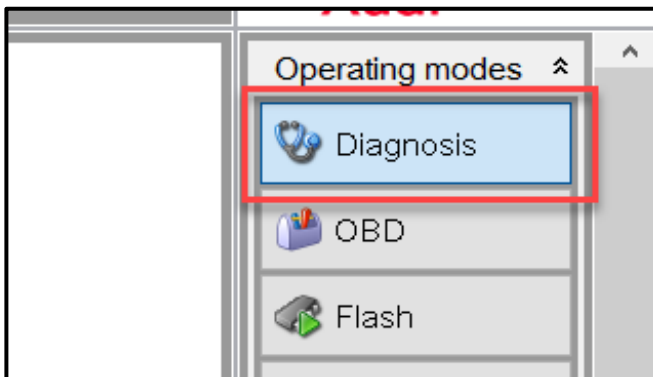
- From the home screen of the scan tool highlight “Diagnosis” and perform a full GFF diagnostic scan.
- Follow the on-screen prompts.

Operating mode “Diagnosis” must be used. Some models will not allow the update to start after changing the communication path to DoIP using operating mode “Flash.”
