Service Action

Code: 90o2

Subject	Gateway Control Module																		
Release Date	November 03, 2020																		
Affected Vehicles

Repair Instruction

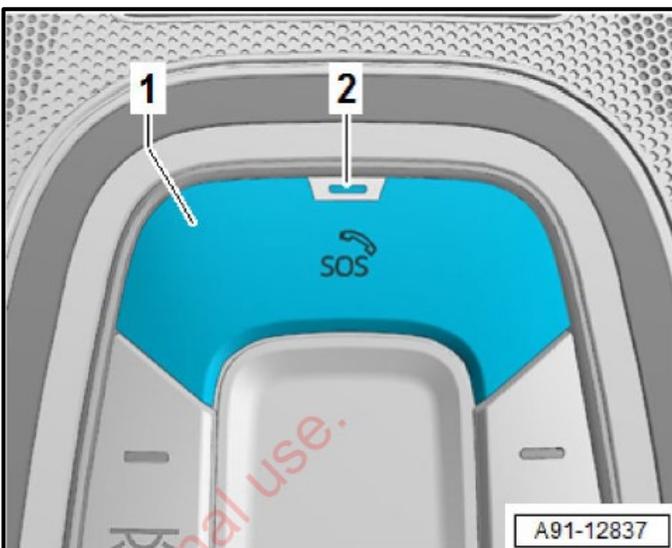
Section B – Check Emergency Call Function Operation

- Switch ignition on.
- Deactivate flight and transport mode (if necessary).
- Check if LED <2> is lit in green.
- If the LED is lit in green:
 - No further work is required.
 - Proceed to Section F.
- If the LED is lit in red:
 - Proceed to Section C.

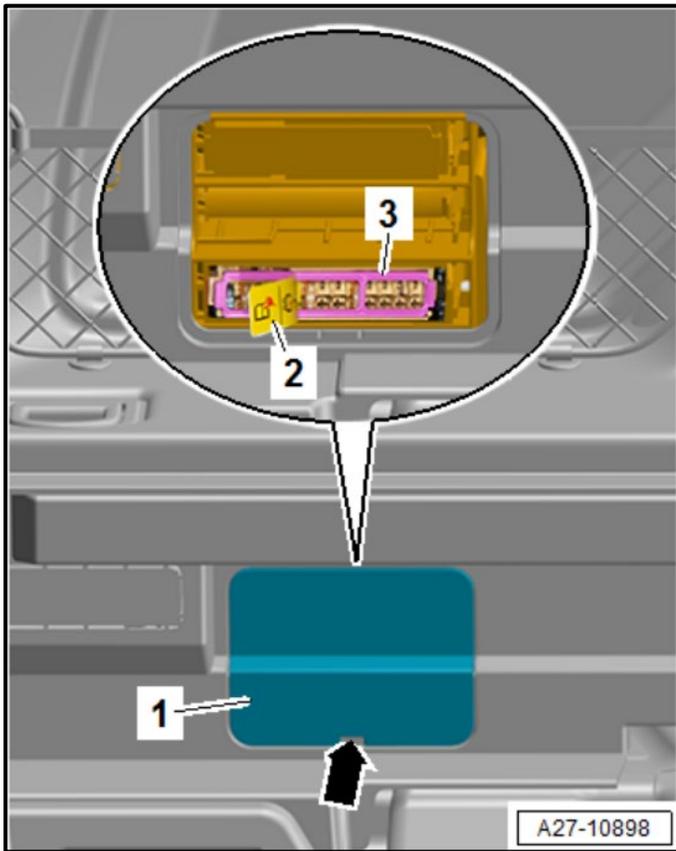
Disconnect the 12V battery:

- Open the tailgate.
- Lift the luggage compartment floor.
- The service cover <1> is located on the left side of the luggage compartment.
- Release the catch <arrow>.
- Remove the service cover <1>.
- Release the fastener <3> and remove it from the fuse panel.
- Remove the fuse <2> with the rescue instructions from fuse location no. 5 (SM5).

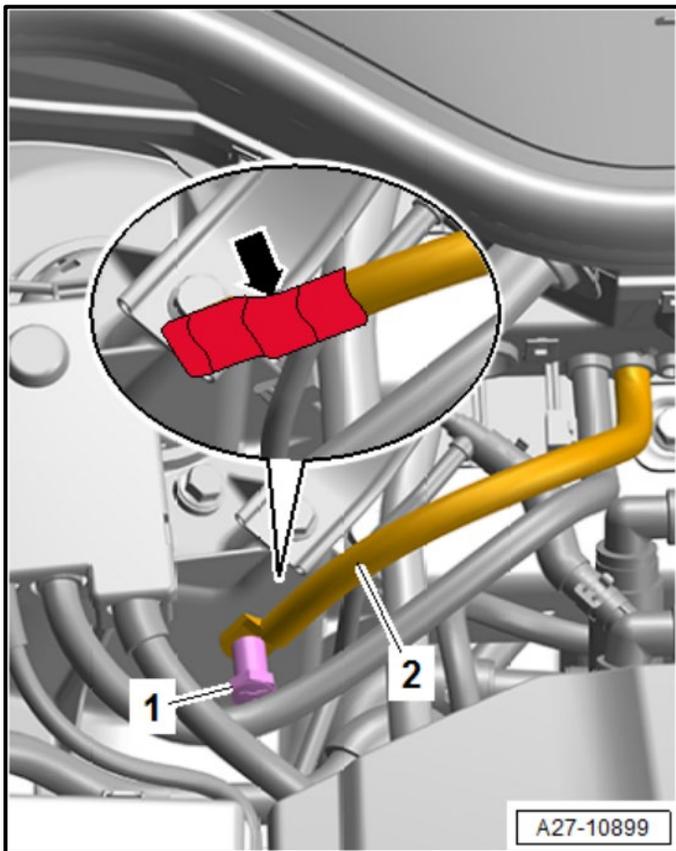
- Open the hood.
- Remove the nut <1> and free up the ground wire <2> from the threaded pin.

If the 12V battery is not being reconnected right away for any reason, immediately wrap the ground wire with insulating tape <arrow> and set it aside.

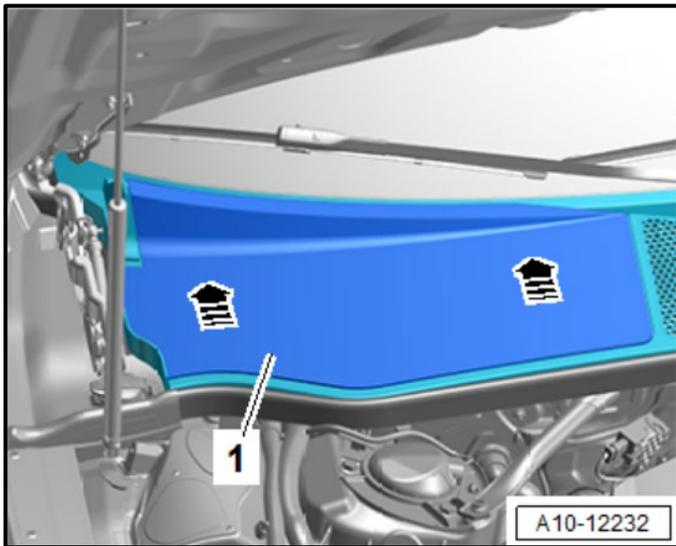
Reconnect the 12V battery:

- Remove the cover <1> toward the rear <arrows>.

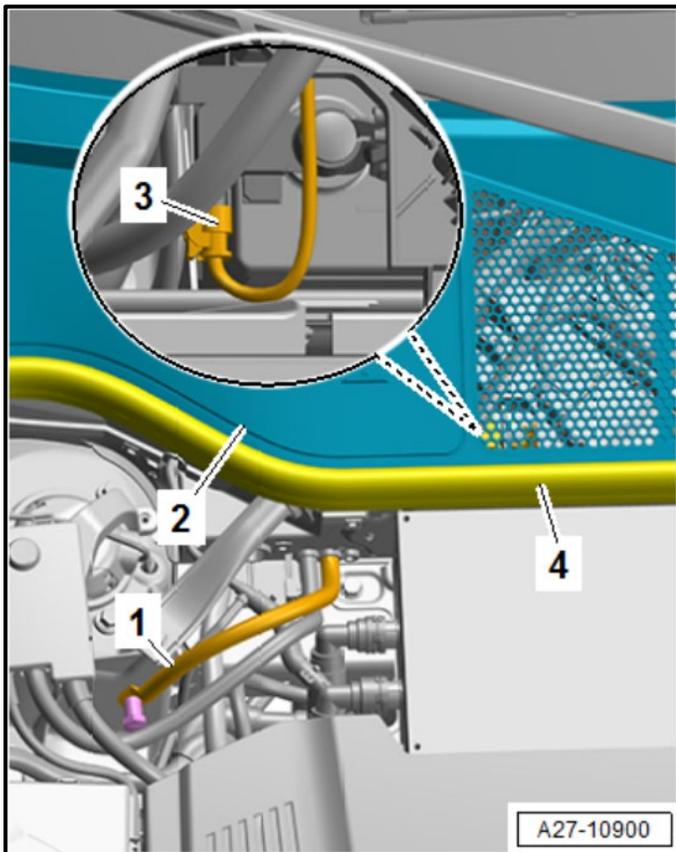
- Disconnect the connector <3> at the Battery Monitoring Control Module -J367-.
- Secure the ground wire <1> on the body, install securing nut and torque to 9 Nm.

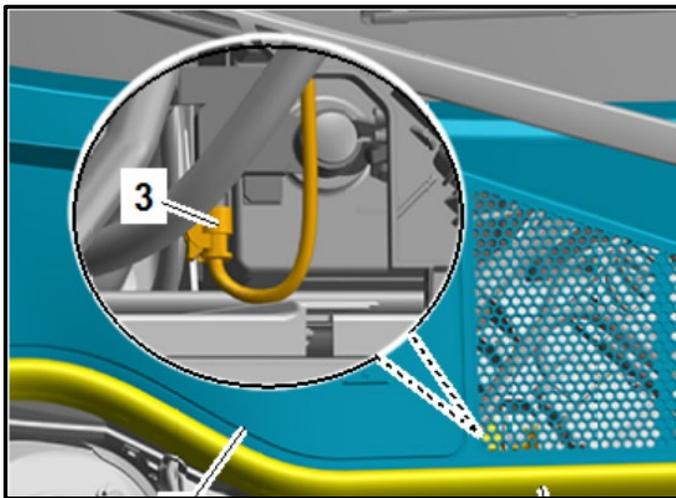
- Reconnect the connector <3> to the Battery Monitoring Control Module -J367-.
- Set clock to local time.
- Activate the convenience open/close functions.
- Check the DTC memories of all the control units and erase under-voltage faults if necessary.

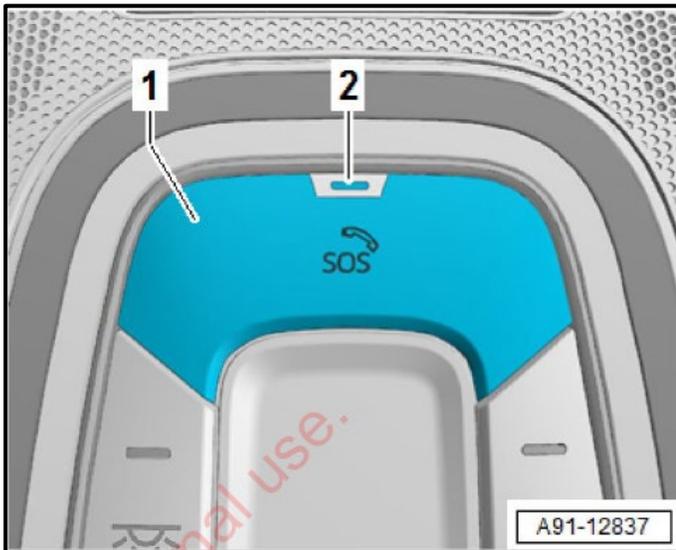
Recheck LED:

- Switch ignition on.
- Check if LED <2> is lit in green.
- If the LED is lit in green:
 - No further work is required.
 - Proceed to Section F.
- If the LED is lit in red:
 - Vehicles with Criteria 01:
 - A software update is required.
 - Proceed to Section D.
 - Vehicles with Criteria 02:
 - Replacement of the gateway control module is required.
 - Proceed to Section E.

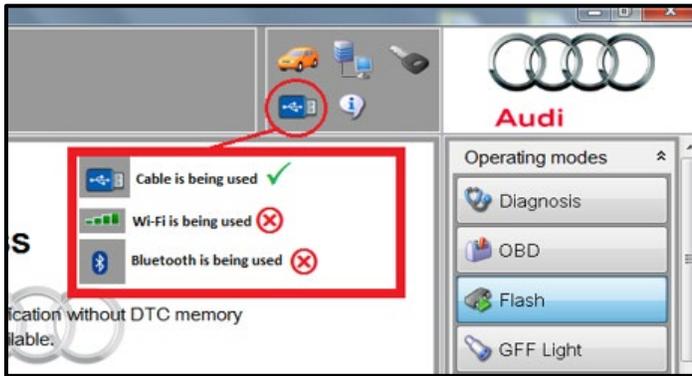
- Confirm that scan tool is communicating with the diagnostic head by USB cable.
 - If the Bluetooth or WiFi symbol is shown, then disconnect the diagnostic head from the vehicle and reconnect the USB cable to the diagnostic head and then reattach to the vehicle.

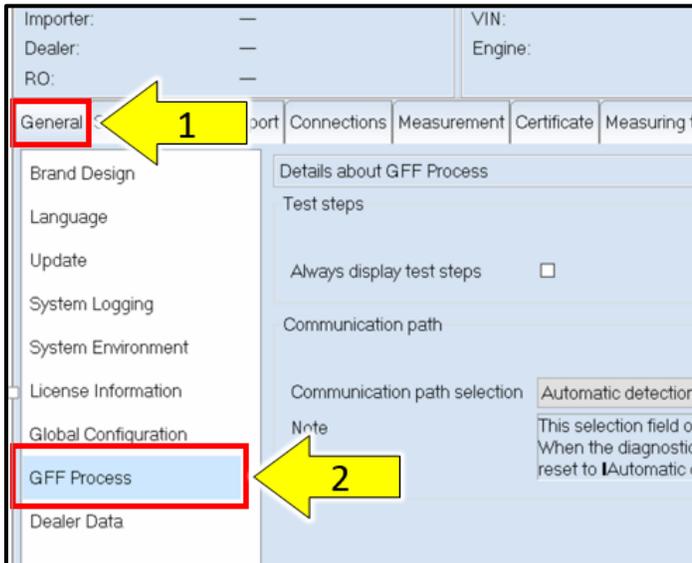
- From the “General” tab <arrow 1>, select “GFF Process” <arrow 2>.

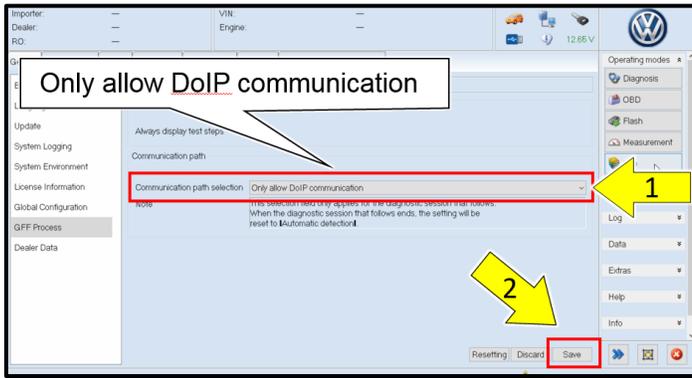
- From the “Communication path selection,” select “Only allow DoIP communication” <arrow 1>.
- Select “Save” <arrow 2>.

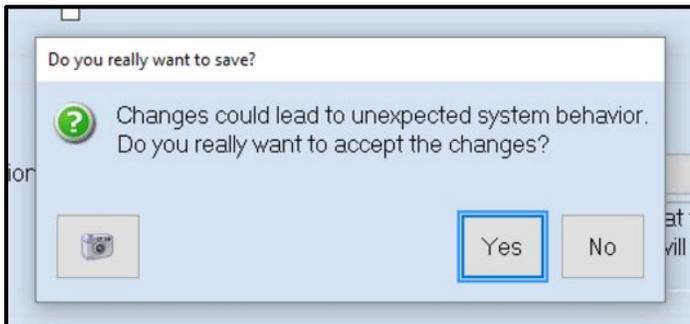
- Select “Yes” when prompted, “Do you really want to save?”
- Return to the home screen of the scan tool.

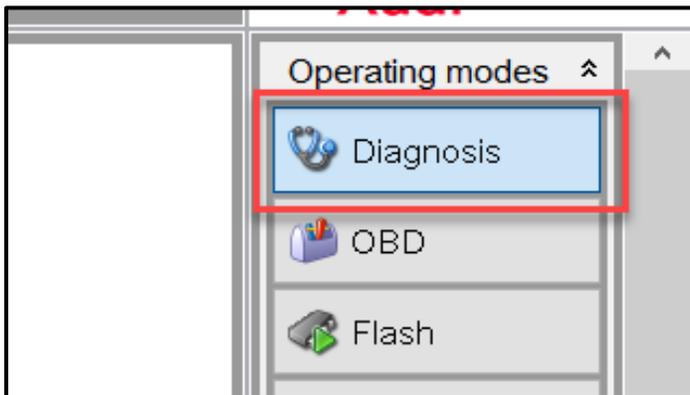
- From the home screen of the scan tool highlight “Diagnosis” and perform a full GFF diagnostic scan.
- Follow the on-screen prompts.

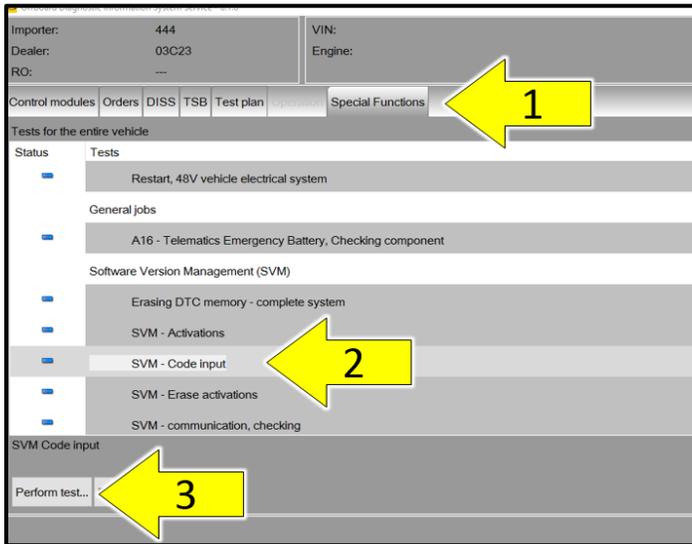
- After the diagnostic scan is complete:
 - Select the “Special Functions” tab <1>.
 - Select “SVM Code Input” <2>.
 - Select “Perform test...” <3>.
- Follow the on screen prompts.

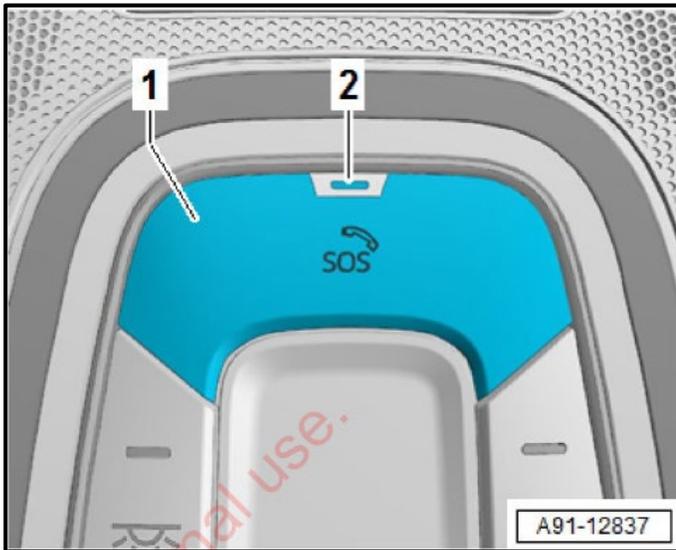
Recheck LED:

- Switch ignition on.
- Check if LED <2> is lit in green.
- If the LED is lit in green:
 - No further work is required.
 - Proceed to Section F.
- If the LED is lit in red:
 - Further diagnosis will be required.
 - Additional diagnosis and repairs will not be covered under this action.

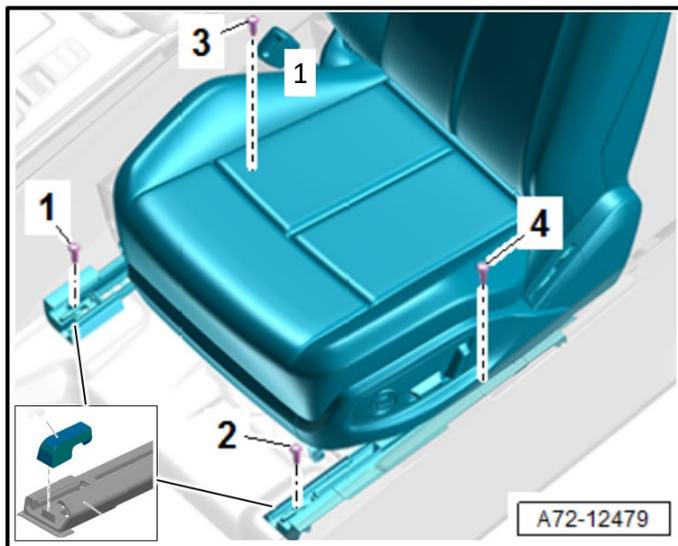
Remove left front seat:

- Move the headrest into the lowest position.
- Move the front seat all the way forward and up.
- Remove rear bolts <3 and 4> from the seat rail.
- Move the front seat all the way to the rear and then into its lowest position.
- Pry off the spindle covers <inset> using a small flat-head screwdriver.
- Remove the front bolts <1 and 2> from the seat rail.

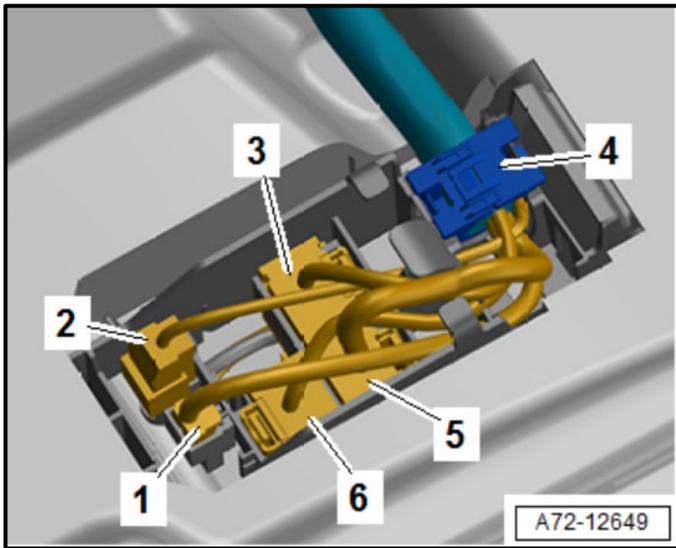
- Unclip the cable holder <4> from the retainers.

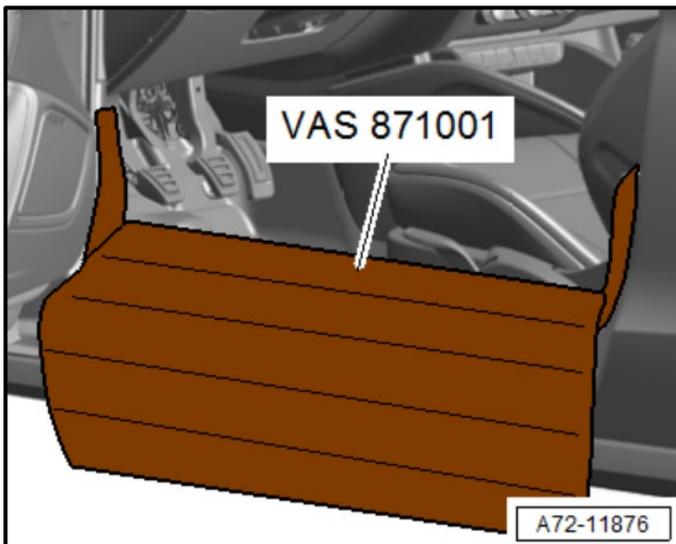
- Disconnect the connectors on the connector station in the floor.
 - 1 - For Versions with Rear Seat Entertainment
 - 2 - Thorax airbag
 - 3 - Seat Belt Latch/Seat Position Sensor
 - 5 - Power Supply
 - 6 - For Versions with Seat Heating
- To protect the sill panel before removing the front seat, attach the -VAS871001-.
- Remove the front seat from the vehicle with a second technician.
- Make sure the seat position sensor is not damaged when setting the seat down.

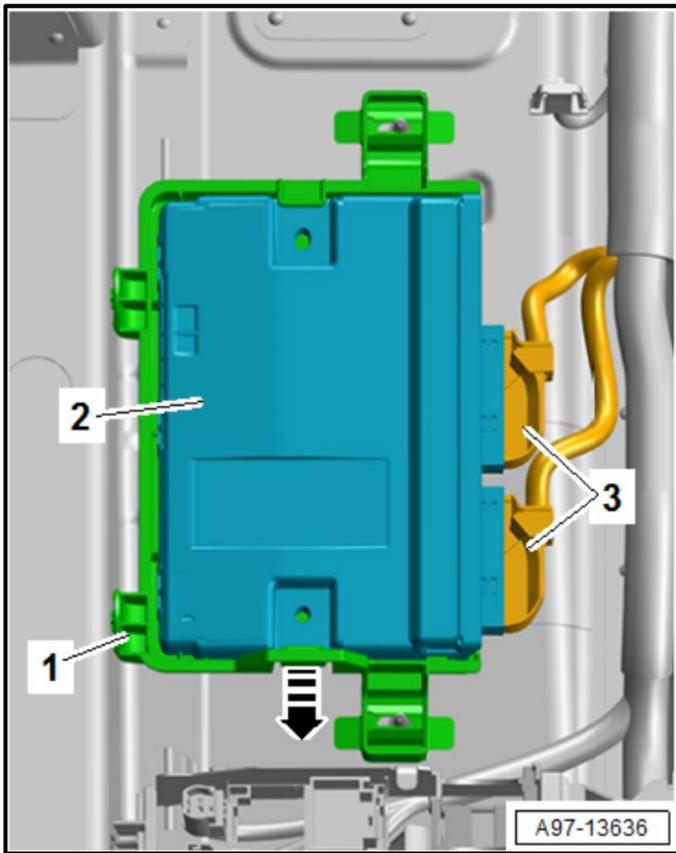
- Detach and lift the front carpet on the left side of the vehicle.

- Release the retainer in direction of <arrow>.
- Remove the data bus on board diagnostic interface <2> from the mount <1>.
- Disconnect the connectors <3>.
- Install the new gateway control module in the reverse order of removal.
- Install the driver front seat in the reverse order of removal.
 - Ensure all connectors are fully seated.
 - Torque seat bolts to 40 Nm.
- Perform replacement test plan for gateway control module using Guided Fault Finding.
