Service Bulletin

Bulletin No.: 20-NA-212

Subject: IPC Gauges Inoperative or Fluctuate, No Crank, Start then Stall

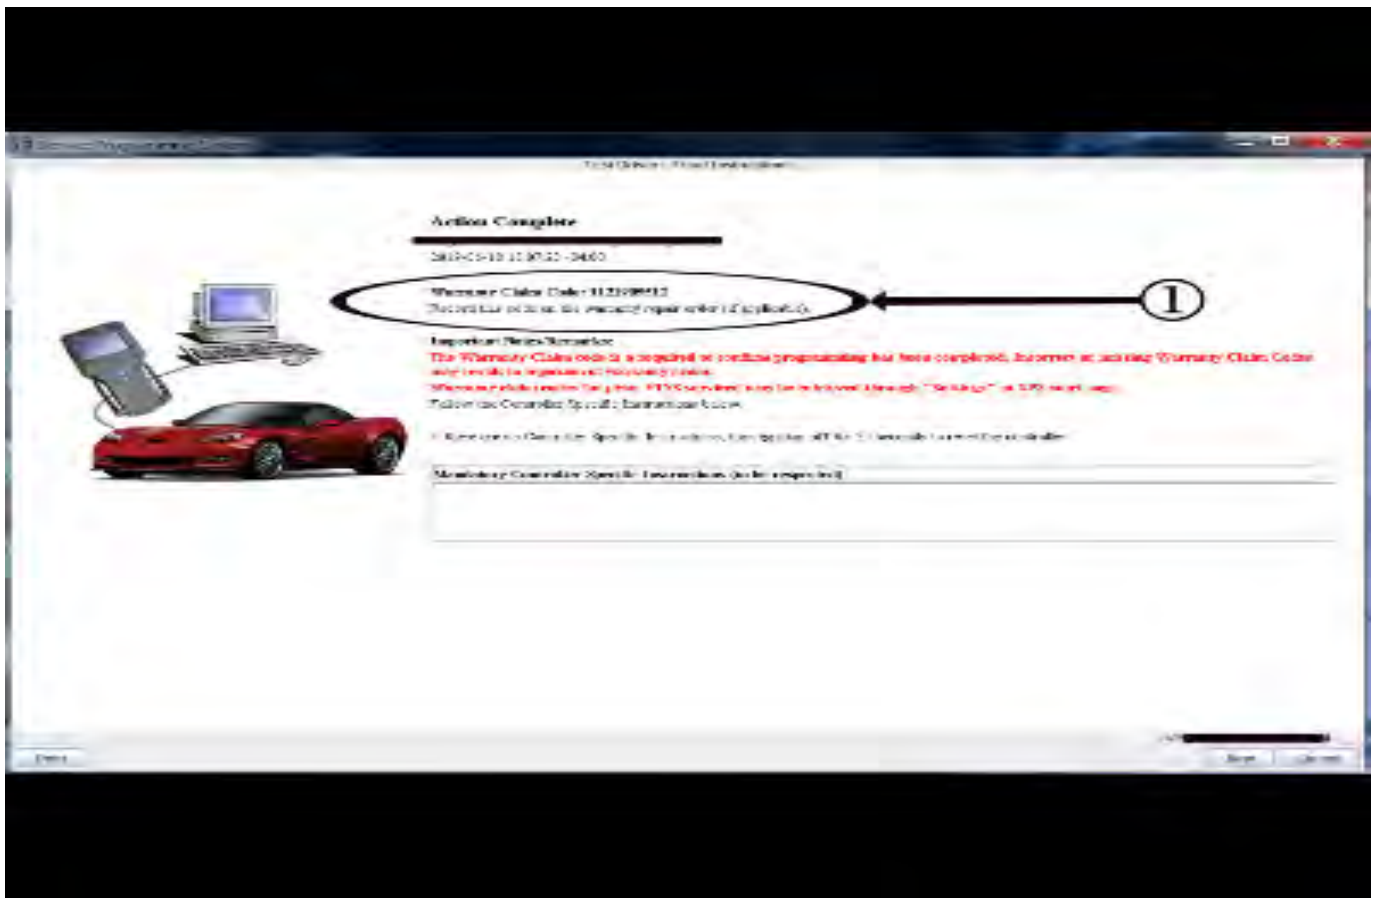
5431209

Important: To avoid warranty transaction rejections, you **MUST** record the warranty claim code provided on the SPS Warranty Claim Code (WCC) screen shown above on the job card. Refer to callout 1 above for the location of the WCC on the SPS screen
