Release Date	11/12/2020	Technical Service Bulletin		
24GD UPDATE

ECM Software Update – (FED EMS)

This Update has been proactively released to prevent the following condition from occurring in the vehicle:	
Criteria	Condition
01	MY19 VW Atlas vehicles with the 2.0 TFSI engine have low misfire detection capability during catalyst heating.

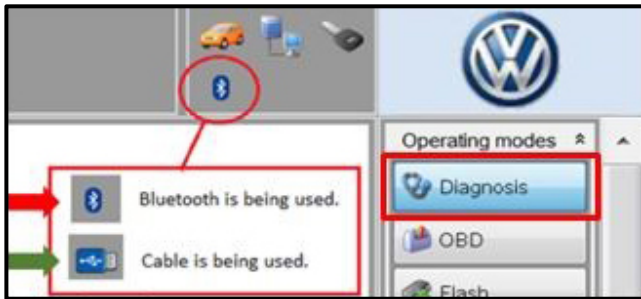
- Confirm that scan tool is communicating with the diagnostic head by USB <Green Arrow>.
 - If the Bluetooth symbol is shown <Red Arrow> then disconnect the diagnostic head from the vehicle and reconnect the USB cable to the diagnostic head and then reattach to the vehicle.
- Upon ODIS startup, verify the “Diagnosis” operating mode is selected <as shown>.
- Once the GFF scan is complete, select “Special functions” <arrow 1>, then “Adapting software” <arrow 2>, then select “Perform test” <arrow 3>.

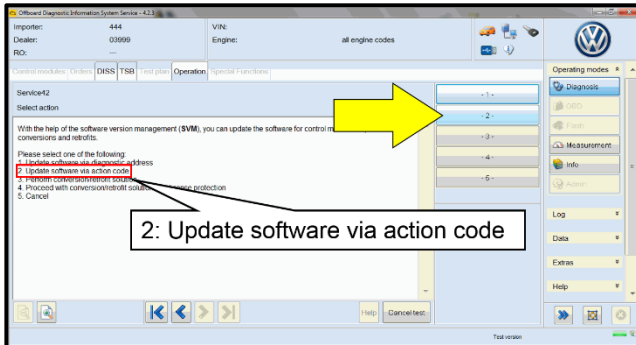
- Select the correct option to “Update software via action code” OR “Software update via measured code”.

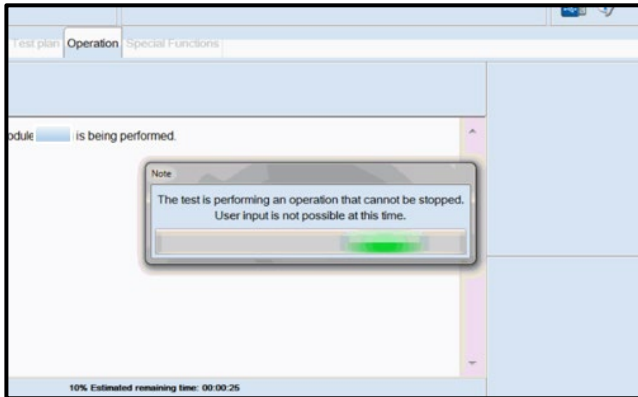
- During the flash, this screen appears when each operation is performed:

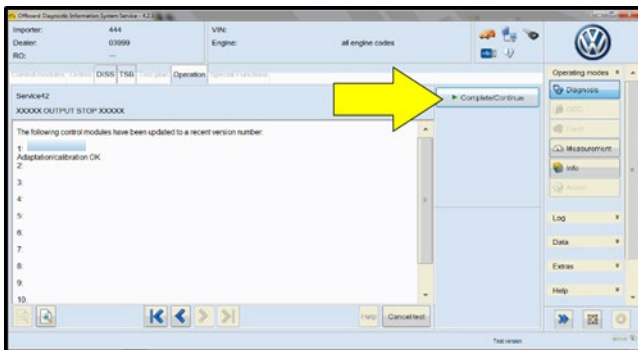
- Select Complete/Continue <arrow> after each operation is completed.
