NUMBER
PI1803Y/Z (Rev 4, 11/12/2020)

PRODUCT IMPROVEMENT CAMPAIGN

ENGINE REPLACEMENT INSTRUCTIONS FOR DTC P1326 (PI1803Y/Z)

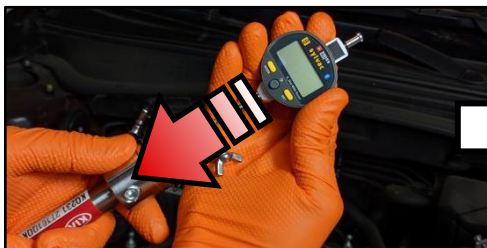
- 7. Install the Dial Gauge fully into the Probe Rod and secure together by hand tightening the locking wingnut.

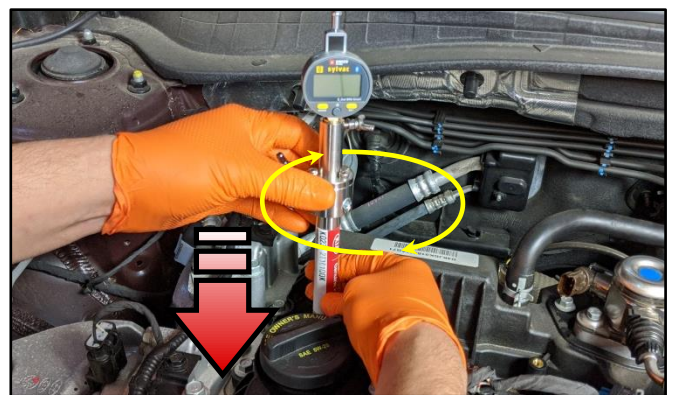
- 8. **Carefully**, insert the assembled SST Probe Rod and Dial Gauge into the Cylinder 1 spark plug hole and **carefully** turn the SST Crankshaft Rotator **by hand** clockwise until hand tight.

CAUTION
Damage to cylinder head can occur if spark plug hole is cross-threaded. DO NOT use a wrench to tighten the SST rod.

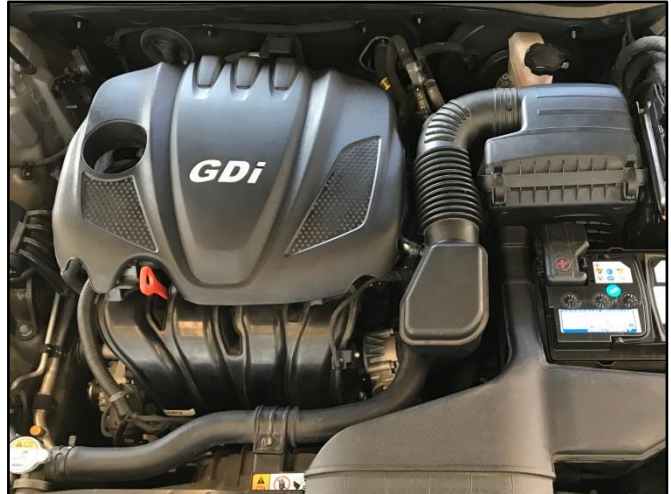
1. Remove the engine assembly by referring to the “Engine And Transmission (Transaxle) Assembly → Engine And Transmission (Transaxle) Assembly → Repair procedures” chapter in the applicable Shop Manual on KGIS.

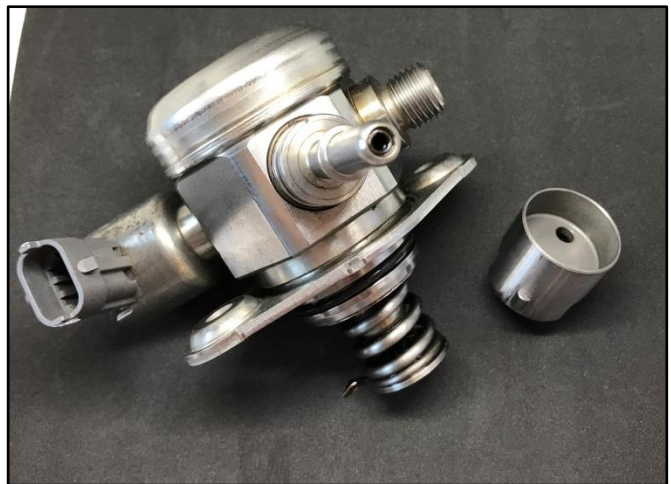
High Pressure Pump & Roller Tappet:

- Refer to [TSB ENG083](#) for special attention and handling procedures of GDI-specific components.
- When installing the high pressure pump and roller tappet onto the new engine, apply engine oil to the roller tappet, and O-rings of the high pressure pump.

Tightening torques of pump bolts:
9.4 – 10.9 lb.ft (12.8 – 14.7 N.m,
1.3 – 1.5 kgf.m)

Tightening torques of pipe flare nut:
19.5 – 23.9 lb.ft (26.5 – 32.4 N.m,
2.7 – 3.3 kgf.m)

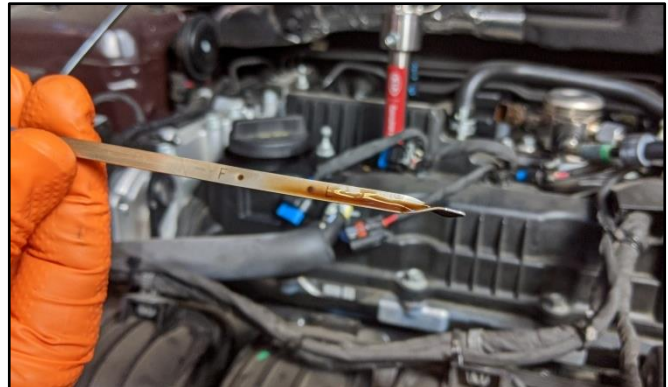
1. Measure and record oil dip stick level.
2. Note oil dip stick reading on the RO.

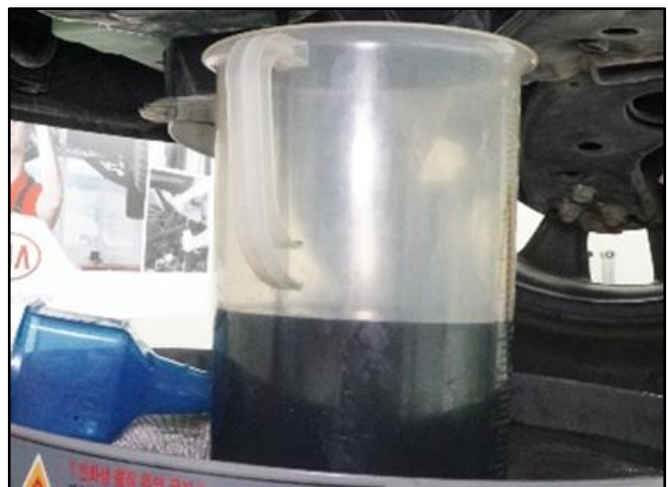
1. Remove oil filler cap, remove oil drain plug and drain oil into the supplied measuring container SST067BUCK and check oil level.
2. Record oil level reading.
3. Take photo of the oil level using KDS.

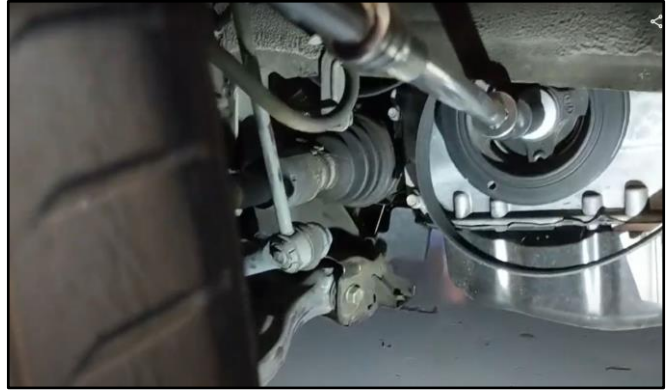
5. Show the removed drive belt and attached torque wrench to crank bolt.

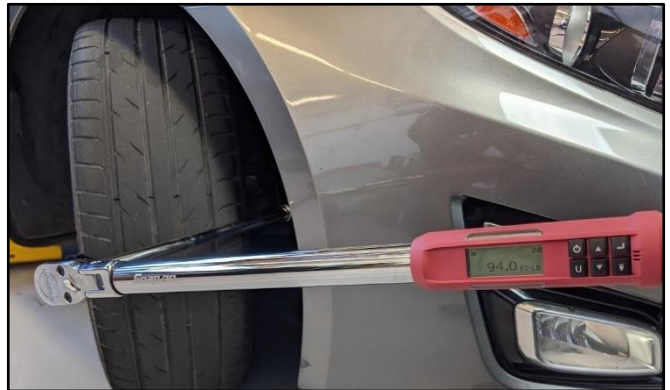
6. Show the engine being cranked and torque specification exceeding 94 lb.ft. torque.
