MODEL
2020-2021MY
Sportage (QL)

NUMBER
220

TECHNICAL SERVICE BULLETIN

**SERVICE ACTION: FRONT CAMERA
OPERATION LOGIC IMPROVEMENT (SA449)**

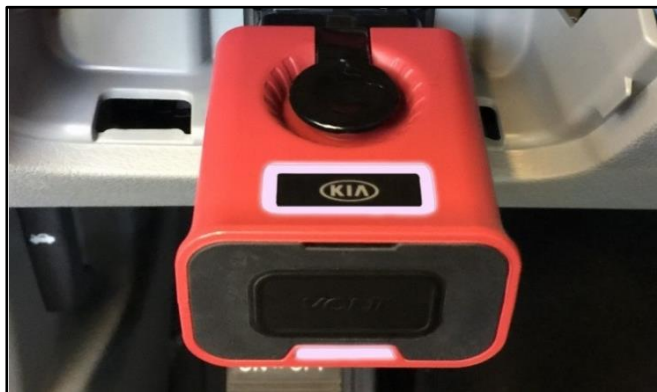
1. Connect the VCI-II to the OBD-II connector, located under the driver's side of the instrument panel.

The ECU upgrade function on KDS operates wirelessly. It is not necessary to perform the upgrade via USB cable.

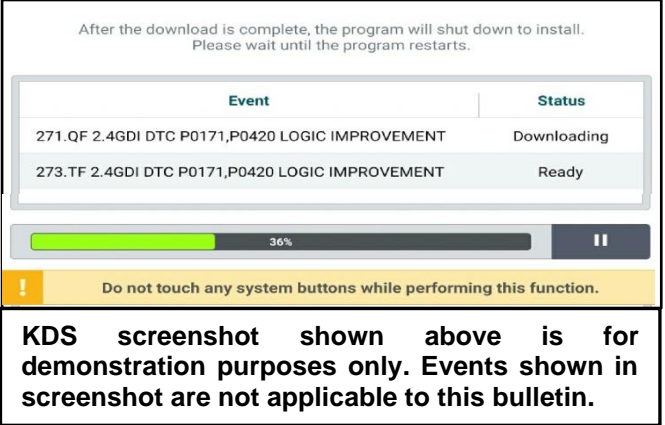
- 5. The KDS will check the server for recently uploaded Events and then automatically download **Upgrade Event #511**.

*** NOTICE**
 The vehicle must be identified in Vehicle Selection to download an Event for that vehicle.

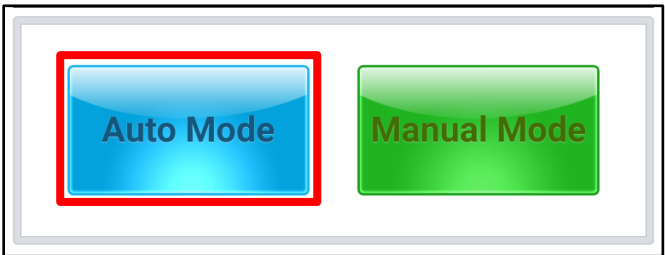
- 6. Select **Auto Mode**.

CAUTION
 Do NOT attempt to perform a Manual Mode upgrade UNLESS Auto Mode fails. Always follow the instructions given on the KDS in either Auto or Manual mode.

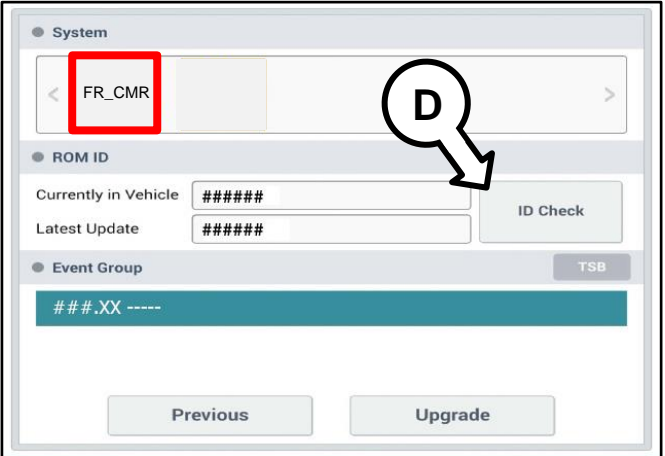
- 7. Select the **FR_CM** system under the System selection menu.

Touch **ID Check** (D) and confirm that the latest update is available.

Select **Upgrade Event #511** and select **Upgrade** to continue.

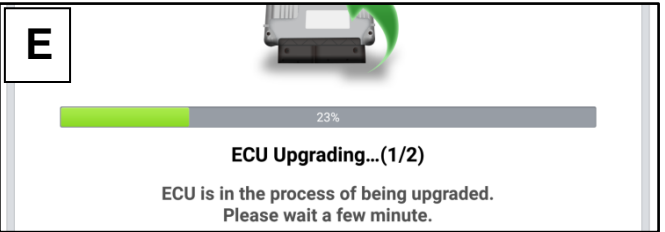
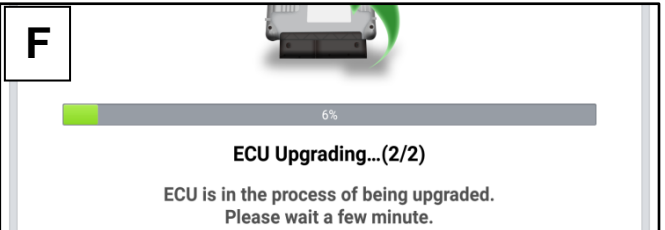
- 8. The ECU upgrade will begin and the progress of the upgrade will appear on the bar graph. Upgrade part (1/2) (E) will download the upgrade event to the VCI-II. Upgrade part (2/2) (F) will upgrade the ECU.

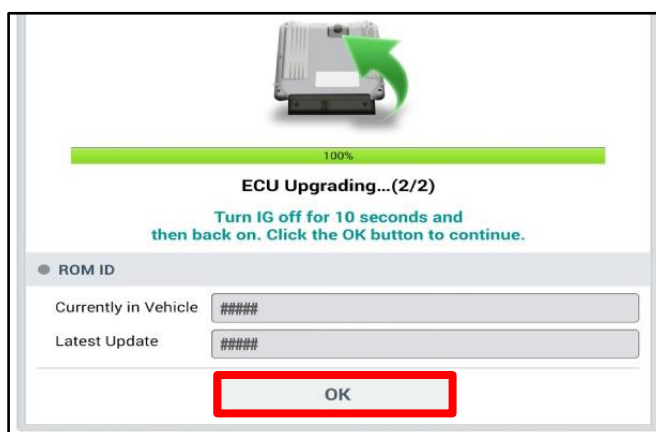
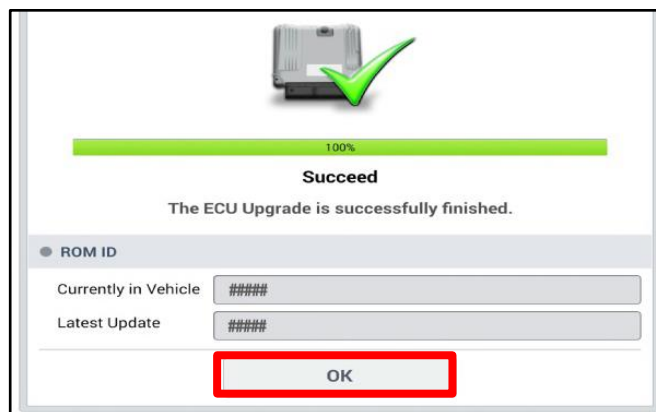
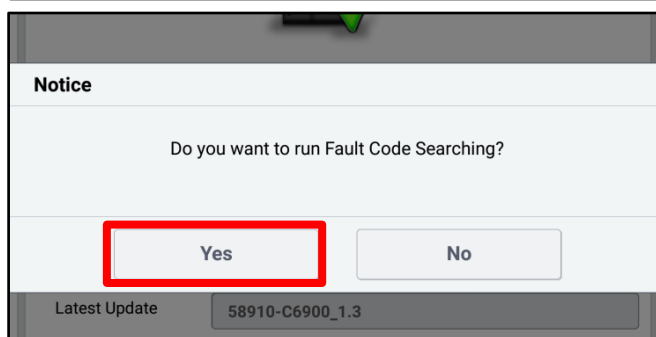
9. If a "Communication Fail" screen appears, verify that the VCI-II and KDS are communicating properly. Touch **OK** and restart the procedure from step 4.

10. When instructed on the KDS, turn the ignition **OFF** for ten (10) seconds then back on. Touch **OK** to continue.

11. Once the upgrade is complete, touch **OK** to finalize the procedure.

12. When prompted, select **YES** to check for Diagnostic Trouble Codes (DTC) and erase any DTCs stored such as EPS, ESC, and TPMS that may have been set during the upgrade.
