WLFO - Re-Programming PDK Control Unit (Workshop Campaign)

Vehicle Type: **Panamera 4 E-Hybrid Sport Turismo (971)**
Panamera 4S (971) / Panamera 4S Sport Turismo (971)
Panamera Turbo (971) / Panamera Turbo Sport Turismo (971)
Panamera Turbo S E-Hybrid (971) / Panamera Turbo S E-Hybrid Sport Turismo (971)

Subject: **PDK control unit**

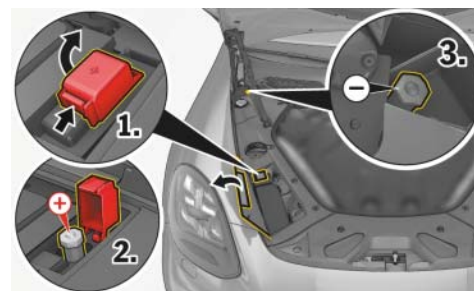
Jump-start terminals

Work Procedure: 1 Connect a battery charger with a current rating of at least 90 A, e.g. **VAS 5908 Battery charger 90A**, to the jump-start terminals in the engine compartment and switch it on ⇒ *Jump-start terminals*.

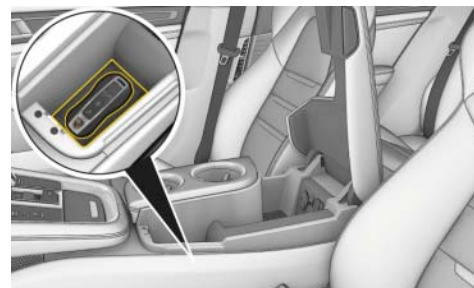
Driver's key in storage compartment

2 Place the driver's key with the back facing down in the front left storage compartment in the center console ⇒ *Driver's key in storage compartment*. This will guarantee an uninterrupted radio link between the vehicle and the driver's key.

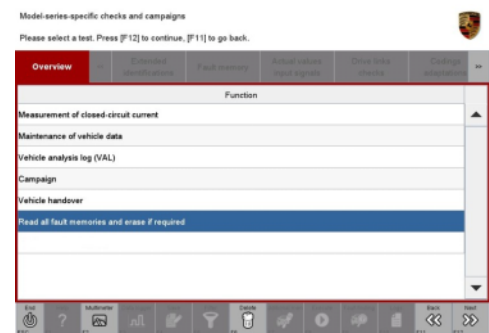
Erasing fault memories

- 1.1 Press •F7" in the control unit selection screen ('Overview' menu) to call up the Additional menu.
- 1.2 Select the function "Read all fault memories and erase if required" and press •F12" ('Next') to confirm your selection ⇒ *Erasing fault memories*.

- 1.4 Press •F8" to delete fault memory entries.
- 1.5 Press •F12" ("Yes") in response to the question as to whether you really want to delete all fault memory entries.

The faults stored in the fault memories of the various control units are deleted.

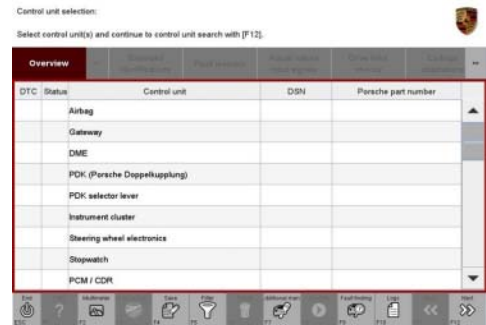
Control unit selection

1.6 Once you have erased the fault memories, select the **'Overview'** menu to return to the control unit selection screen ⇒ *Control unit selection*.

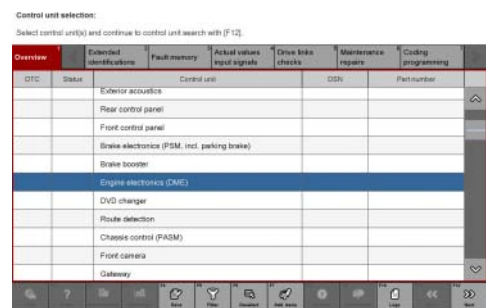
Selecting DME control unit

2.1 Select the **'DME' control unit** in the control unit selection screen ('Overview' menu) and press •F12" ('Next') to confirm your selection ⇒ *Selecting DME control unit*.

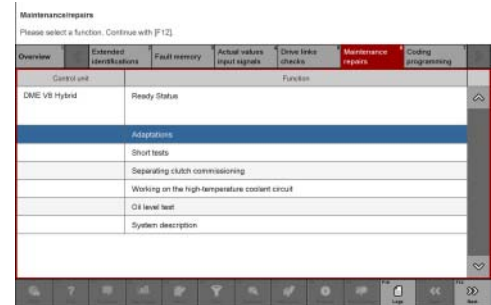
DME control unit adaptations

- 2.3 Select menu item 'Adaptations' and press
 •F12" ('Next') to confirm your selection
 ⇒ *DME control unit adaptations.*

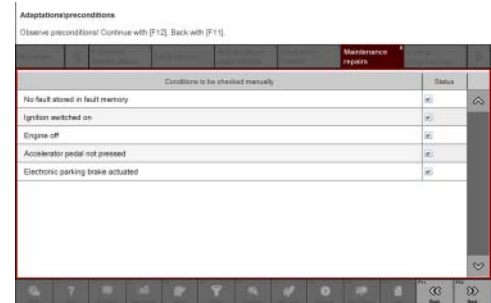
Adaptations: Observe the prerequisites

- 2.4 Comply with the preconditions displayed on the PIWIS Tester and press •F12" ('Next') to confirm ⇒ *Adaptations: Observe the prerequisites.*
- 2.5 Select the **displayed adaptations individually and one after the other** and press •F12" ('Next') to confirm your selection. Then, start the selected adaptation by pressing •F8" ('Start') and follow the instructions on the PIWIS Tester.

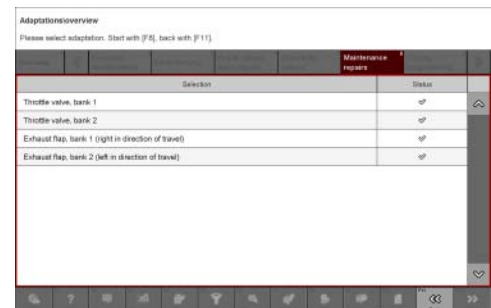
Adaptations performed successfully

Then, press •F11" ('Back') to return to the selection of adaptations and **repeat** the process until **all the displayed adaptations** have been carried out.

- 2.6 Press •F11" to return to the overview of the **'Maintenance/repairs'** menu.
- 2.7 Select the **'Overview'** menu and press •F11" ('Back') to return to the control unit selection screen.
