## Field campaign

<b>Topic</b>	Bentayga Hybrid - Software update to 008C Hybrid battery management and 06D0 Battery interrupt switch (SC20/11)
<b>Market area</b>	Bentley: worldwide (2WBE)
<b>Brand</b>	Bentley
<b>Transaction No.</b>	2059286/2
<b>Campaign number</b>	EB53
<b>Note</b>	
<b>Type</b>	
<b>US code</b>

Software update required to address 008C - Hybrid battery management control module and address 06D0 - Battery interrupt switch control module

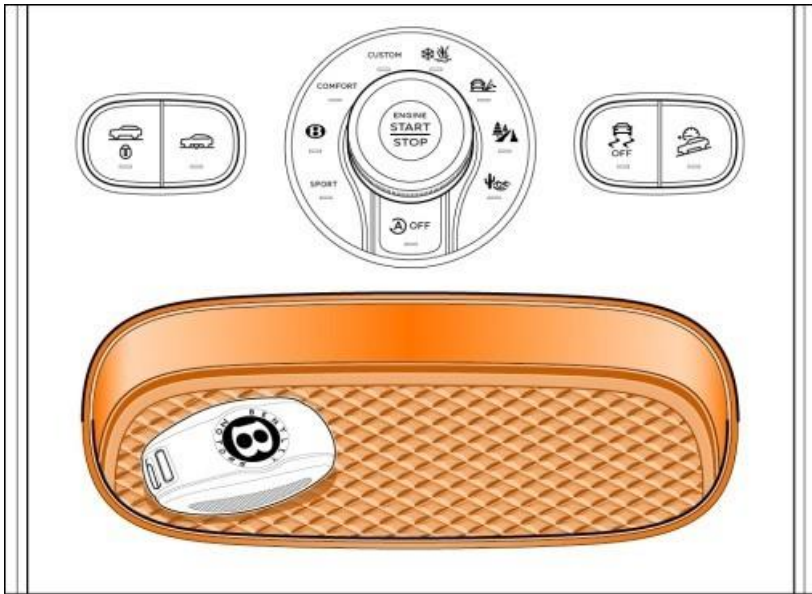
1) Place the ignition key in the remote control key reader and switch on the ignition - Figure 1

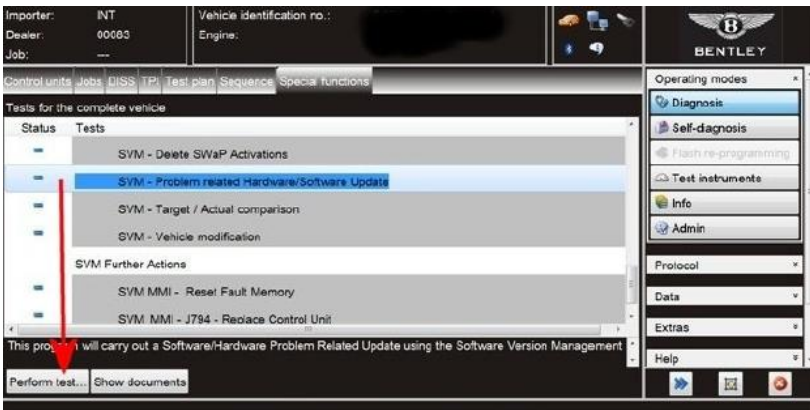
Figure 2

- Within the Special functions tab select SVM – Problem related Hardware/Software update then select Perform test (Figure 2)

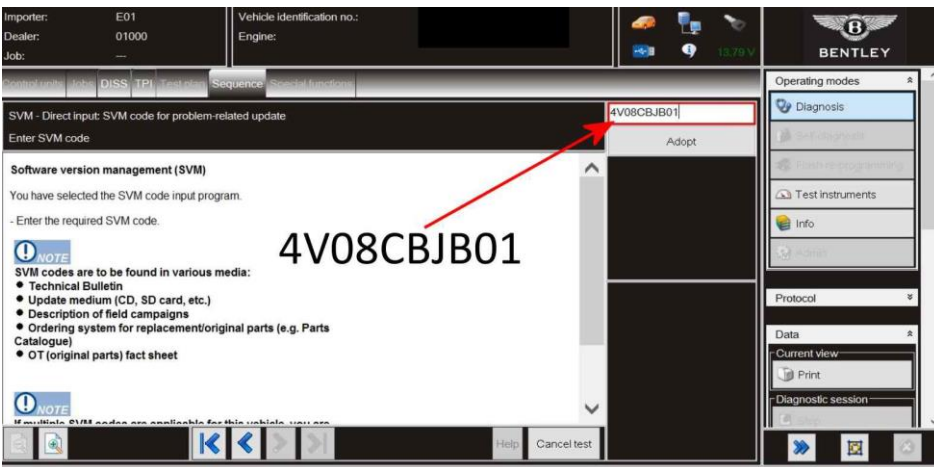
Figure 3

3) On the next screen enter the SVM code 4V08CJB01 and select Adopt (Figure 3)

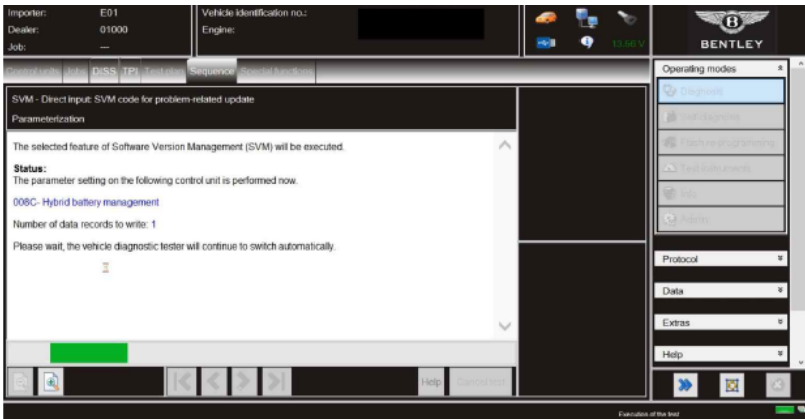
Figure 5

4) Referring to Figure 5, once the update is complete, the parameters will then be applied

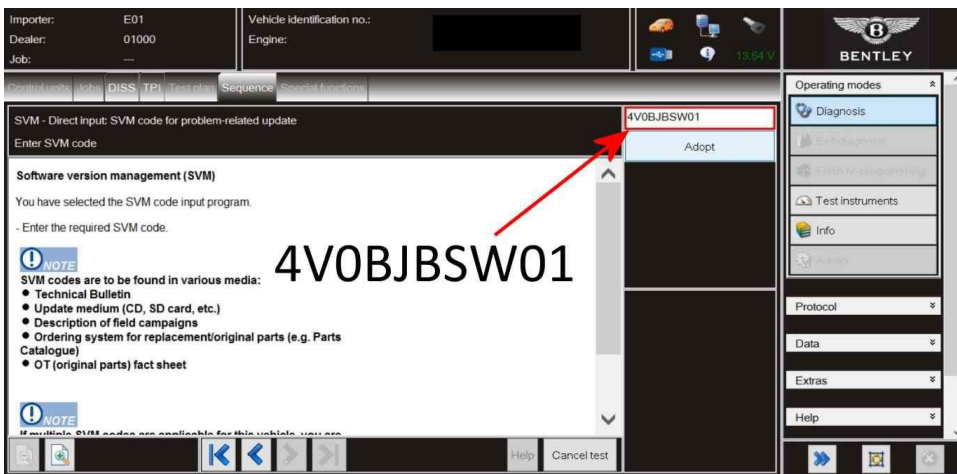
Figure 6

- When prompted enter the SVM code 4V0BJBSW01 and select Adopt (Figure 6)

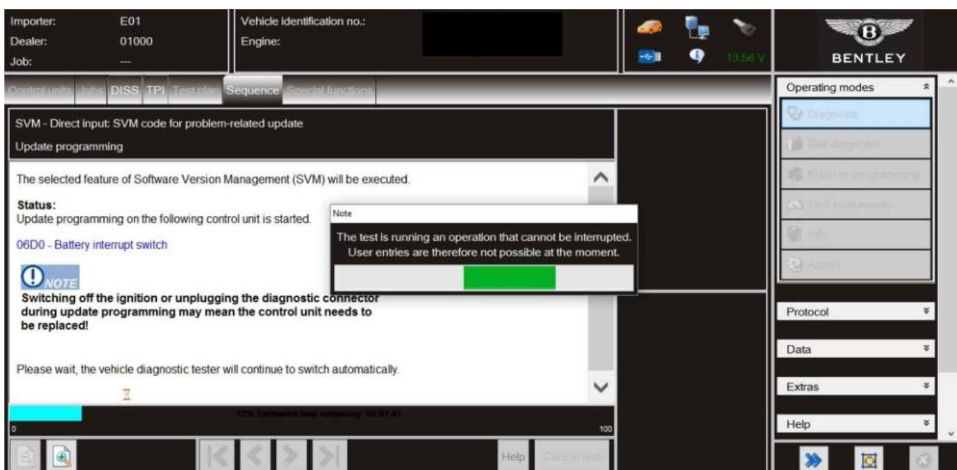
Figure 7

- All control modules will now be interrogated.
- The software update will then be suggested, select Yes
- The software of the Battery interrupt switch will then be updated, a progress bar will be displayed (Figure 7)
