# SERVICE CAMPAIGN BULLETIN

SUBJECT: <b>ECM REPROGRAMMING FOR ENGINE KNOCKING NOISE - SERVICE CAMPAIGN - REVISION</b>			No: <b>SC-16-001REV2</b>
			DATE: <b>November 2020</b>
			MODEL: <b>2014-15 Mirage</b>
<b>CIRCULATE TO:</b>	<input checked="" type="checkbox"/> GENERAL MANAGER	<input checked="" type="checkbox"/> PARTS MANAGER	<input checked="" type="checkbox"/> TECHNICIAN
<input checked="" type="checkbox"/> SERVICE ADVISOR	<input checked="" type="checkbox"/> SERVICE MANAGER	<input checked="" type="checkbox"/> WARRANTY PROCESSOR	<input checked="" type="checkbox"/> SALES MANAGER

During cold start, the engine ECU may order inappropriate fuel amounts which may cause engine noise. This campaign bulletin instructs dealers to reprogram the ECM with new software on all affected vehicles. In rare cases, if the vehicle exhibits an engine knocking noise, the engine may need to be replaced.

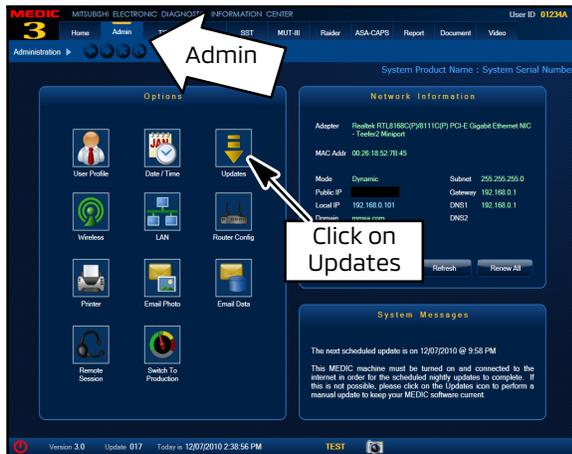
3. Select the MEDIC 3/4 Admin tab and click on "Updates."

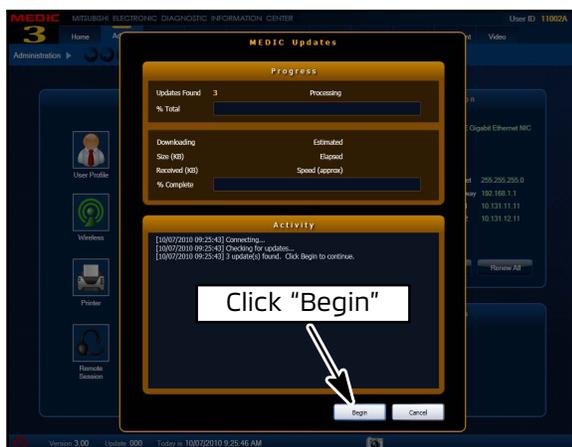
4. If the MEDIC update screen advises updates are available, click the "Begin" button. After all updates are complete, **GO TO THE REPROGRAMMING PROCEDURE.**

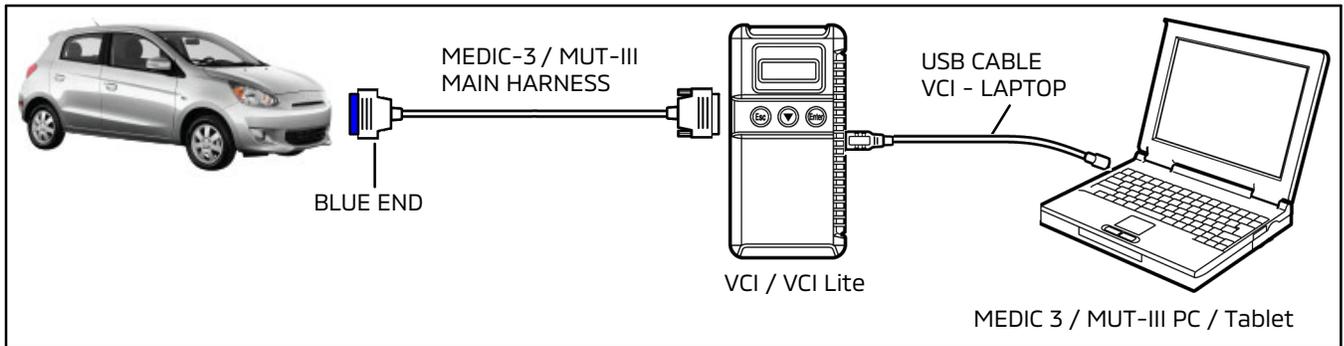
- Turn the MEDIC PC/tablet on. If the battery indicator in the lower right hand corner of the screen does not show a full charge, it is recommended that either the battery be charged prior to beginning, or be used with the A/C power adaptor connected.
- Connect the USB cable to the VCI/VCI Lite.
- When the laptop/tablet displays the MUT-III main screen, connect the USB cable to the device.
- Connect the MUT-III main harness with the blue DLC connection to the VCI/VCI Lite.
- Connect the blue connection of the MUT-III main harness to the vehicle's data link connector.
- Turn the VCI power switch ON . Verify that the indicator lamp in the upper right corner of the screen is green.

**NOTE:** VCI and MEDIC 3.5 Laptop shown for illustration purposes only.

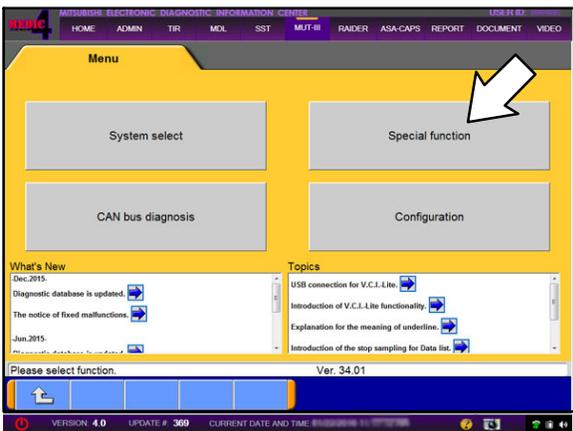
4. Go to the MUT-III home screen and click on "Special function."

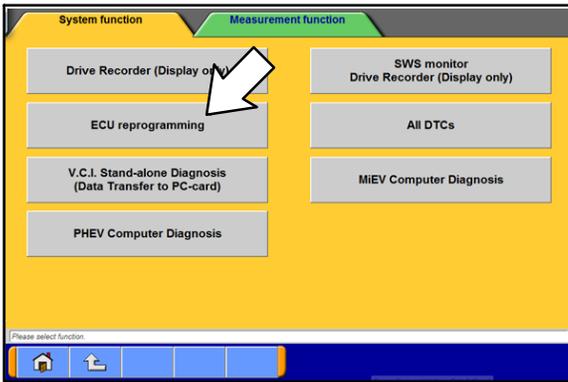
5. Select "ECU reprogramming."

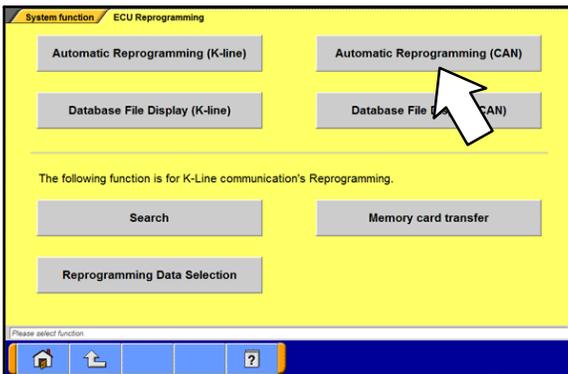
6. In ECU reprogramming, select "Automatic Reprogramming (CAN)."

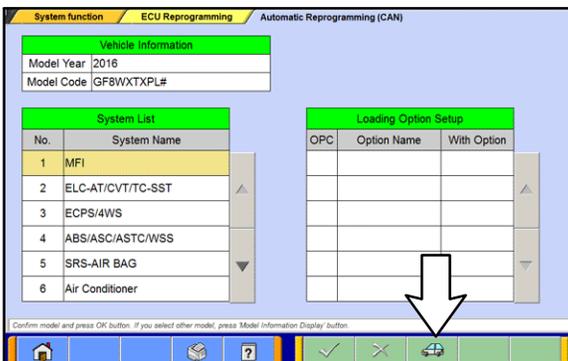
7. Press the model information display button (car icon) and verify that all vehicle information is correct.

- If vehicle information is NOT correct, follow steps a - e below.
- If vehicle information is correct, click the check mark at the bottom of the page, then go to step 8.

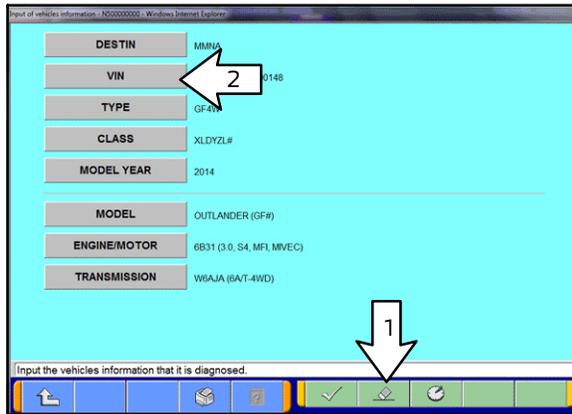
- a. If the VIN or vehicle description displayed does not match the vehicle you are working on, click the eraser icon at the bottom of the page to erase vehicle data. Then click the “VIN” button.

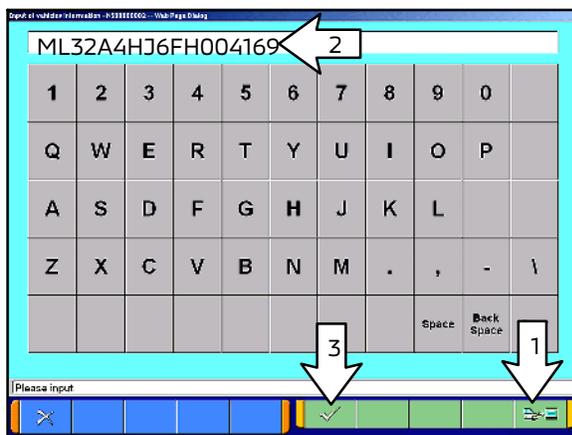
- b. Click the icon in the lower RH corner of the screen to have MUT-III automatically read the VIN.

If a message appears saying the VIN cannot be input automatically, manually enter the 17 digit VIN into the VIN field at the top of the page.

Make sure the VIN is correct and click the check mark.

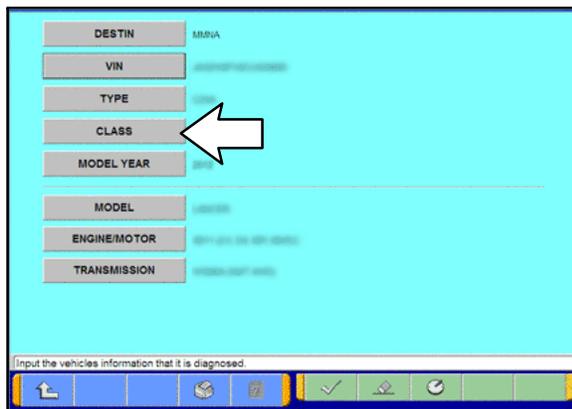
- c. Click the CLASS button.

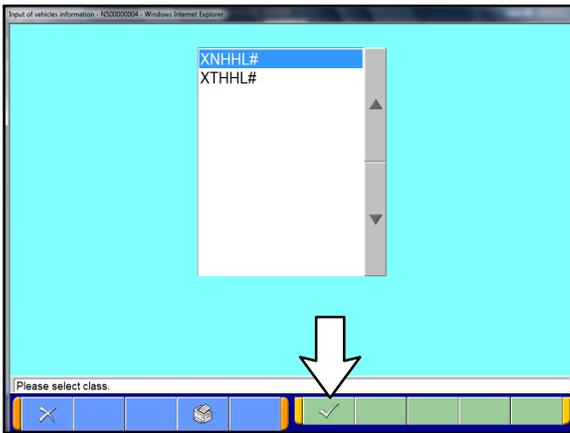
- d. Look at the label on the passenger side B-pillar to identify the appropriate class. Select it and click the check mark at the bottom of the page.

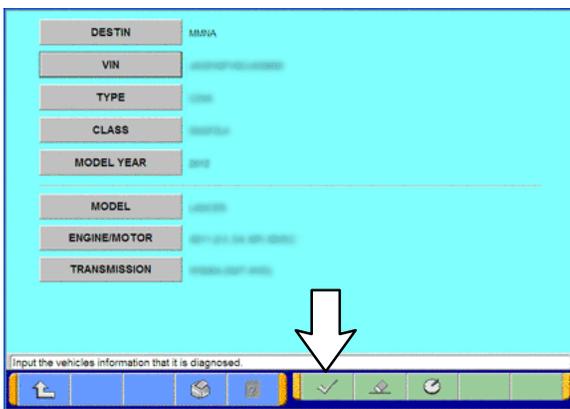
- e. Confirm all data matches the vehicle, then click the check mark at the bottom of the page.

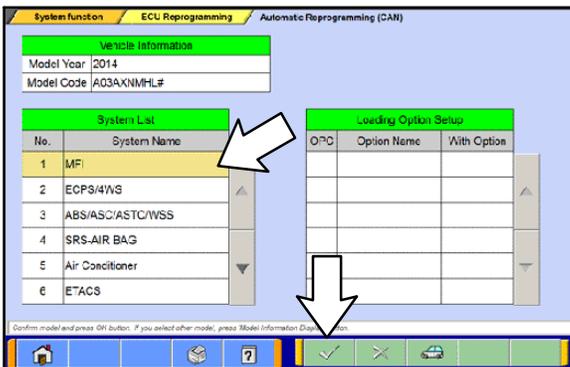
8. "MFI" should be highlighted by default. If not, click on it to highlight it. Click the **check mark** to continue.

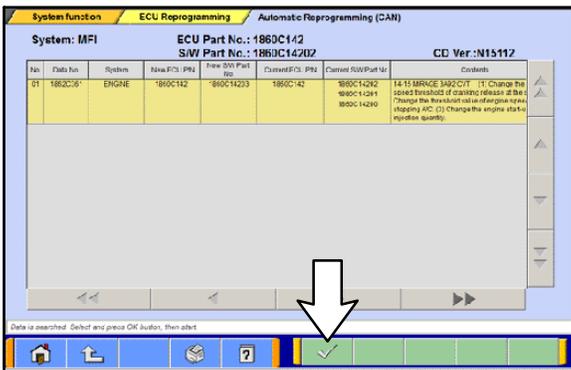
10. The Automatic Reprogramming (CAN) database screen will display.

- Verify that the new ECU and S/W part numbers are listed in the table.
- Confirm the database number at the top right of the table is N15112 or higher.
- If more than one row is displayed in the table, refer to the ECM Reprogramming Chart on page 2 to highlight and select the correct row.
- Click the check mark to continue.

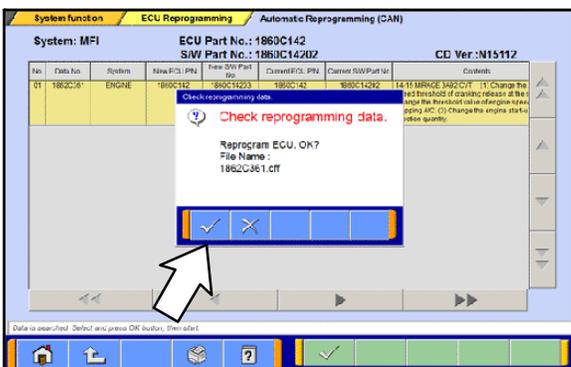
11. The "Check reprogramming data" window should appear with the new file name.

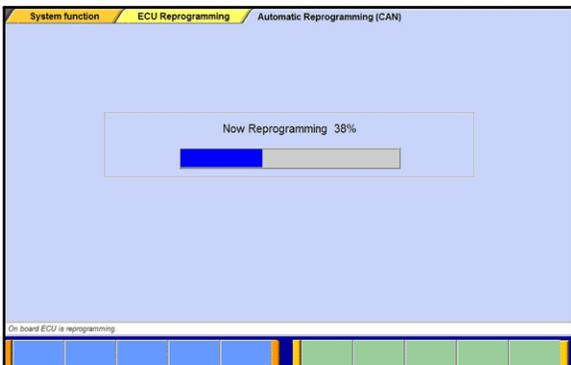
13. Once the reprogramming is initiated, the screen as shown will indicate the reprogramming progress.

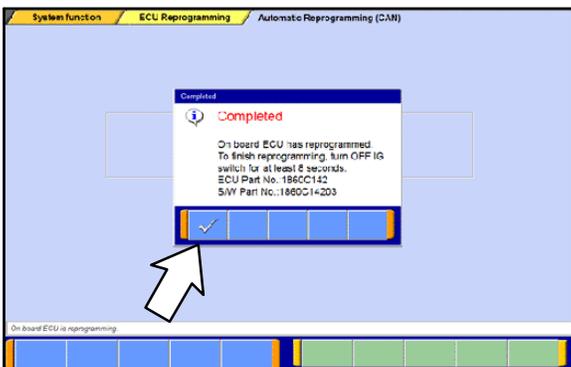
14. Reprogramming is completed.

- Verify that the S/W Part No. is correct.
- Click on the check mark.
- Turn OFF ignition switch for at least 8 seconds.
- Turn ignition switch ON, then proceed to the next step.

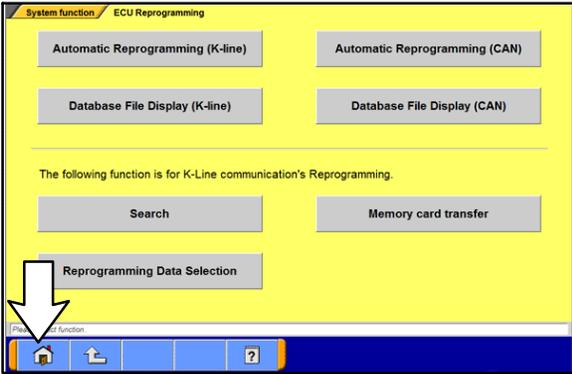
15. Click on the "home" button.

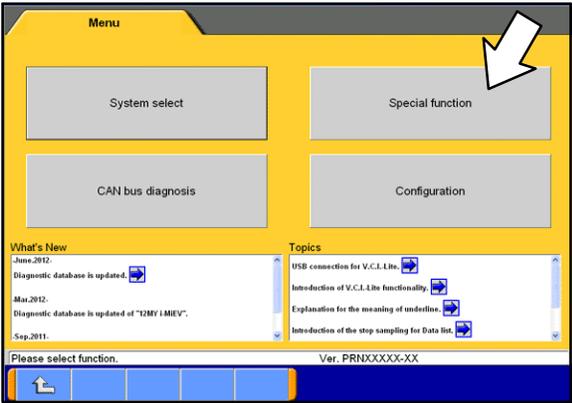
16. Perform an "Erase and Read all DTCs."  
a. Select "Special function."

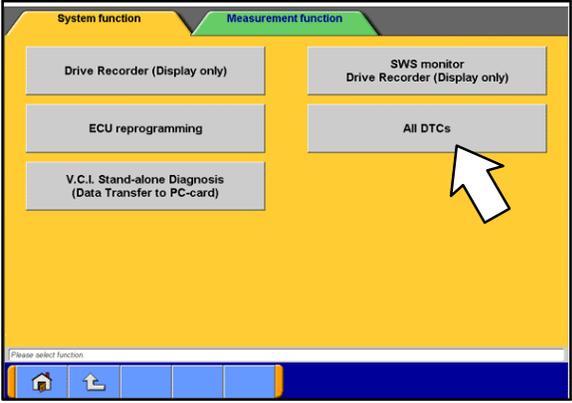
b. Select "All DTCs."

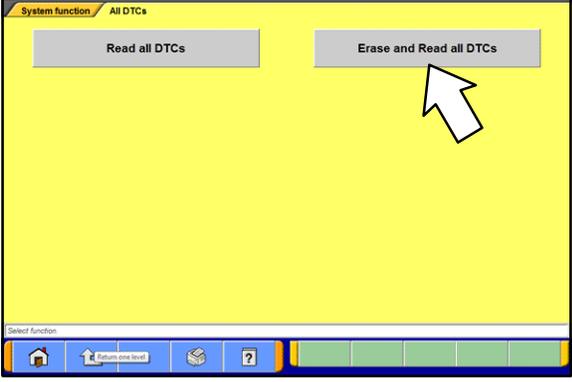
c. Select "Erase and Read All DTCs."

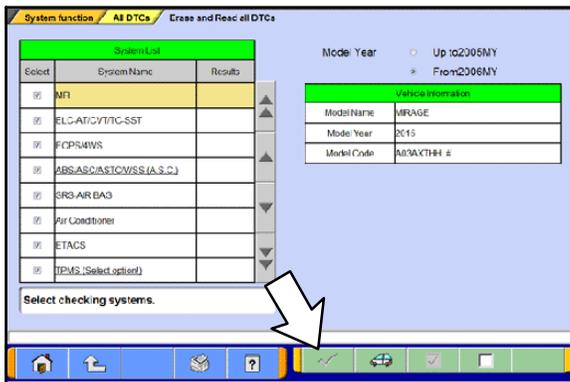
- d. The "System List" on the left side of the screen will have all selections checked. **Do not** change these selections. DTCs may be set if the vehicle is equipped with options that are unchecked.
- e. Click the check mark to continue.

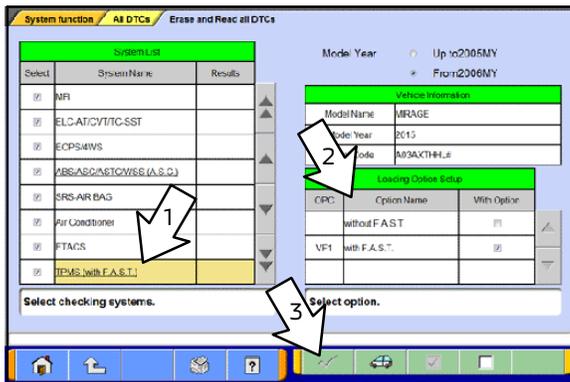
**NOTE:** If, in some cases, the check mark button at the bottom is not active, perform the following:

- 1) Select the System name that is underlined (for example, TPMS, as shown on left).
- 2) Select the appropriate option for the vehicle. Repeat steps 1 and 2 for all underlined systems.
- 3) Click on the check mark. Wait until MUT-III is finished and click the check mark again to confirm.

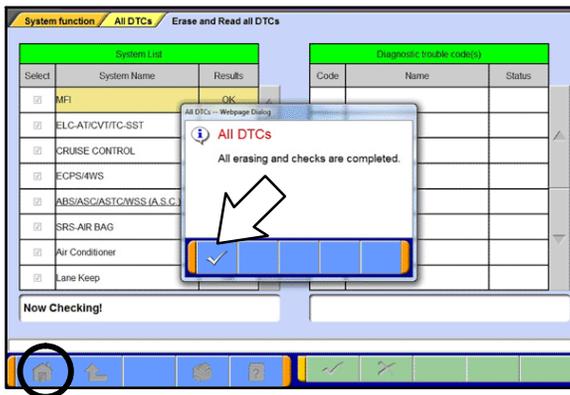
17. When DTC erasing is completed, click the check mark in the pop-up message that reads "All erasing and checks are completed."
  - a. If DTCs return after reprogramming, click the check mark to clear the window. Diagnose and repair per the Service Manual.
  - b. If DTCs do not return, click the check mark to clear the window, then click the home icon at the lower left of the screen to return to the main menu.
