2019-20 Fit: *Bluetooth*[®] HandsFreeLink[®] Freezes After Calls; Voice Tags Are Missing at Startup

AFFECTED VEHICLES

Year	Model	Trim Level	VIN Range
2019-20	Fit	LX	ALL

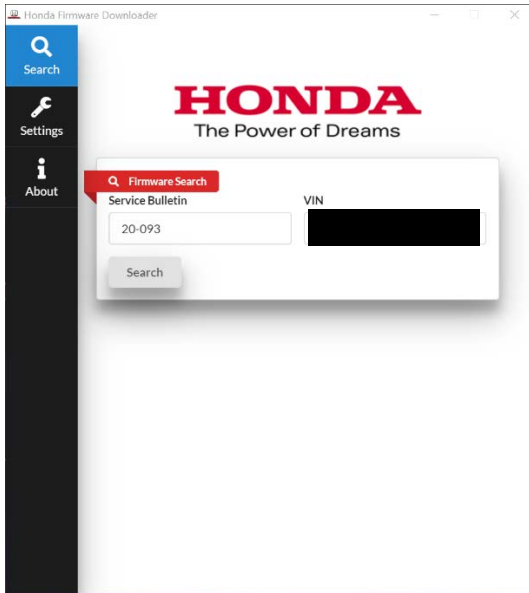
- Before updating the software, write down the customer's audio unit presets.
 - Connect a fully charged battery jumper to the vehicle, and leave it connected during the entire procedure to maintain steady voltage.
 - Apply the parking brake to keep the headlights off during the update.
1. From your computer's desktop, open Honda Firmware Downloader. Refer to job aid *Honda Firmware Downloader* for additional information. Make sure to use an empty USB flash drive that is formatted to FAT 32.
 2. Enter the service bulletin number and the VIN. This is important, as the software can be different depending on the trim level. Select the download icon when the correct software is found.

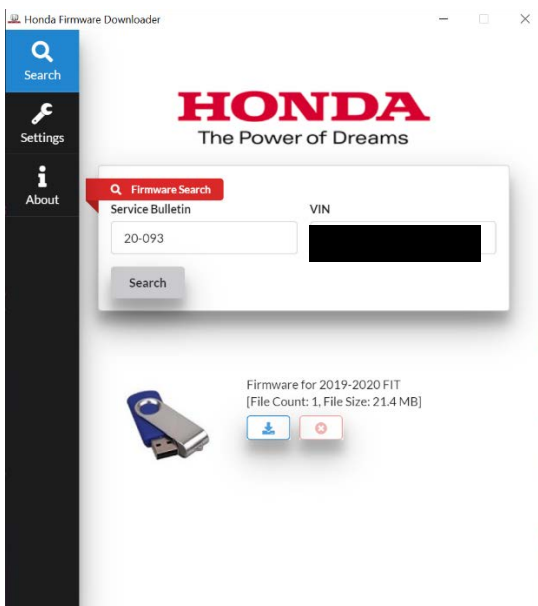
The software download may take up to **10-15 minutes**, depending on the size of the file.

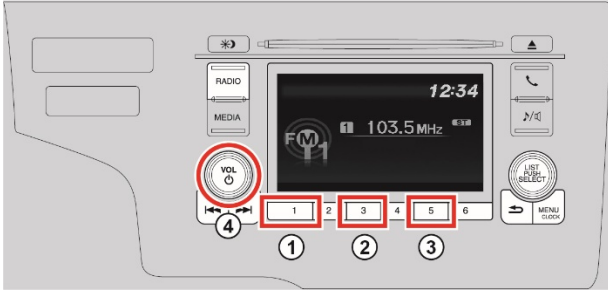
- With the audio unit OFF, press and hold the buttons in sequential order as shown. This will let you view the **Version display** screen.

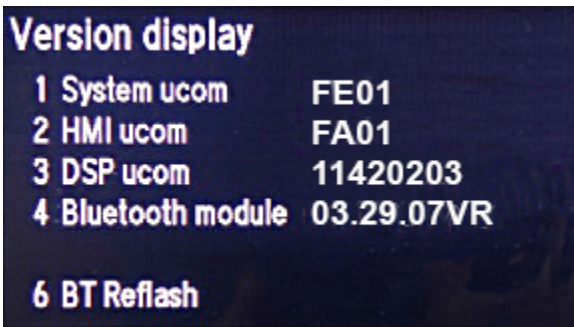
The image below is an example.

If any of the software versions do not match the ones listed in the table below, do not update the audio unit because you can damage it.

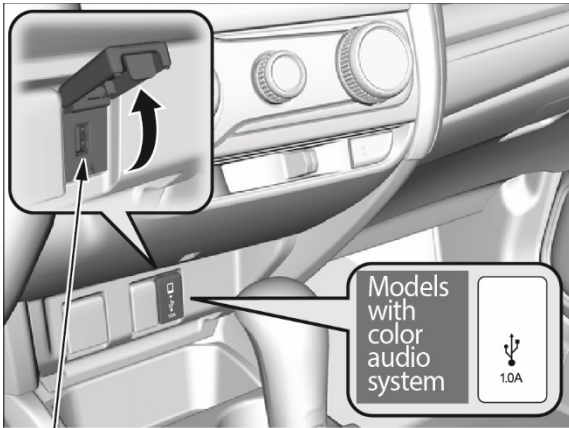
USB PORT

8. Plug the USB flash drive into the USB port to start updating the audio unit. The audio unit will automatically detect the USB flash drive and start the update process.

Never disconnect the battery, turn the ignition to OFF, remove the USB flash drive, or press the **BACK** button while the update is in progress

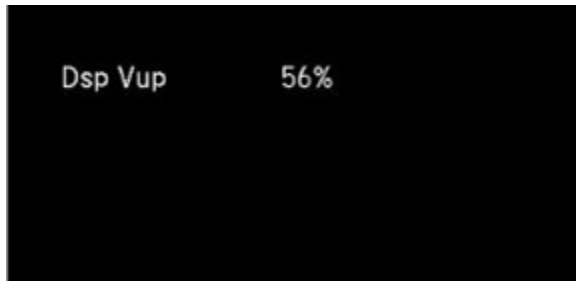
- Dsp Vup

You will see the following screens as the update runs.

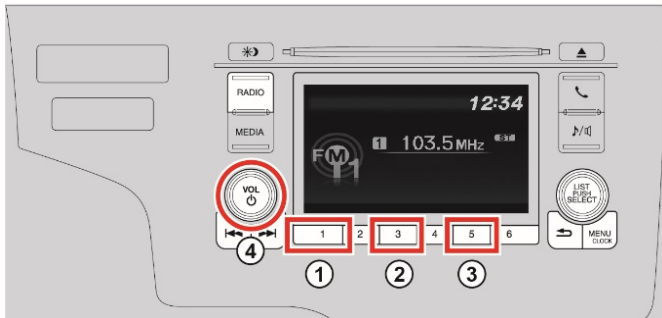
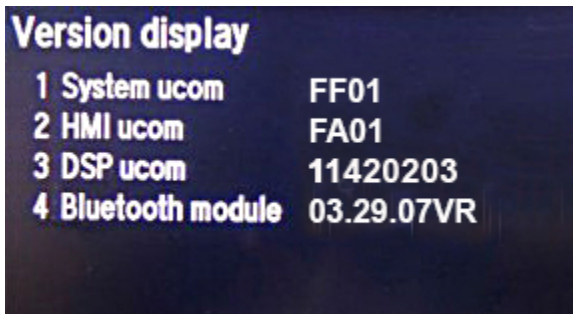
1. With the audio unit turned OFF, press and hold the buttons in sequential order as shown. This will let you view the **Version display** screen and verify the software version was updated.

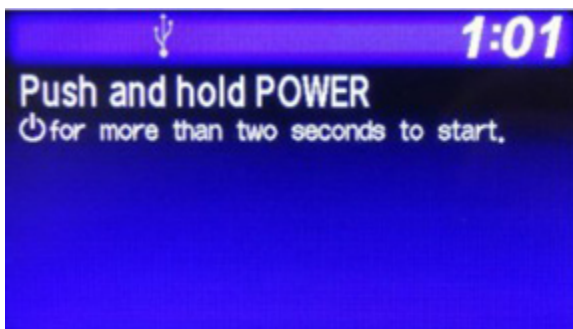
2. Press the VOL/Power button to exit the **Version display** screen.
3. Remove the USB flash drive.
4. Press and hold the VOL/Power button to sync the security code.
