2019-20 Passport: *Bluetooth*[®] HandsFreeLink[®] Freezes After Calls; Voice Tags Are Missing at Startup

AFFECTED VEHICLES

Year	Model	Trim Level	VIN Range
2019-20	Passport	LX	ALL

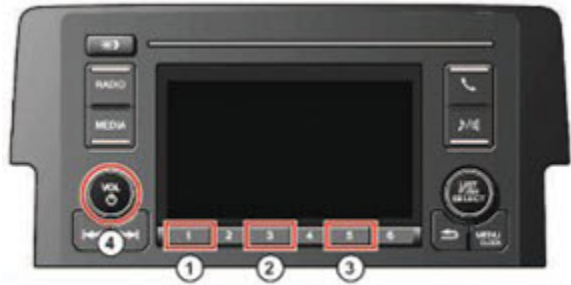
- With the audio unit OFF, press and hold the buttons in sequential order as shown. This will let you view the **Version display** screen.

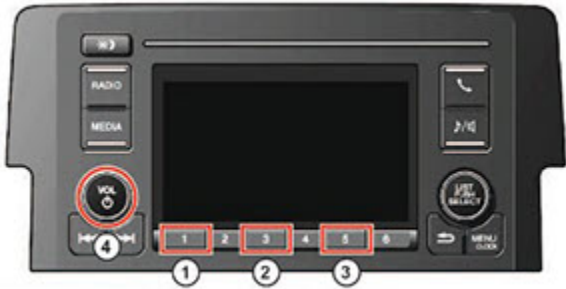
1. With the audio unit turned OFF, press and hold the buttons in sequential order as shown. This will let you view the **Version display** screen and verify the software version was updated.
