December 04, 2020

Version 1

2019-20 Pilot: *Bluetooth*[®] HandsFreeLink[®] Freezes After Calls; Voice Tags Are Missing at Startup

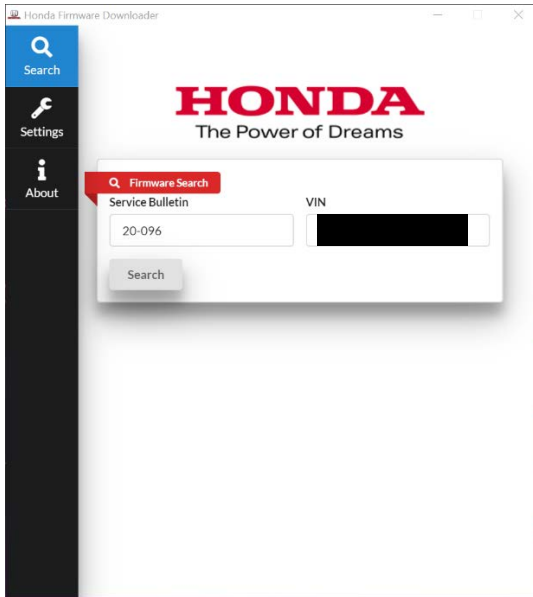
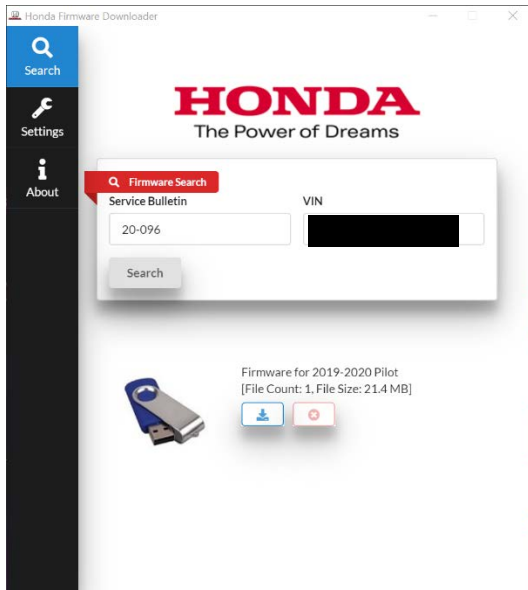
- Before updating the software, write down the customer's audio unit presets.
 - Connect a fully charged battery jumper to the vehicle, and leave it connected during the entire procedure to maintain steady voltage.
 - Apply the parking brake to keep the headlights off during the update.
1. From your computer's desktop, open Honda Firmware Downloader. Refer to job aid *Honda Firmware Downloader* for additional information. Make sure to use an empty USB flash drive that is formatted to FAT 32.
 2. Enter the service bulletin number and the VIN. This is important, as the software can be different depending on the trim level. Select the download icon when the correct software is found.

The software download may take up to **10-15 minutes**, depending on the size of the file.

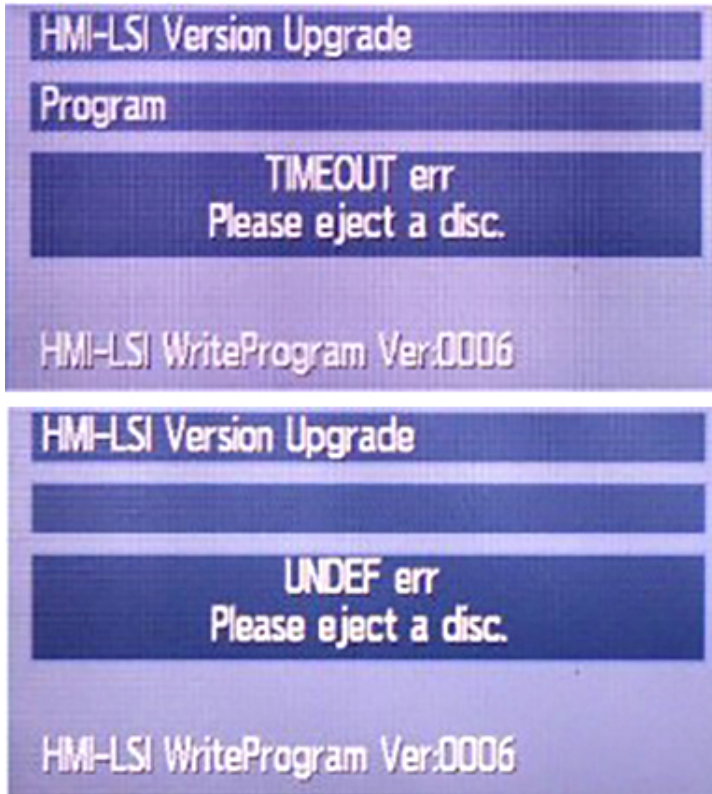
If at any time during the update process a **TIMEOUT err** or **UNDEF err** message appears, check the USB flash drive for damage, or use a different one.

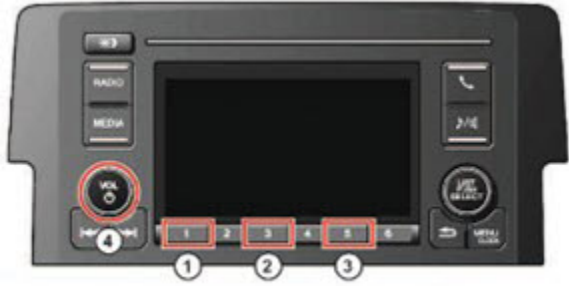
- With the audio unit OFF, press and hold the buttons in sequential order as shown. This will let you view the **Version display** screen.

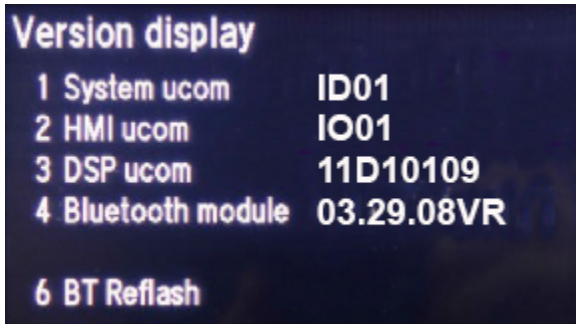
The image below is an example.

If any of the software versions do not match the ones listed in the table below, do not update the audio unit because you can damage it.

Software Details	Affected Software Versions
System ucom	ID01
HMI ucom	I001
DSP ucom	11D10109
Bluetooth module	03.29.08VR

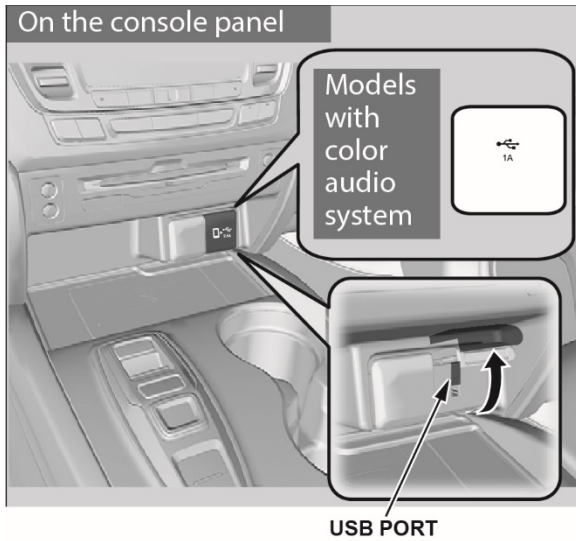
8. Plug the USB flash drive into the USB port to start the update. The audio unit will automatically detect the USB flash drive and start the update process.

Never disconnect the battery, turn the ignition to OFF, remove the USB flash drive, or press the **BACK** button while the update is in progress.

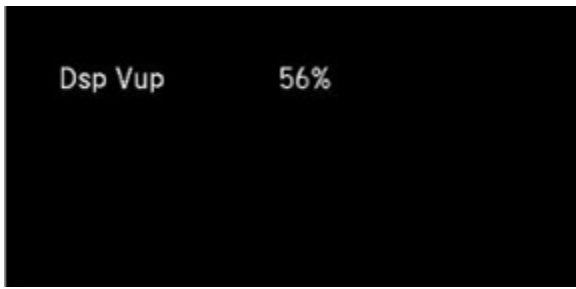
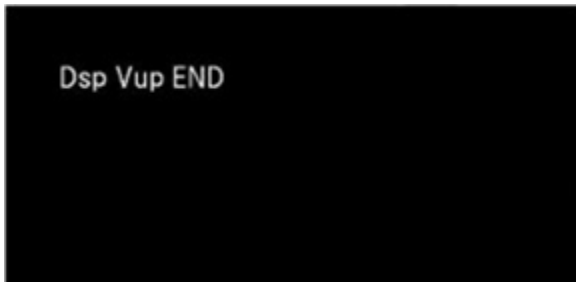
- Dsp Vup

You will see the following screens as the update runs.

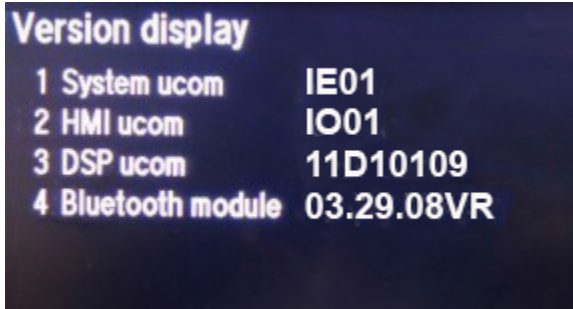
1. With the audio unit turned OFF, press and hold the buttons in sequential order as shown. This will let you view the **Version display** screen and verify the software version was updated.

Software Details	Affected Software Versions
System ucom	IE01
HMI ucom	IO01
DSP ucom	11D10109
Bluetooth module	03.29.08VR

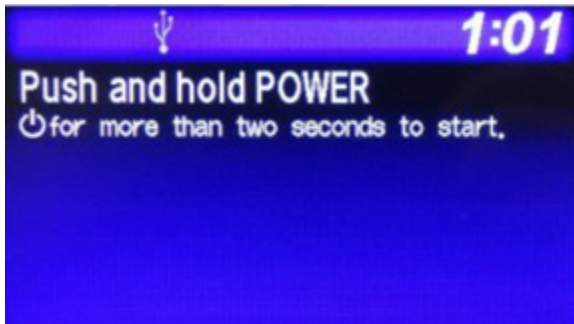
2. Press the VOL/Power button to exit the **Version display** screen.
3. Remove the USB flash drive.
4. Press and hold the VOL/Power button to sync the security code.
