# SERVICE BULLETIN

Classification: EL20-008b	Reference: NTB20-016b	Date: November 12, 2020
------------------------------	--------------------------	----------------------------

## RADIO INTERMITTENTLY REBOOTS DURING AUDIO PLAYBACK VIA BLUETOOTH CONNECTED IPHONE

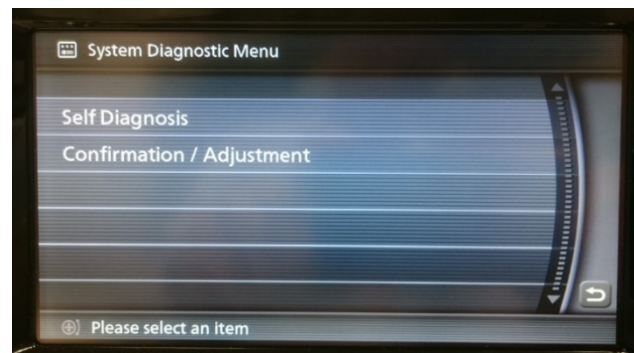
1. Turn the ignition ON.
2. Turn the audio system OFF.
3. Access the System Diagnostic Menu as follows:
  - a. Press and hold the **MENU** button.
  - b. Turn the **VOLUME** knob 40 or more clicks in either direction.

**NOTE:** The screen in Figure 2 should display.

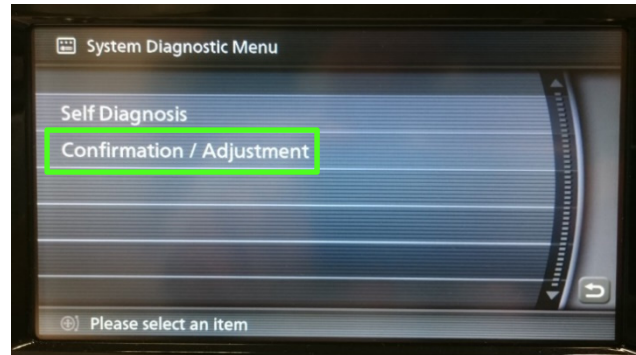
Figure 3

4. Select **Confirmation / Adjustment**.

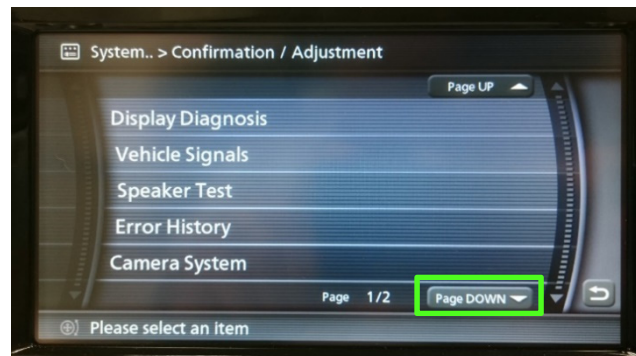
Figure 4

5. Select **Page DOWN**.

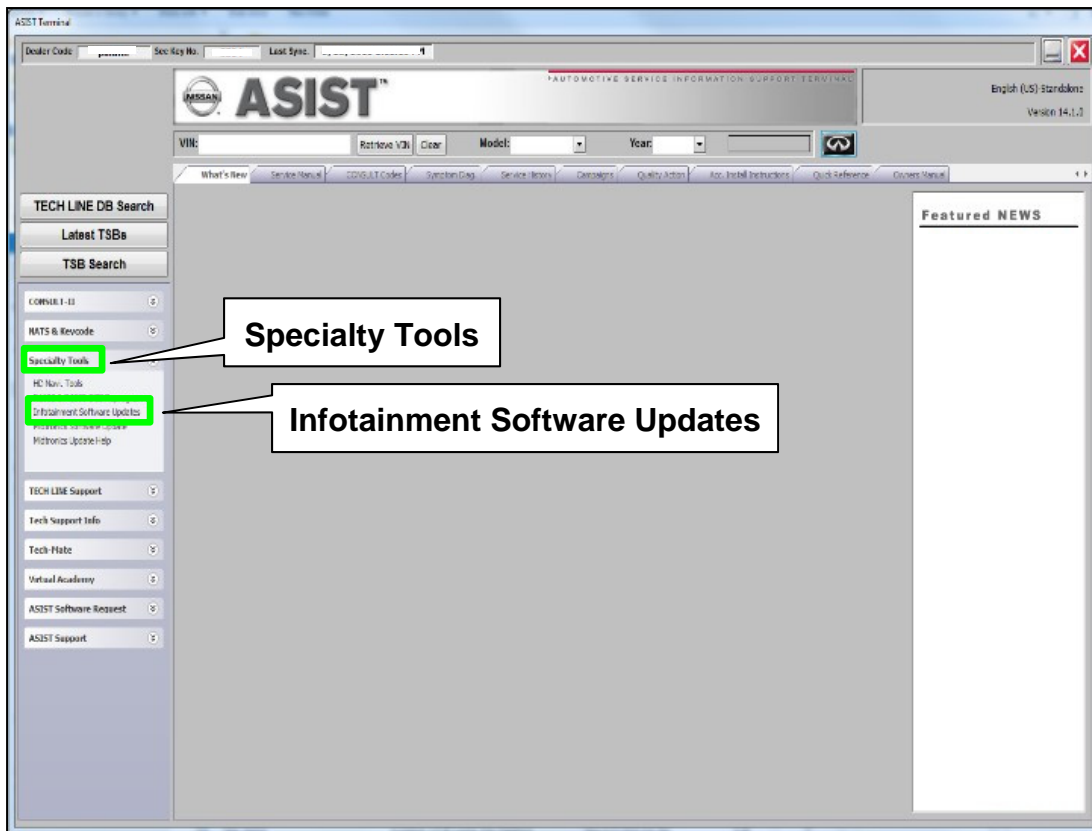
Figure 7

9. Select **Specialty Tools**, and then select **Infotainment Software Updates**.

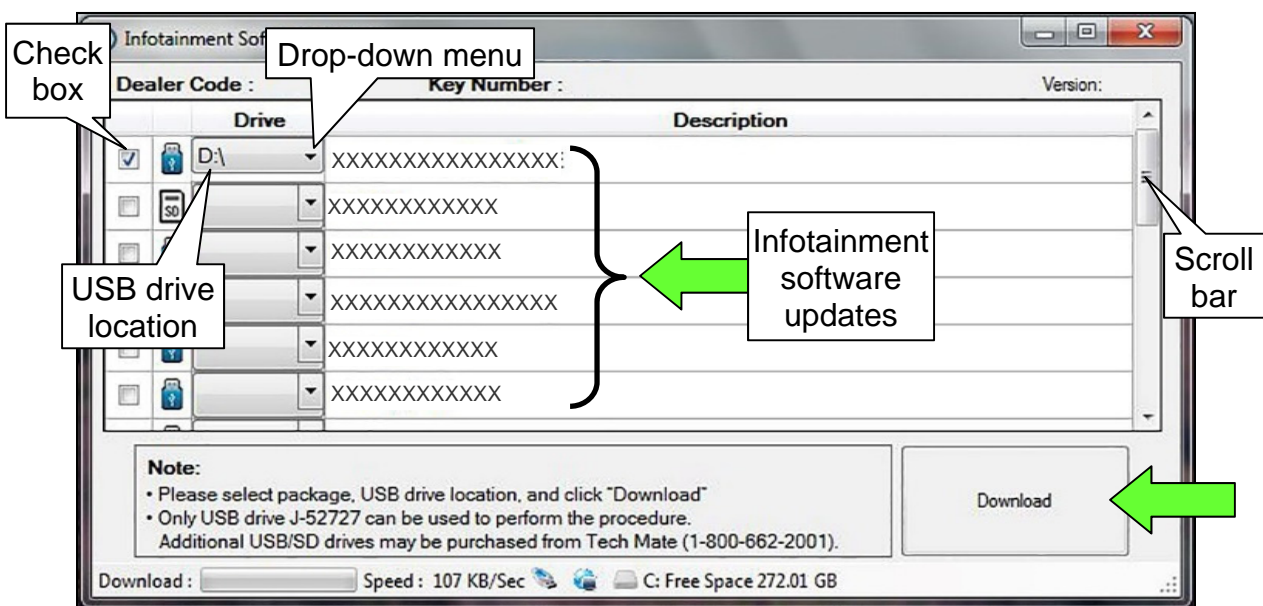
**Figure 8**

- Select the check box next to the correct update software package (Figure 8).
  - Locate update file #1 (LD001) and update file #2 (see **Table A** above).
  - Only one (1) update will be loaded at a time, starting with update #1 (LD001).

- Use the drop-down menu and select the location of the USB drive that was inserted in step 7 on page 4.

**HINT:** The **Description** section in Figure 8 may be different than on your C-III plus screen.

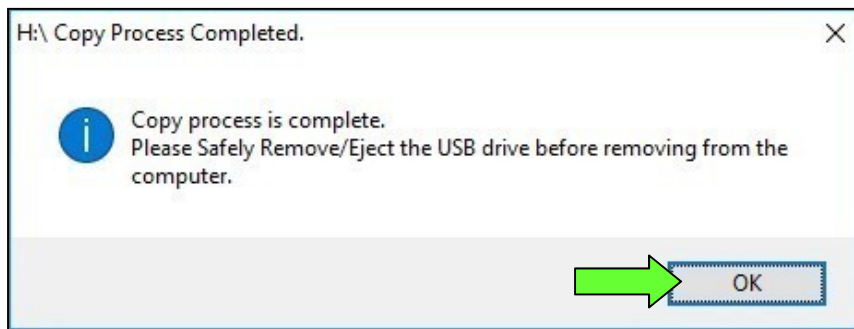
Figure 9

12. Select **Download**, and then wait for the download to complete (see Figure 9).
13. Select **OK**.

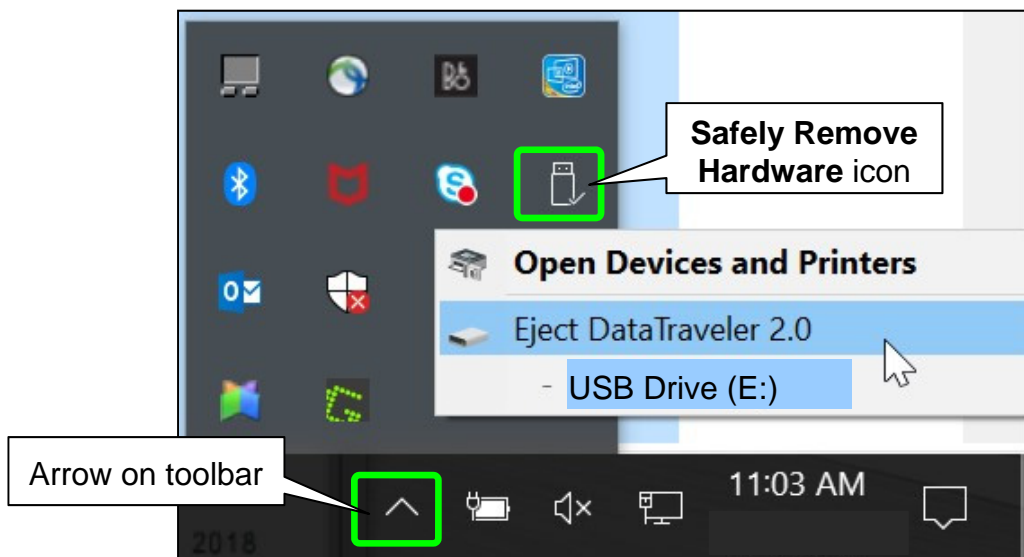
Figure 10

14. Once the transfer is complete, safely remove the USB drive from the ASIST station.
  - a. From the PC toolbar, select the **Safely Remove Hardware** icon.
    - The icon is on the toolbar, or to be found after selecting the arrow.
  - b. Select the USB drive to be removed, and then remove the USB drive from the ASIST station.

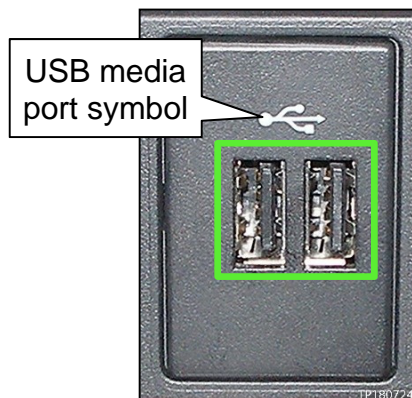
Figure 11

20. Turn OFF the audio system.
21. Insert the special tool USB drive J-52727 into the USB media port (Figure 11).

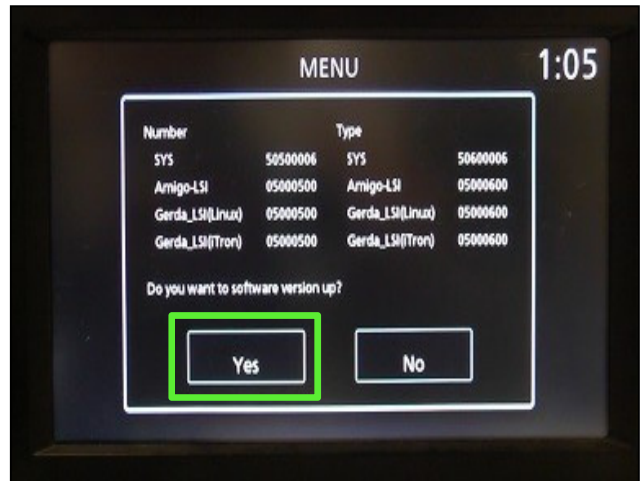
Figure 13

22. Select **Yes** to begin the reprogramming process.

**HINT:** Reprogramming will take about 5-10 minutes.

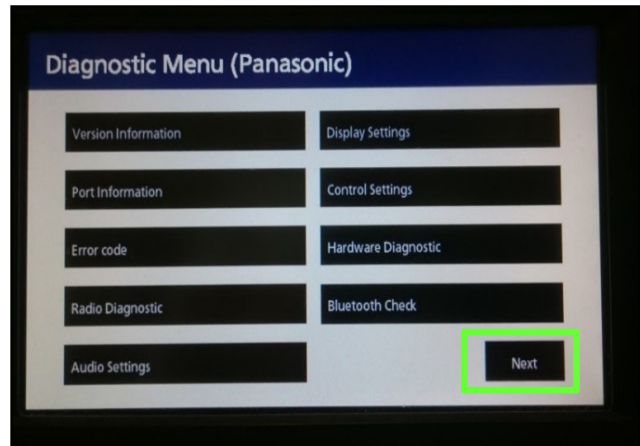
- a. Press and hold the **Menu** button.
- b. Press and hold the **Audio** button.
- c. Press the **Seek right** button three (3) times.

**HINT:** A screen similar to the one in Figure 15 will appear.

- d. Select the **Next** button at the bottom right side of the screen.

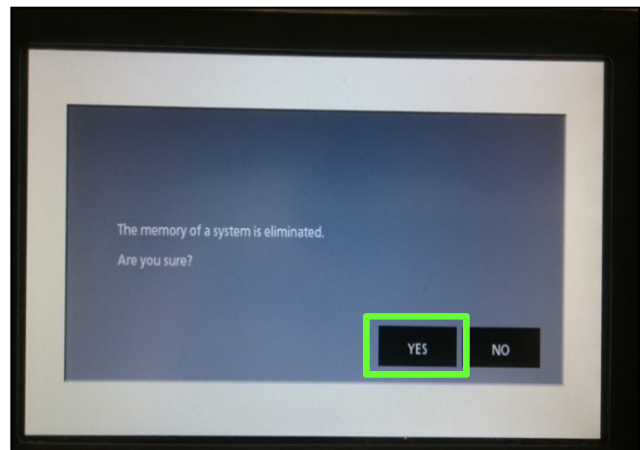
Figure 16

- f. Select **Yes** on the confirmation screen shown in Figure 16.

**HINT:** Initialization is complete after the audio unit reboots.
