## SERVICE BULLETIN

Reference number:	SB-61-1428	Issued: 14 December 2020
Subject:	Instrument Cluster Software Updates	
Model(s):	DBX	
Applicable to:	All Dealers	
Distribute to:	After Sales Manager Executive Manager Service Manager Sales Manager	Warranty Staff Technician(s) Parts Staff

### Reason for this Service Bulletin

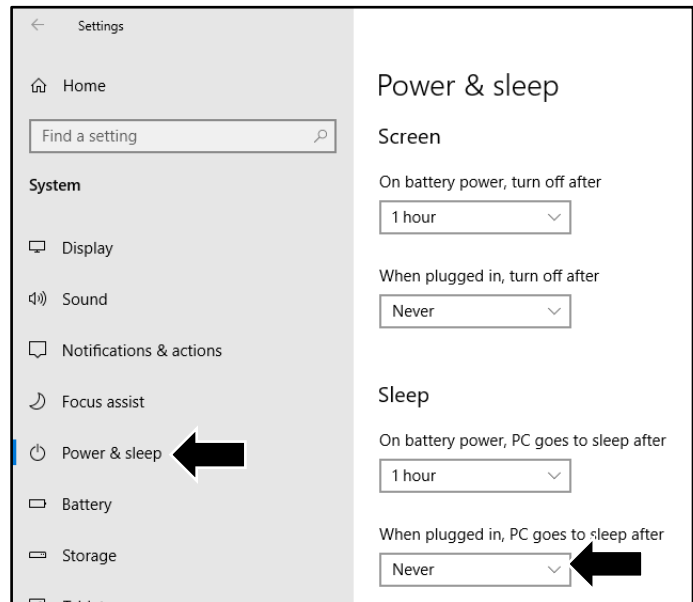
Figure 1

1. Before you do the steps that follow go to "Settings" on your laptop and click "Power & sleep".  
Under "When plugged in, PC goes to sleep after" click "Never" (refer to Figure 1).

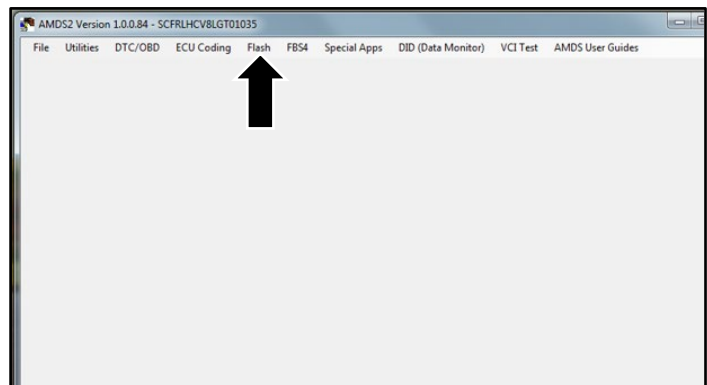
Figure 2

2. Set the ignition to ON but do not start the engine.
3. Connect the Vehicle Communication Interface (VCI) to the vehicle by using the Diagnostic Link Cable (DLC).
4. Start the AMDS 2.0 software and, if necessary, update to the latest version.
5. Select "Flash" (refer to Figure 2).

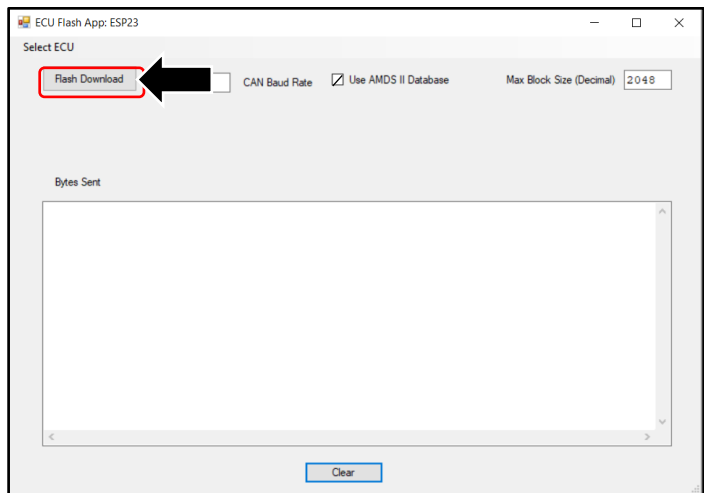
Figure 4

7. Click the "Flash Download" button (refer to Figure 4).

**Note: If this is the first time AMDS has been used for this update, it will need to download the software files from the server. These files are large so make sure there is sufficient time to do the download.**

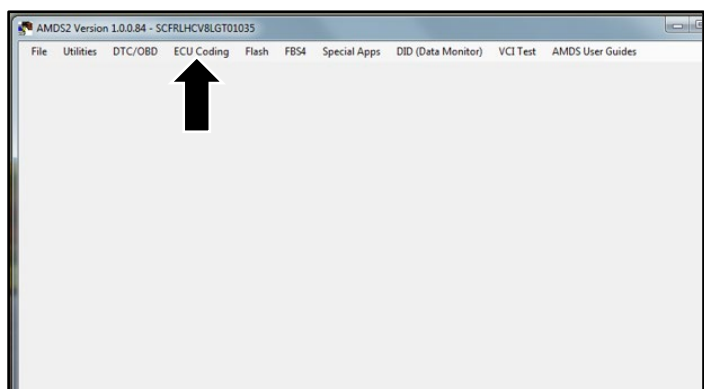
Figure 5

9. Select "ECU Coding" (refer to Figure 5).

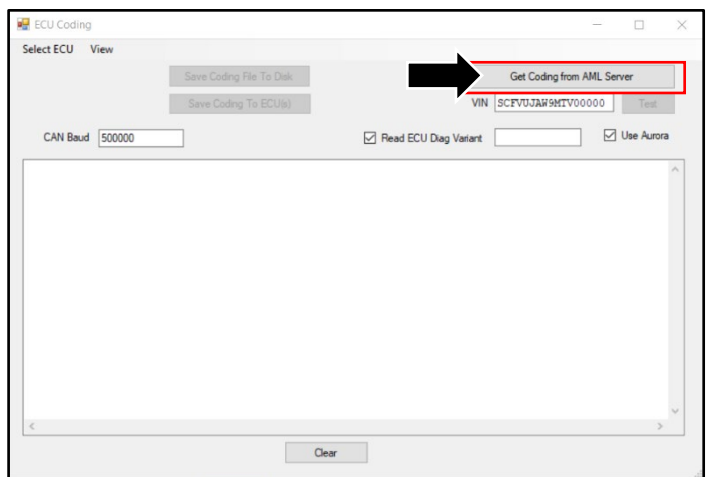
Figure 7

11. Select "Get coding from AML Server" (refer to Figure 7).

Coding will appear in the main display.

**Note: Make sure the correct VIN is shown.**

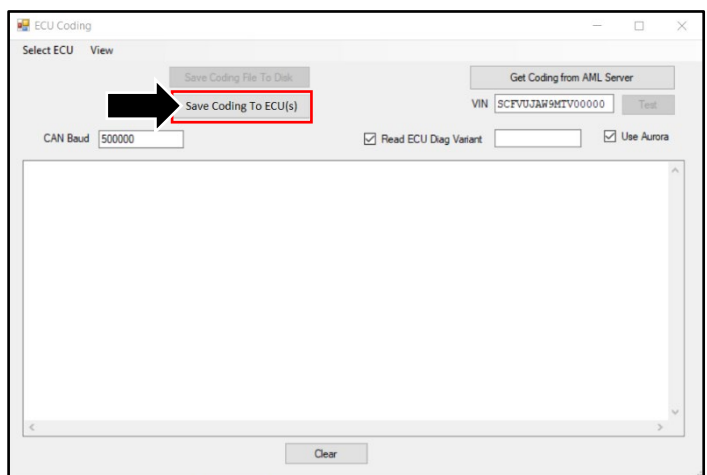
Figure 8

12. Select "Save Coding To ECU(s)" (refer to Figure 8).

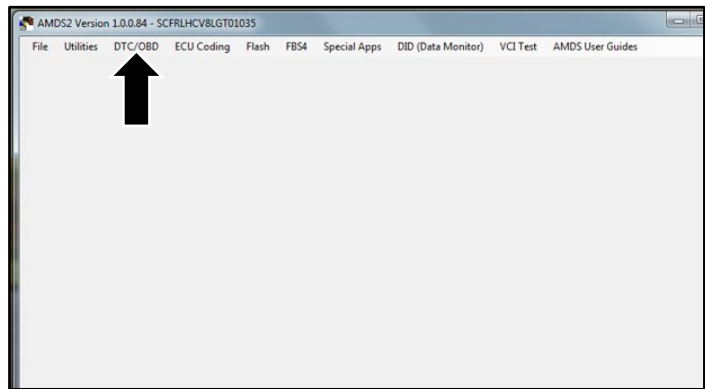
Figure 9

13. Click the “DTC/OBD” button (refer to Figure 9).
