December 11, 2020

2018 Odyssey: *Bluetooth*[®] HandsFreeLink[®] Freezes After Calls; Voice Tags Are Missing at Startup

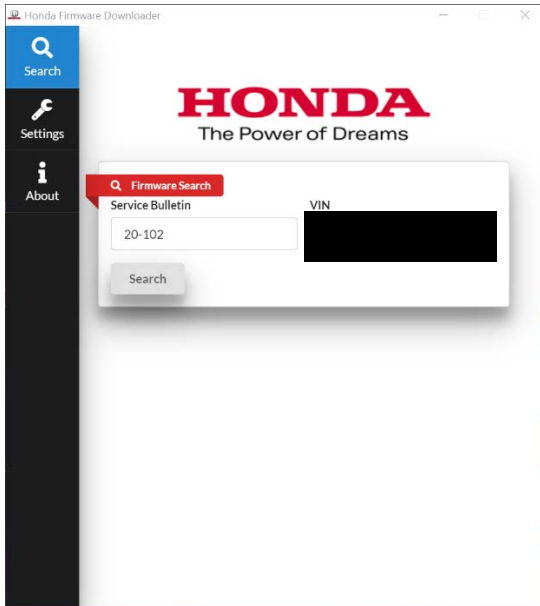
- Before updating the software, write down the customer's audio unit presets.
 - Connect a fully charged battery jumper to the vehicle, and leave it connected during the entire procedure to maintain steady voltage.
 - Apply the parking brake to keep the headlights off during the update.
1. From your computer's desktop, open Honda Firmware Downloader. Refer to job aid *Honda Firmware Downloader* for additional information. Make sure to use an empty USB flash drive that is formatted to FAT 32.
 2. Enter the service bulletin number and the VIN. This is important, as the software can be different depending on the trim level. Select the download icon when the correct software is found.

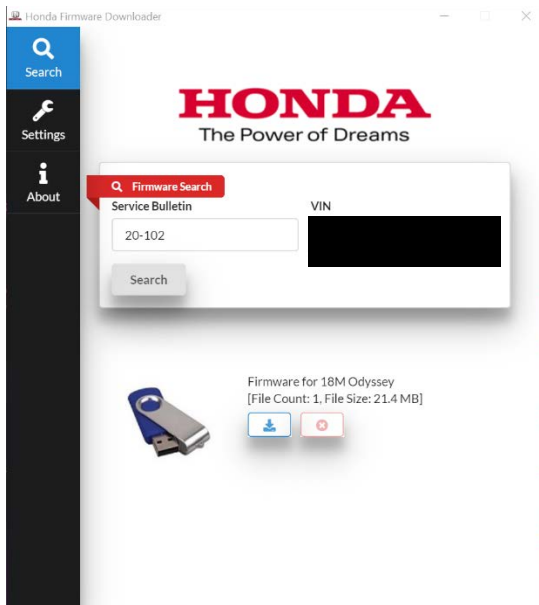
The software download may take up to **10-15 minutes**, depending on the size of the file.

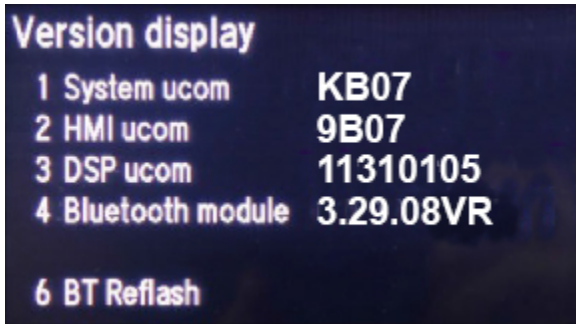
The image below is an example.

If any of the software versions do not match the ones listed in the table below, do not update the audio unit because you can damage it.

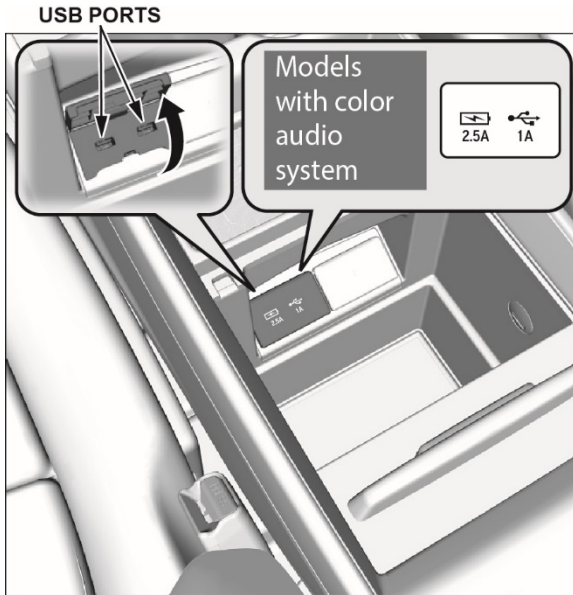
8. Plug the USB flash drive into the USB port to start the update. The audio unit will automatically detect the USB flash drive and start the update process.

Never disconnect the battery, turn the ignition to OFF, remove the USB flash drive, or press the **BACK** button while the update is in progress.

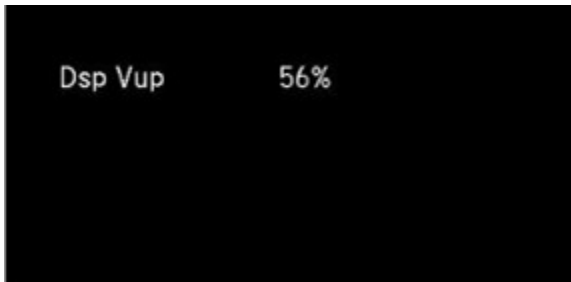
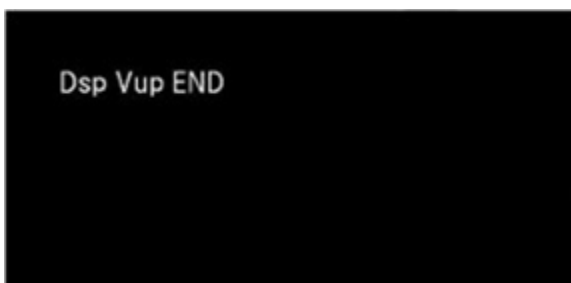
- Dsp Vup

You will see the following screens as the update runs.

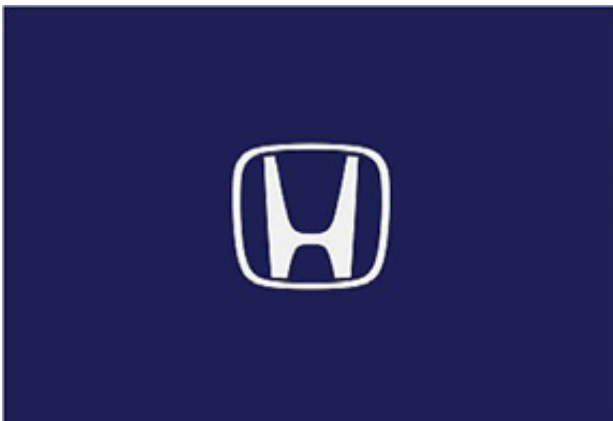
- The screen will go black and the buttons will begin blinking. The blinking will speed up and you will hear a beep every 10% of progress.
- When the software update is complete, you will hear a long beep, then the Honda logo will appear, and the audio unit will turn off.

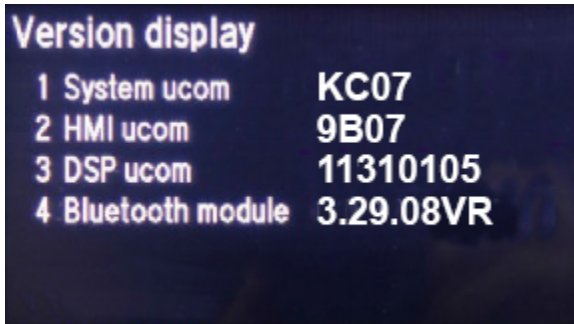
1. With the audio unit turned OFF, press and hold the buttons in sequential order as shown. This will let you view the **Version display** screen and verify the software version was updated.
