December 11, 2020

Version 1

2018 Pilot: *Bluetooth*[®] HandsFreeLink[®] Freezes After Calls; Voice Tags Are Missing at Startup

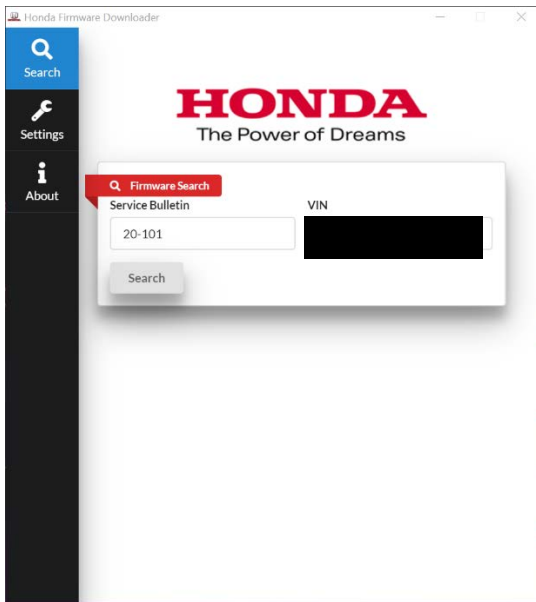
- Before updating the software, write down the customer's audio unit presets.
 - Connect a fully charged battery jumper to the vehicle, and leave it connected during the entire procedure to maintain steady voltage.
 - Apply the parking brake to keep the headlights off during the update.
1. From your computer's desktop, open Honda Firmware Downloader. Refer to job aid *Honda Firmware Downloader* for additional information. Make sure to use an empty USB flash drive that is formatted to FAT 32.
 2. Enter the service bulletin number and the VIN. This is important, as the software can be different depending on the trim level. Select the download icon when the correct software is found.

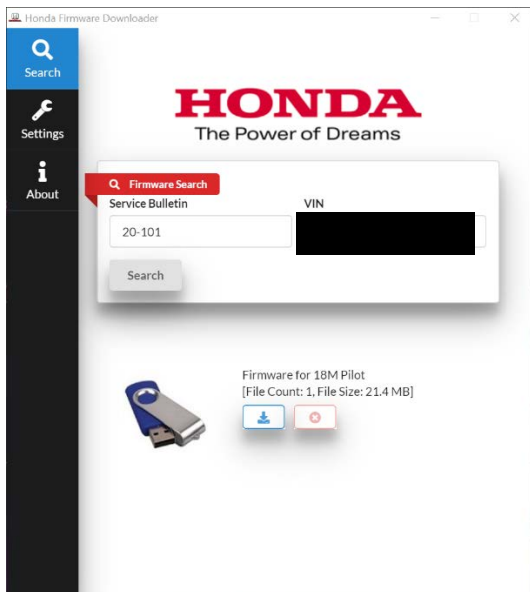
The software download may take up to **10-15 minutes**, depending on the size of the file.

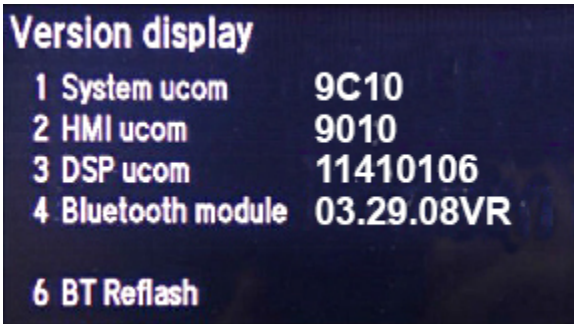
The image below is an example.

If any of the software versions do not match the ones listed in the table below, do not update the audio unit because you can damage it.

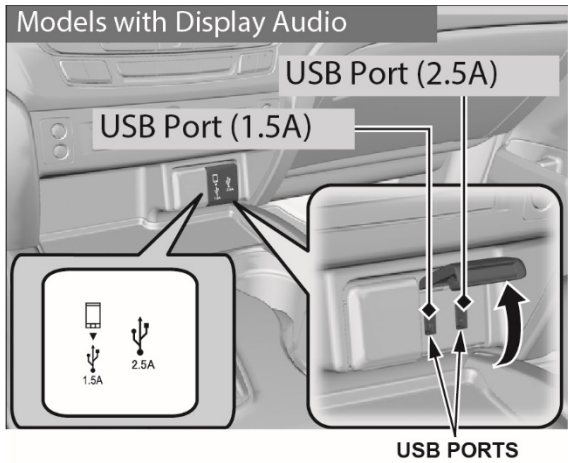
8. Plug the USB flash drive into the USB port to start the update. The audio unit will automatically detect the USB flash drive and start the update process.

Never disconnect the battery, turn the ignition to OFF, remove the USB flash drive, or press the **BACK** button while the update is in progress.

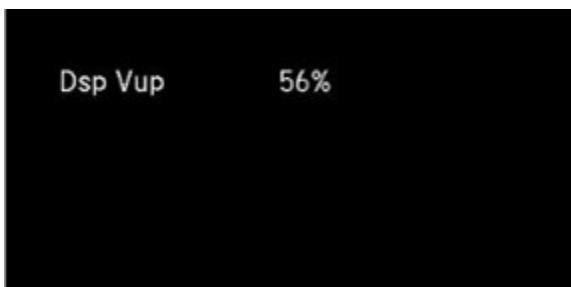
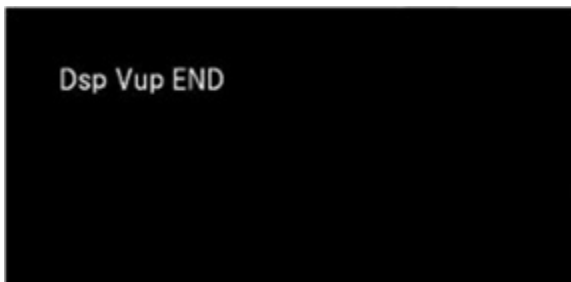
- Dsp Vup

You will see the following screens as the update runs.
