Service Bulletin

Bulletin No.: 19-NA-076

Subject: Blue or Black Screen and Service Rear Vision System Message on Radio Display Shifting into Reverse

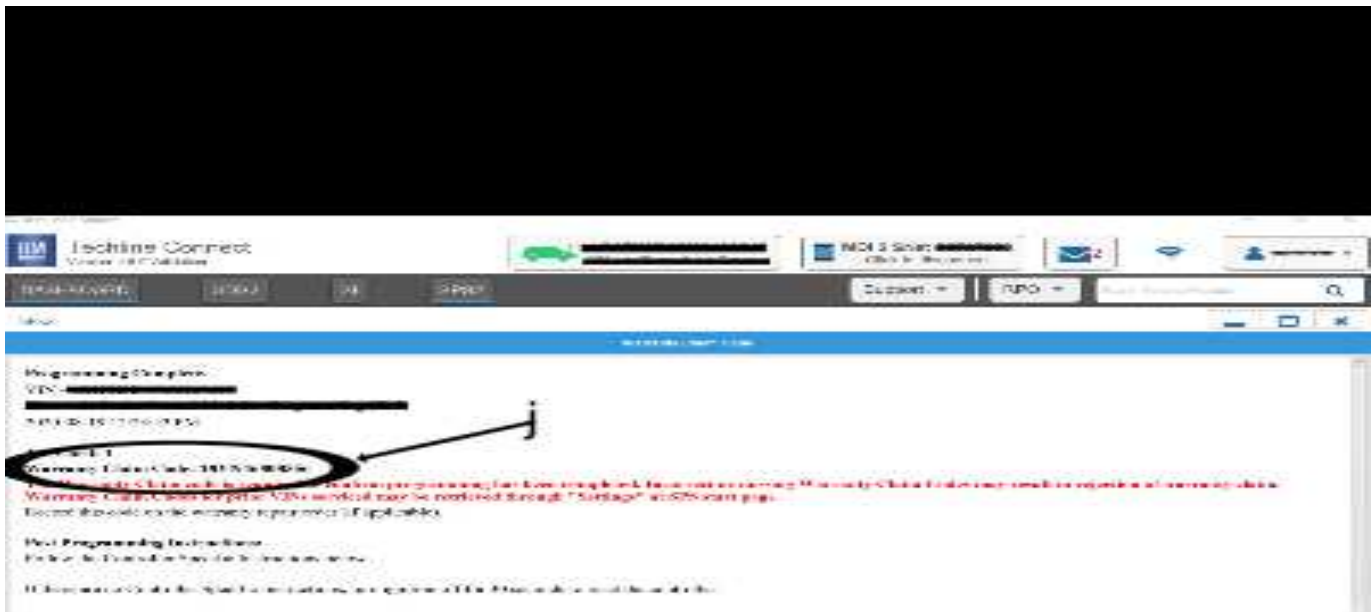
5431209

Important: To avoid warranty transaction rejections, you **MUST** record the warranty claim code provided on the SPS Warranty Claim Code (WCC) screen shown above on the job card. Refer to callout 1 above for the location of the WCC on the SPS screen.
