SIB 54 02 20
SUNROOF ROLLER SUNBLIND INOPERATIVE

E-Series	Model Description
G20	3 Series Sedan

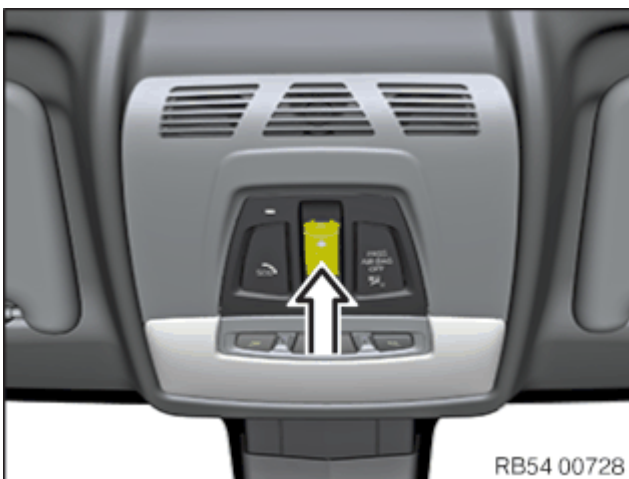
Vehicle interior temperature	15 °C - 30 °C
On-board voltage	12 V - 15 V
Vehicle condition	The vehicle is not standing on its own wheels.
	Vehicle is in a horizontal position.
	- Speed 0 km/h (vehicle must not roll)
	- Remote control is in the vehicle
	-

Terminal 15 is switched on or the vehicle is in the PFW state living
Operating point	- FZD button
	- Diagnostic function: "Initialize sliding/tilting sunroof"
Miscellaneous	No other work may be carried out on the vehicle during initialization in order to avoid impacts or vibrations.

The following prerequisites are the basis for a correct initialization and must be strictly observed.

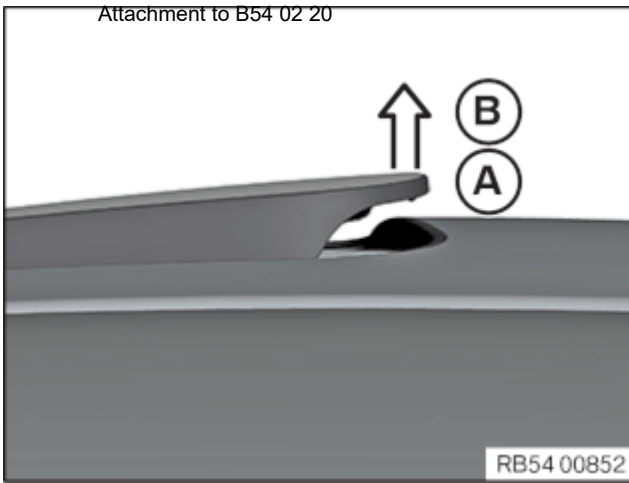
- Press and hold the switch in the "Vent Position" direction.

The glass slide/tilt sunroof shifts to vent position.
- In the event of a delayed start or sudden stop of the glass slide/tilt sunroof, continue to press and hold the switch in the "Vent Position" direction.

- Continue to keep the switch pressed during the entire test module.
- After reaching vent position (A), continue to press and hold the switch for about 30 s.
