GROUP ELE	MODEL 2021MY Seltos (SP2)
	NUMBER 222	DATE December 2020

TECHNICAL SERVICE BULLETIN

SERVICE ACTION: DISPLAY AUDIO 2.0 SOFTWARE UPDATE (SA451)

This bulletin provides the procedure to update the head unit software on some 2021MY Seltos (SP2) vehicles produced from December 18, 2019 through November 22, 2020, equipped with the D-AUDIO 2.0 head unit, in order to improve wireless CarPlay and Android Auto feature. To correct this concern, perform the head unit software update procedure outlined in this bulletin. Before conducting the procedure, verify that the vehicle is included in the list of affected VINs.

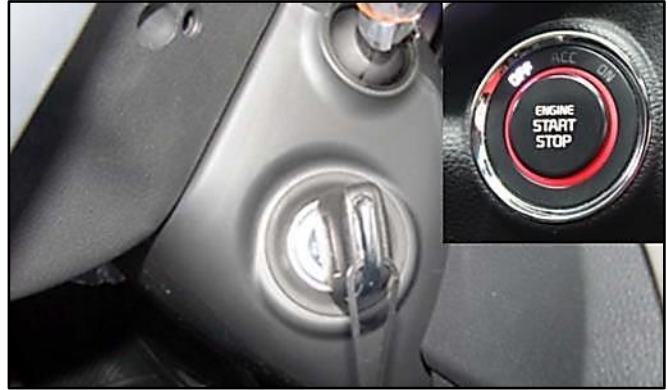
1. Turn engine **ON** and record customer radio presets.

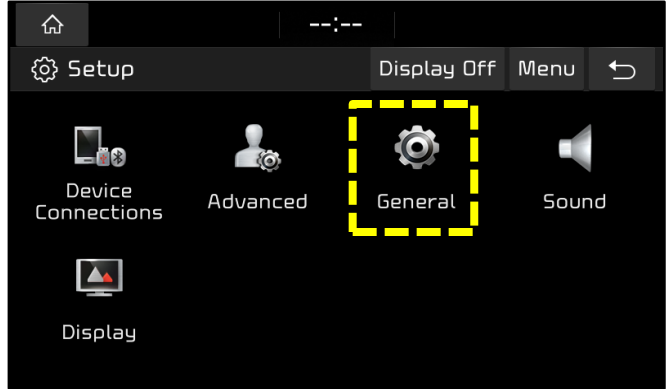
3. Select "General".

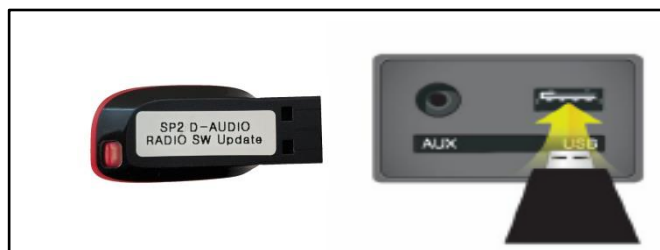
6. Insert USB Flash Drive into the vehicle's USB Port. (Location will vary by model)

Note: When inserting the USB flash drive, the “Update to next version now?” screen may pop up. If so, proceed to step 7.

If the “Update to next version now?” screen does not pop up, select “Update”.

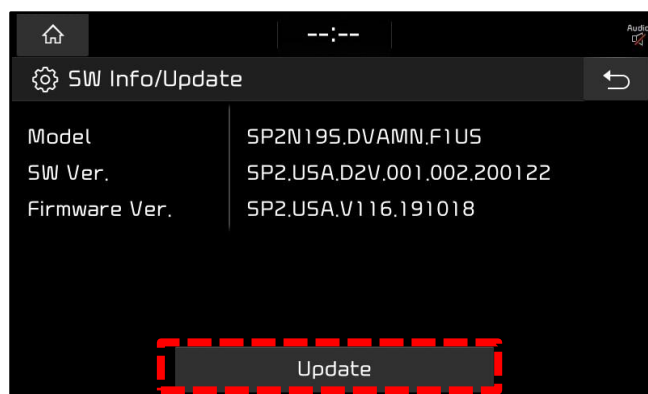
7. Confirm the available software version is applicable to (SP2) model:

SP2.USA.D2V.001.003.201028

Select “Update”.

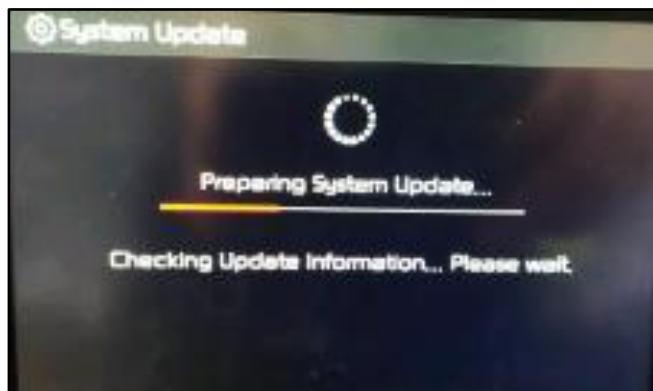
8. The software update will begin...

- Wait 9 -10 minutes.
- System will reboot automatically.
- Wait until the update is completed.

If the update fails, repeat the step 3 – 7.

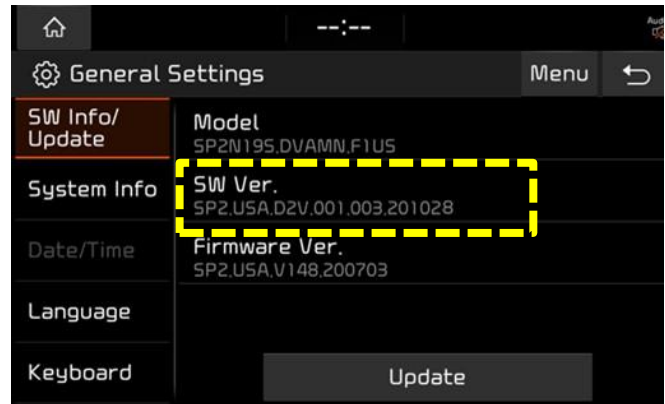
- 10. Confirm **SW Ver.** was installed correctly.

Model		Software Version (SW Ver.)
SP2	Before	SP2.USA.D2V.001.002.200122
	After	SP2.USA.D2V.001.003.201028
