MODEL  
2021MY  
Seltos (SP2)

## TECHNICAL SERVICE BULLETIN

### SERVICE ACTION: FRONT CAMERA OPERATION LOGIC IMPROVEMENT (SA453)

This bulletin provides the procedure to improve the logic of the front view camera software on some 2021MY Seltos (SP2) vehicles, produced from November 20, 2019 through October 22, 2020, to improve the logic of the Lane Departure Warning (LDW) / Lane Keep Assist (LKA) operation. To improve driving experience and customer satisfaction, apply the improved logic to the ECU using the KDS ECU Upgrade function as described in this bulletin. For confirmation that the latest reflash has been applied to a vehicle you are working on, verify the ROM ID using the table on page 2 of this bulletin. Before conducting the procedure, verify the vehicle is included in the list of affected VINs in dealer stock.

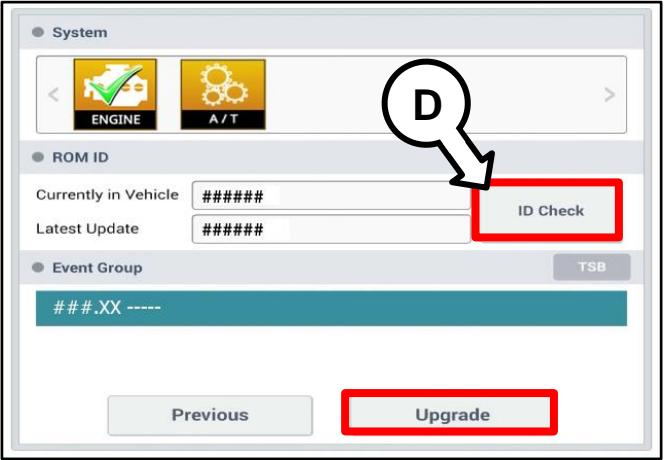
KDS screenshot shown below is for demonstration purposes only. Events shown in screenshot are not applicable to this bulletin.

- Select the **FR\_CM** system under the System selection menu.

Touch **ID Check** (D) and confirm that the latest update is available.

Select **Upgrade Event #510** and select **Upgrade** to continue.

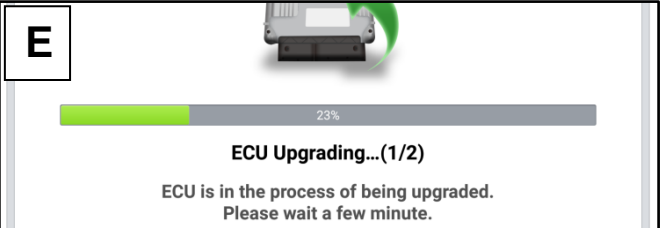
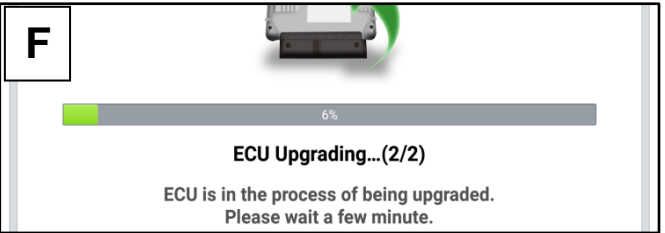
- The ECU upgrade will begin and the progress of the upgrade will appear on the bar graph. Upgrade part (1/2) (E) will download the upgrade event to the VCI-II. Upgrade part (2/2) (F) will upgrade the ECU.

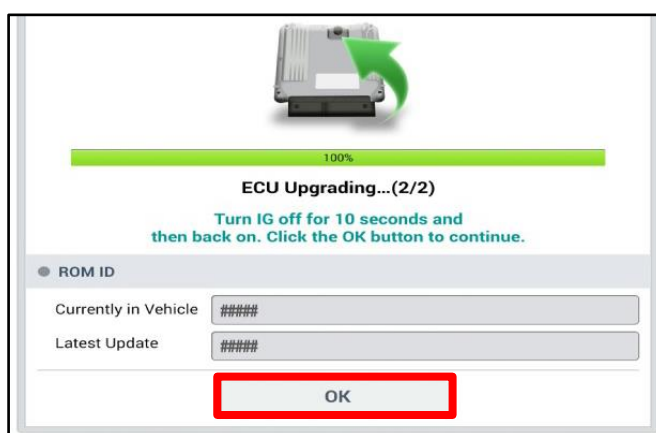
10. When instructed on the KDS, turn the ignition **OFF** for ten (10) seconds then back on. Touch **OK** to continue.

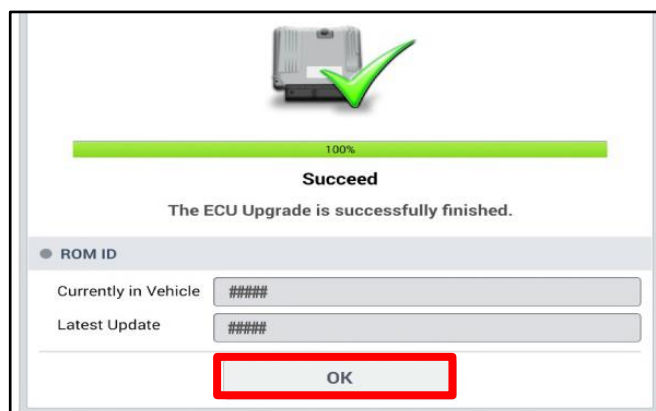
11. Once the upgrade is complete, touch **OK** to finalize the procedure.

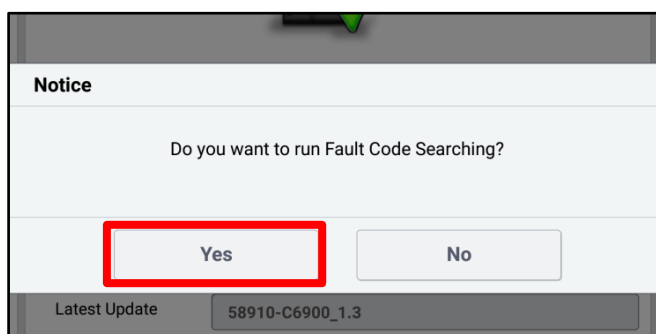
12. When prompted, select **YES** to check for Diagnostic Trouble Codes (DTC) and erase any DTCs stored such as EPS, ESC, and TPMS that may have been set during the upgrade.
