MODEL
2021MY
Seltos (SP2)
1.6L T-GDI w/7DCT

TECHNICAL SERVICE BULLETIN

**SUBJECT: SERVICE ACTION: DUAL CLUTCH TRANSMISSION (DCT)
DTC P060194 LOGIC IMPROVEMENT (SA454)**

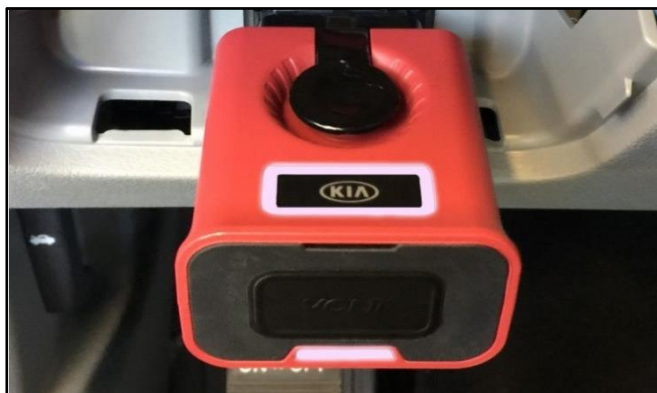
The ECU upgrade function on KDS operates wirelessly. It is not necessary to perform the upgrade via USB cable.

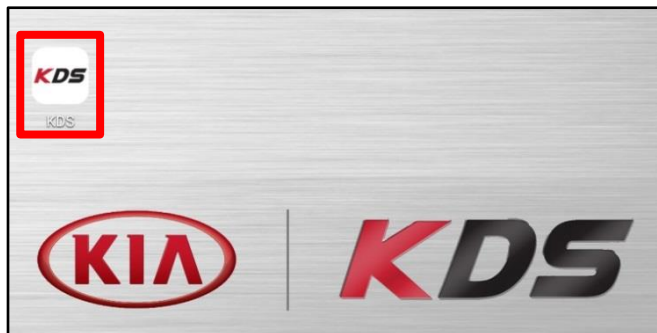
2. With the ignition ON, turn ON the KDS tablet. Select **KDS** from the home screen.

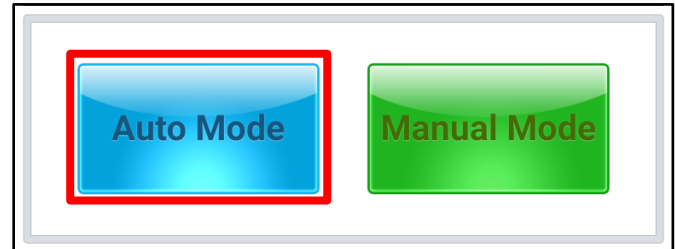
6. Select **Auto Mode**.

CAUTION
Do NOT attempt to perform a Manual Mode upgrade UNLESS Auto Mode fails. Always follow the instructions given on the KDS in either Auto or Manual mode.

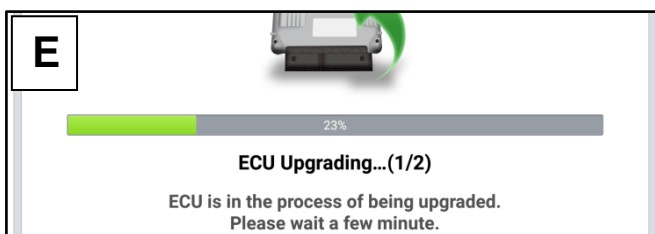
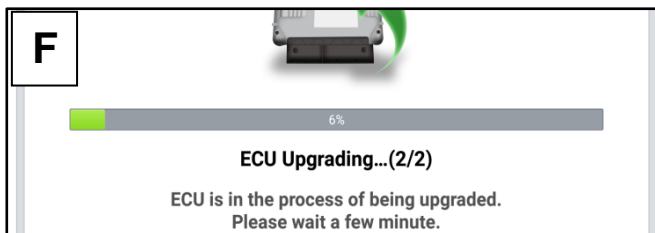
8. The ECU upgrade will begin and the progress of the upgrade will appear on the bar graph. Upgrade part (1/2) (E) will download the upgrade event to the VCI-II. Upgrade part (2/2) (F) will upgrade the ECU.

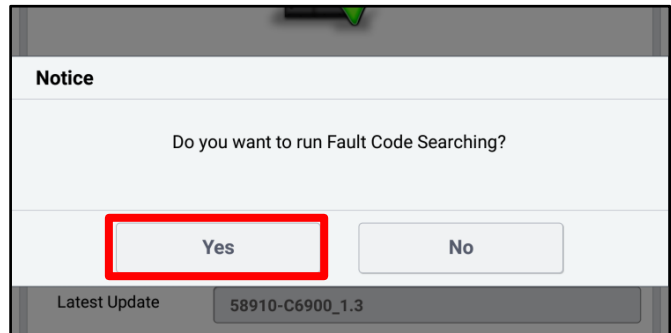
- When prompted, select **YES** to check for Diagnostic Trouble Codes (DTC) and erase any DTCs stored such as EPS, ESC, and TPMS that may have been set during the upgrade.
