Subject: LOUD STATIC NOISE FROM SPEAKERS (WITH BOSE AUDIO)	Bulletin No.: 09-038/20
	Last Issued: 12/14/2020

2020-2021 CX-30 equipped with Bose® Audio

DESCRIPTION

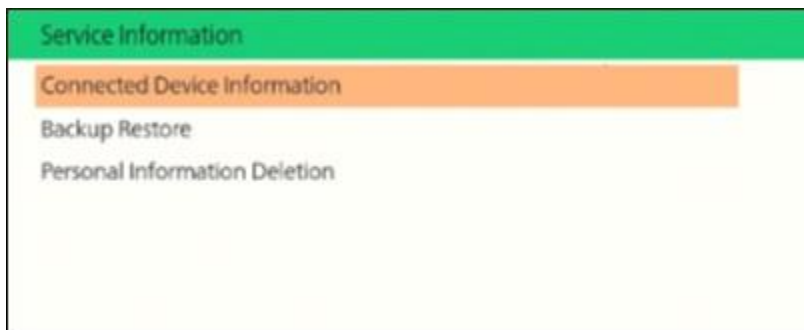
4. Select "Connected Device Information".

5. Select "AMP".
6. Check the AMP version.

Example: "Device Name/Ver.: Package / 10001" (1) and "Part No.: DFR7-66A20" (2).

Device Version Information		AMP
Manufacturer Name	:	BOSE
Device Name/Ver.	:	Package / 10001 ①
Device Name/Ver.	:	A / 010200
Serial No.	:	00000000000142
Part No.	:	DFR7-66A20 ②

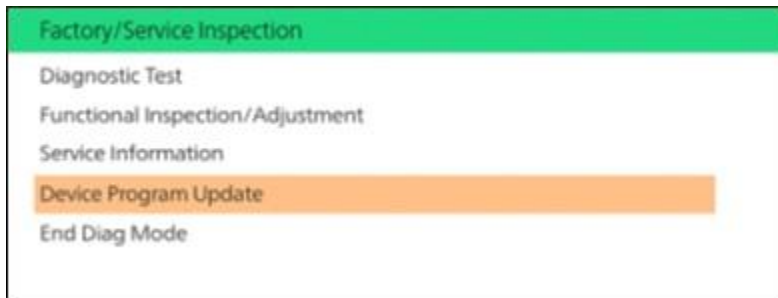
6. Select "Device Program Update".

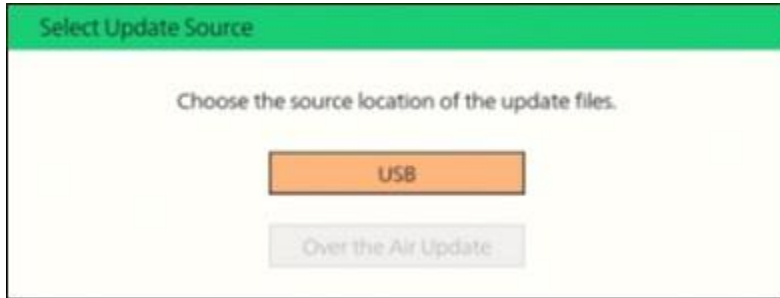
8. Select "USB" and check for the update file to start.

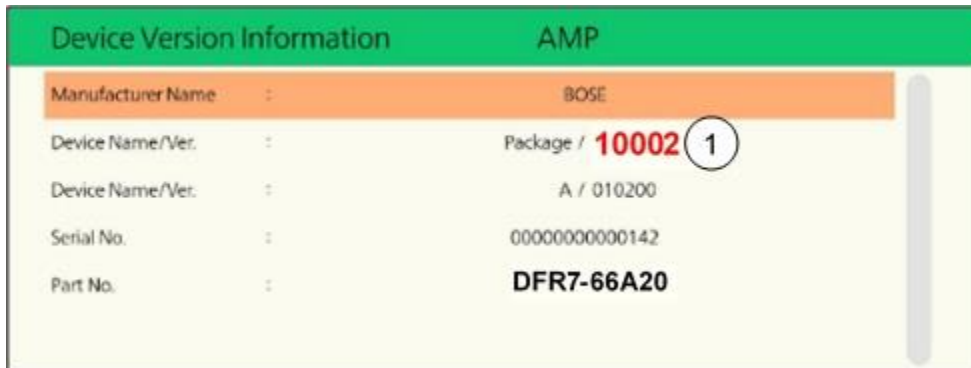
12. Verify the AMP software version is "Package / 10002" (1) according to the previous "AMP SOFTWARE VERSION CHECK".
