Articles Contained in this Issue

TECH TIPS GREATEST TIPS

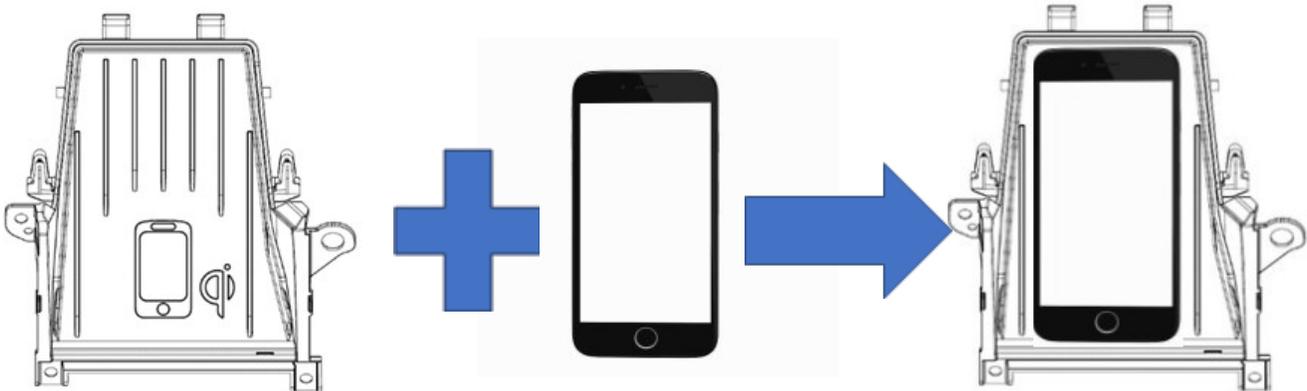
Proper Placement

- 2) Place the **Qi (pronounced “chee”)** enabled mobile device into the charging pocket with the screen facing up.

Wireless Charger Details:

- 5W charging capability (Samsung Fast Charge enabled, boosting certain Samsung phones to 7.5W charging)
- Operating Temperature Range: -40°C - 60°C, -40°F - 140°F (Over temperature shutdown at 45°C, 113°F.)
- Maximum Phone/Case Combination Size: 180mm x 80mm x 13mm (7.1" x 3.1" x 0.47")
- The Subaru wireless charger is integrated into the internal Keyless Access antenna system. In situations where the key fob is unable to be detected by the vehicle (Key Not Found on MFI screen), the wireless charger will shut down. After the key fob is found by the vehicle, the wireless charger may take up to 3 minutes to reinitialize.
