**WLL1 - Re-Programming DME Control Unit (Workshop Campaign)**

Vehicle Type: **Macan (95B)**

Concerns: **DME control unit**

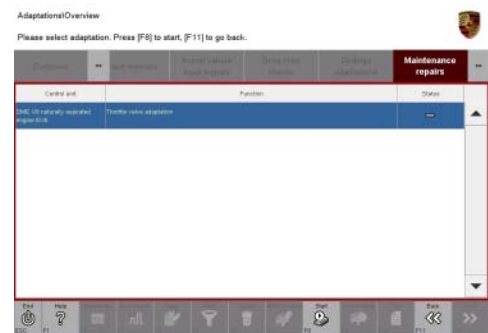
*Throttle valve adaptation*

- 5 Select the ⇒ **'Throttle valve adaptation'** function so that the corresponding text line turns blue and press •F8" ('Start') to start throttle valve adaptation ⇒ *Throttle valve adaptation*.

- 6 Follow the instructions on the PIWIS Tester while throttle valve adaptation is being performed.  
Once throttle valve adaptation is complete, a tick will appear in the "Value" field on the PIWIS Tester display.  
If throttle valve adaptation is **not** completed successfully, adaptation must be **repeated**.
- 7 Press •F8" ('Stop') to end throttle valve adaptation.

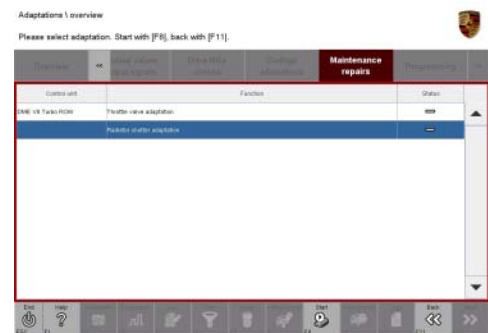
*Radiator shutter adaptation*

Work Procedure: 1 Select the ⇒ **'Radiator shutter adaptation'** function so that the corresponding text line turns blue and then press •F8" ('Start') to start radiator shutter adaptation ⇒ *Radiator shutter adaptation*.

Once adaptation is complete, a tick will appear in the "Value" field on the PIWIS Tester display.

If radiator shutter adaptation is **not** completed successfully, the adaptation must be **repeated**.

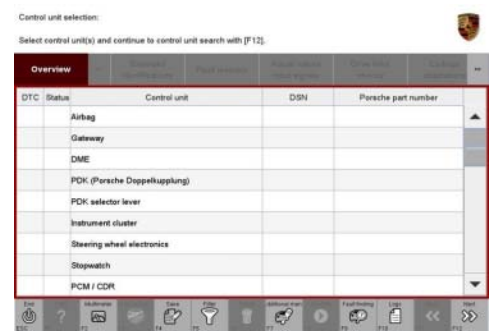
*Control unit selection*

- 3 End radiator shutter adaptation by pressing •F8“ ('Stop').
- 4 Press •F11“ ('Back') to return to the start page of the ⇒ **'Maintenance/repairs'** menu.
- 5 Select the ⇒ **'Overview'** menu to return to the control unit selection screen ⇒ *Control unit selection*.
