WLK7 - Porsche Communication Management (PCM) Software Update (Workshop Campaign)

Model Line: **Panamera (971)**

Model Year: **2021**

Information: **Optimized software is available for the Porsche Communication Management (PCM) system.**

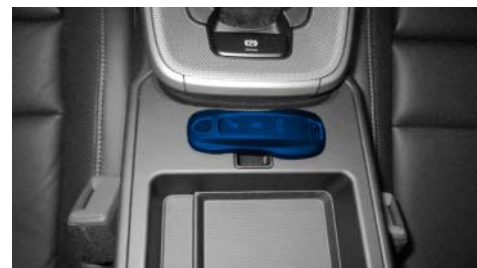
2 Place the driver's key with the back facing down in the area in front of the storage compartment under the armrest (emergency start tray) in order to guarantee a permanent radio link between the vehicle and driver's key ⇒ *Emergency start tray*.

Emergency start tray
