WLK8 - Porsche Communication Management (PCM) Software Update (Workshop campaign)

Model Line: Cayenne (9YA)/Cayenne Coupé (9YB)

Model Year: 2021

Information: Optimized software is available for the Porsche Communication Management (PCM) system.

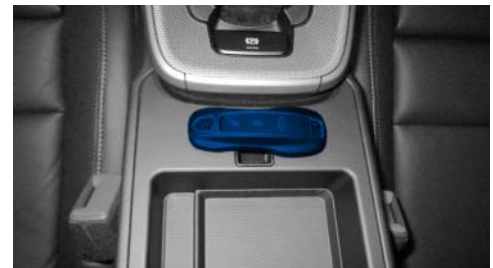
Emergency start tray

2 Place the driver's key with the back facing down in the area in front of the storage compartment under the armrest (emergency start tray) in order to guarantee a permanent radio link between the vehicle and driver's key ⇒ *Emergency start tray*.
