Release Date	12/01/2020	Technical Service Bulletin		
13H3 UPDATE				  Audi
ECM Software Update – (FED_EMS)

13H3 UPDATE

ECM Software Update – (FED_EMS)

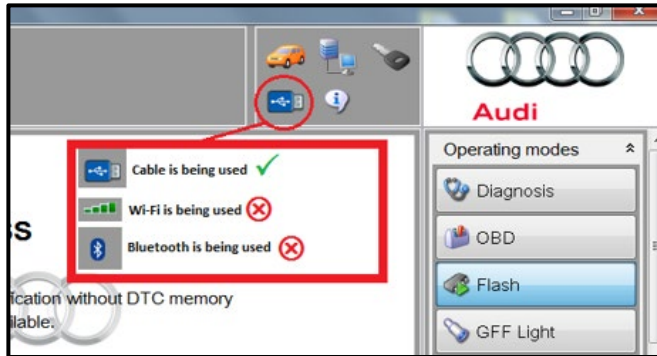
- Confirm that scan tool is communicating with the diagnostic head by USB cable.
 - If the Bluetooth or WiFi symbol is shown, then disconnect the diagnostic head from the vehicle and reconnect the USB cable to the diagnostic head and then reattach to the vehicle.

- ✓ **The VAS Diagnostics Interface MUST ONLY be connected to the tester with a USB cable.**
 - Performing a software update using a Bluetooth or WiFi connection increases the risk of losing connection during the update, which could result in damage to the control module. It also greatly increases the time required to perform the update. Requests for additional time or parts will be denied if the GFF log shows the update was performed using Bluetooth or WiFi.

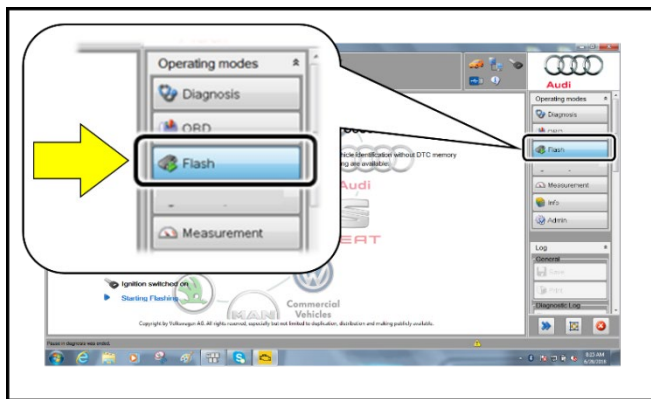
- From the home screen of the scan tool highlight “Flash” <1>.
- Follow the on-screen prompts.

Operating mode “Flash” must be used. Performing this software update using “Diagnosis” (Guided Fault Finding) could result in non-payment of the claim.

- ✓ **Flash process through “Audi Flashing” not Guided Fault Finding (GFF).**
 - DO NOT USE Guided Fault Finding (GFF) to perform this flash. Using GFF will cause the flash to take longer. Requests for additional time will not be considered.

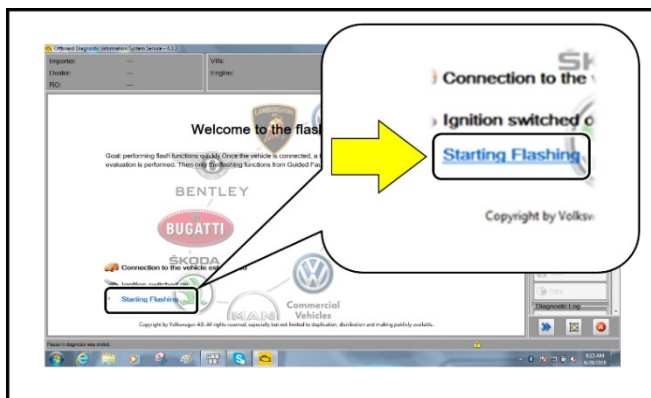
- Select “Starting Flashing” and follow the on-screen prompts.

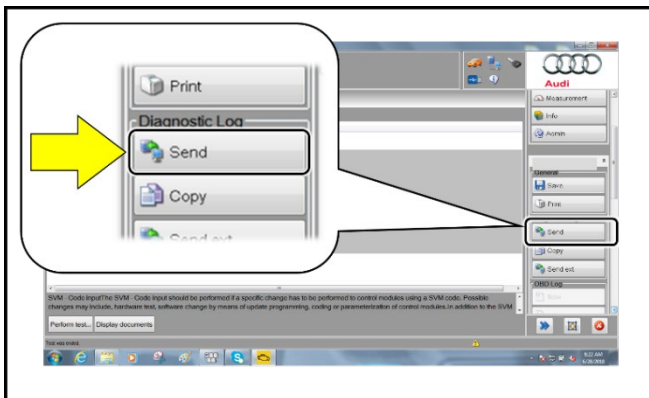
- After receiving confirmation that the flash completed successfully, select "Send" <arrow> to send the diagnostic protocol online.

- Follow the on-screen prompts.

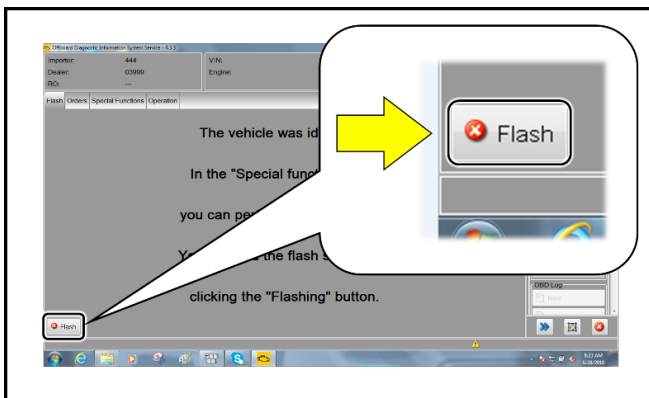
- Click "Flash" <arrow> to exit the flash session.

Various event memory entries may be generated after the flashing procedure on some vehicles. Put the vehicle in a corresponding bus sleep mode after performing the update in order to clear the faults.

To put the vehicle in bus sleep mode, disconnect the diagnostic tester, remove the key from the vehicle and lock the vehicle with the remote for 5 minutes.

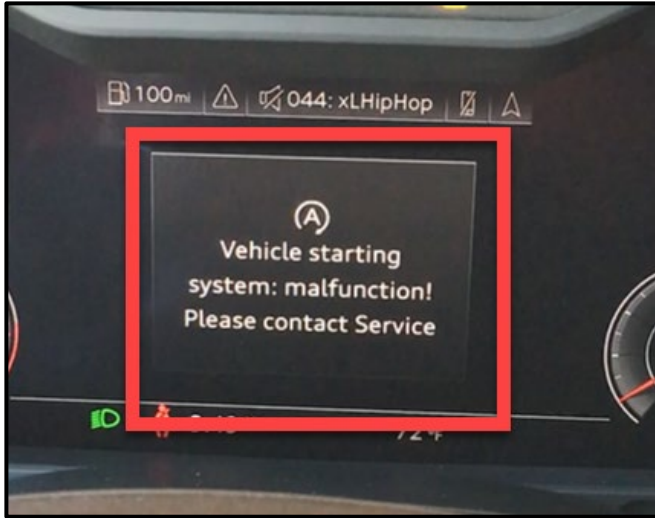
- If the message shown is displayed on the instrument cluster after the flash and it was not present prior to the flash, the adaptation channel for the start/stop activation may have to be changed from inactive to active.
- To change the adaptation channel, use Diagnosis Mode OBD and change the adaptation channel, "*Activation of start/stop function* [\$0927]" from "not active" to "active".
- The adaptation will also change on its own after the vehicle is driven for 50 km (~32 miles). However, the message in the cluster might not disappear until the ignition is cycled after the vehicle has been driven for 50 km (~32 miles).
