HYUNDAI Technical Service Bulletin	GROUP CAMPAIGN	NUMBER 20-01-045H
	DATE DECEMBER 2020	MODEL(S) SONATA (DN8A)
SUBJECT: SONATA (DN8A) SAFE EXIT ASSIST ACTIVATION PROCEDURE (SERVICE CAMPAIGN T5L)

Description: This bulletin describes the procedure to identify and program certain Sonata vehicles Rear Corner Radars from the Advanced Driver Assistance Systems (ADAS) modules to enable the Safe Exit Assist (SEA) warning feature.

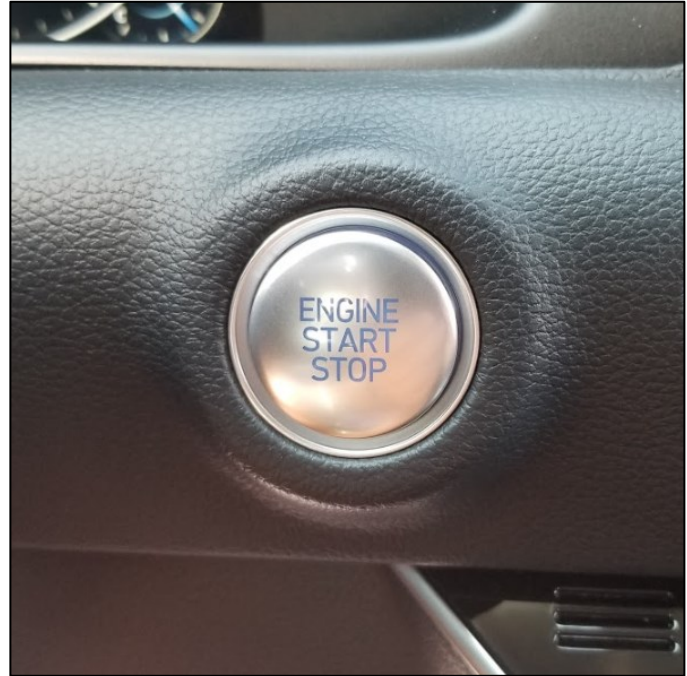
1. Press the **Engine Start Stop** button to start the vehicle with the engine off.

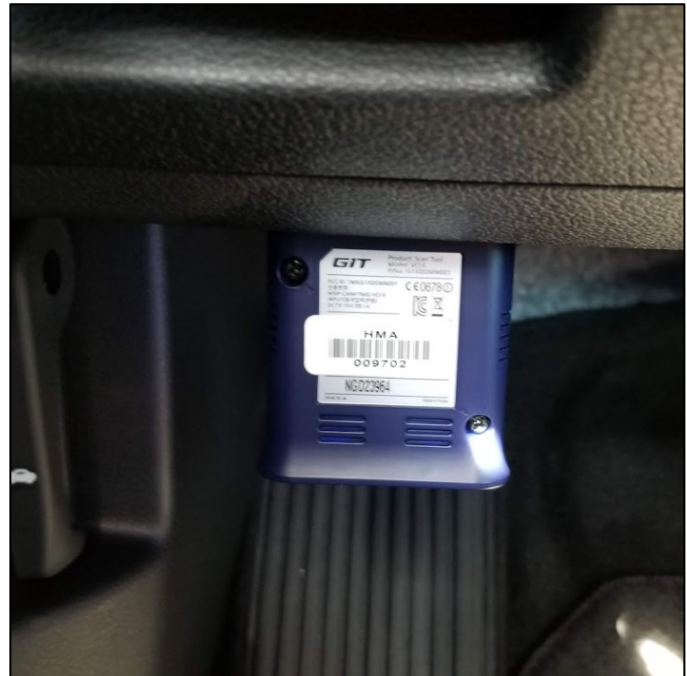
2. Insert the GDS scan tool into the vehicle's Onboard Diagnostic II (OBDII) port.

The GDS scan tool must sit flush inside the OBD II port, and the Function light must illuminate before proceeding.

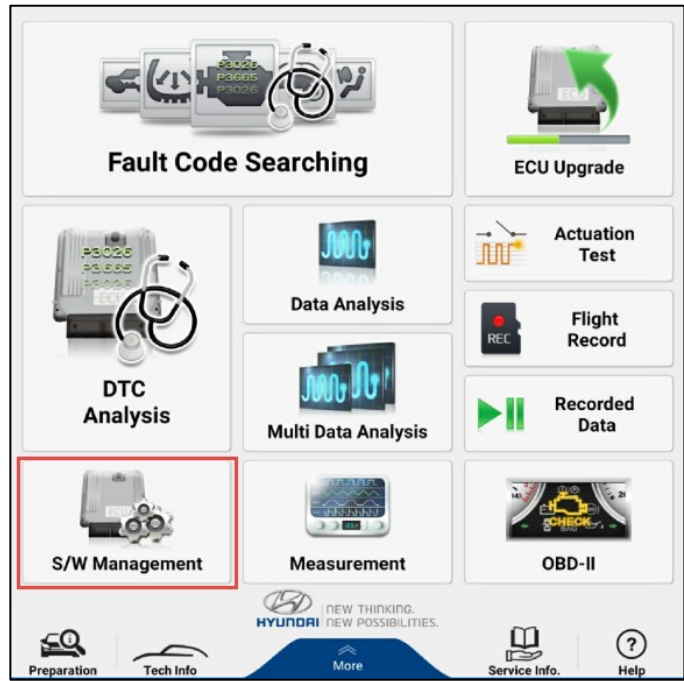
- Turn on the GDS tablet, and select **S/W Management**.

An error message will appear on GDS screen if the scan tool is not properly inserted in the OBD II port after selecting S/W Management.

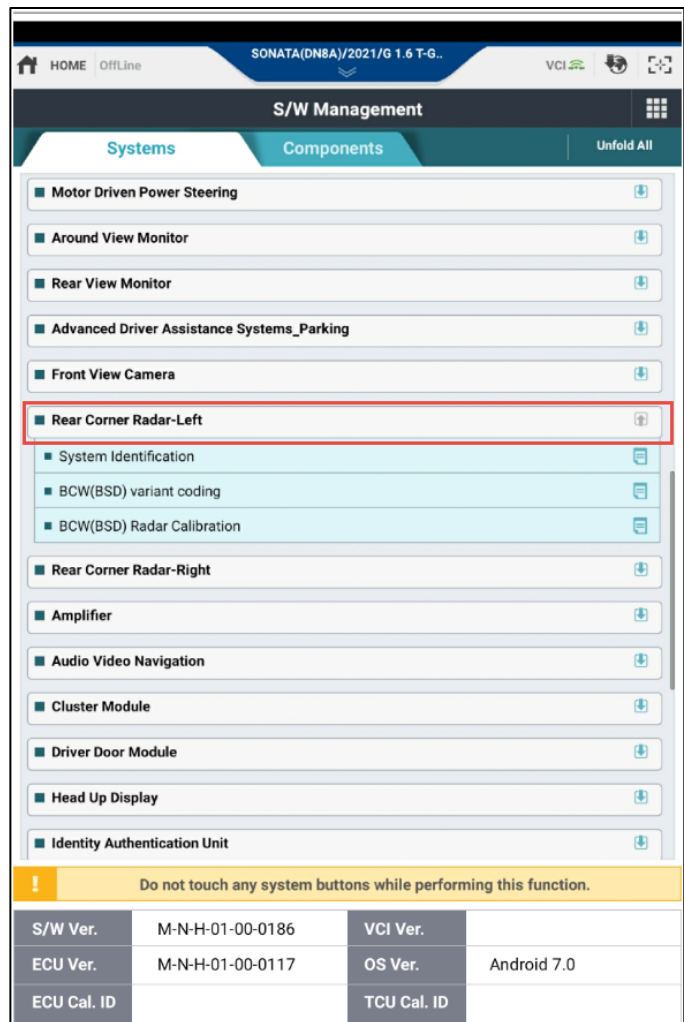
- After selecting S/W management, a list of onboard vehicle components should appear on the GDS screen.

Select **Rear Corner Radar-Left**.

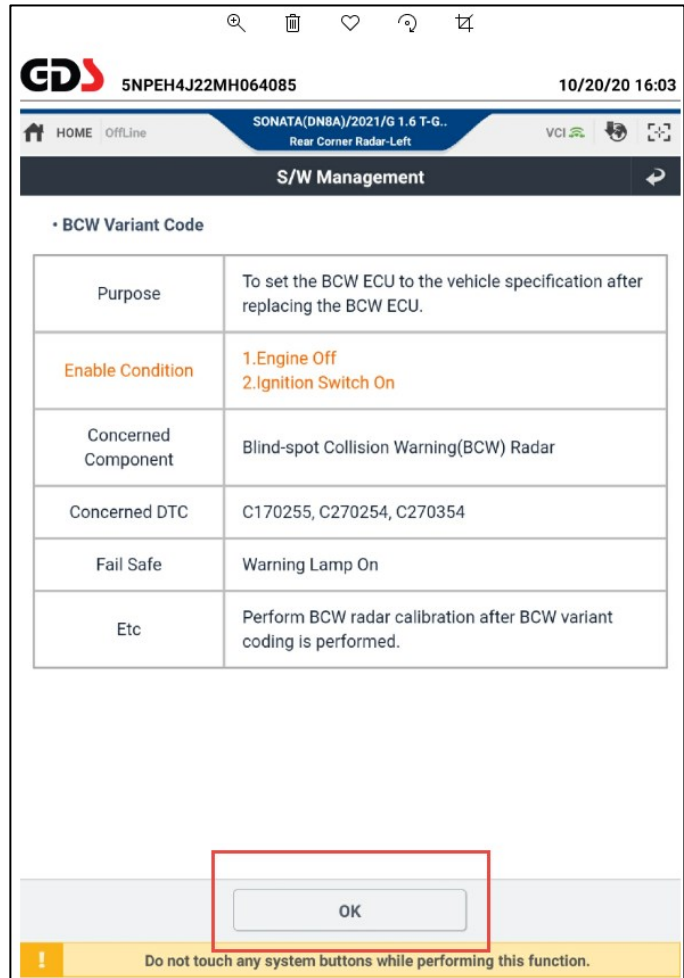
6. After selecting BCW (BSD) variant coding, two instruction screens will appear.

Select **OK**.

Do not perform recalibration of the BCW radar after variant coding is complete as the onscreen instructions states.

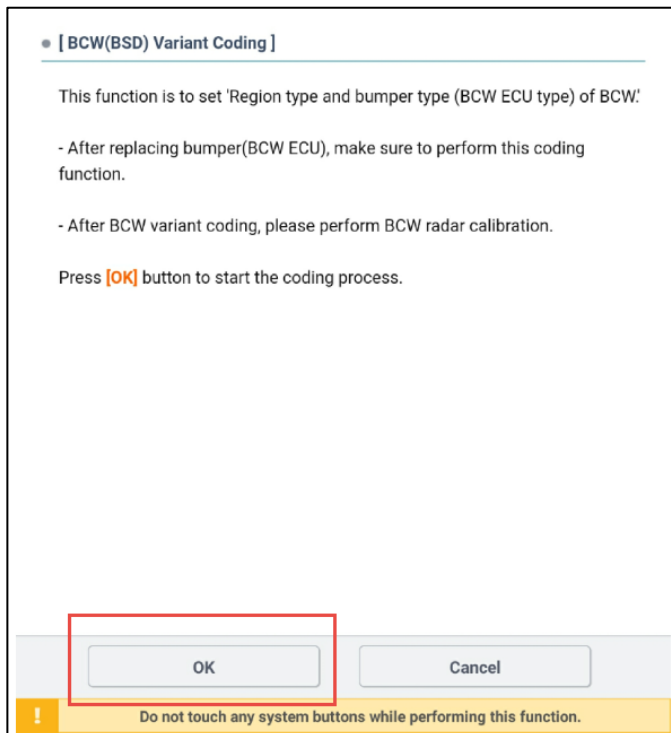
7. Select **OK**.

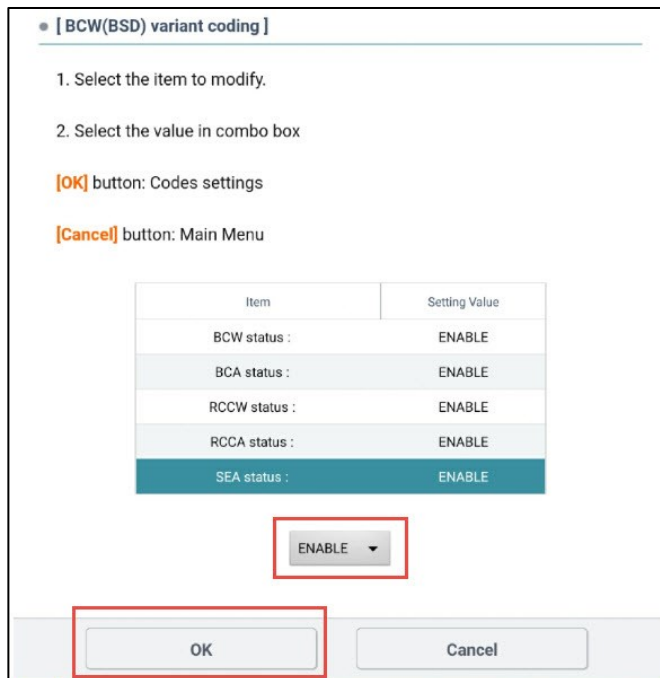
8. Select **SEA Status** then select **ENABLE** from the “DISABLE/ENABLE” drop down tab.

Select **OK**.

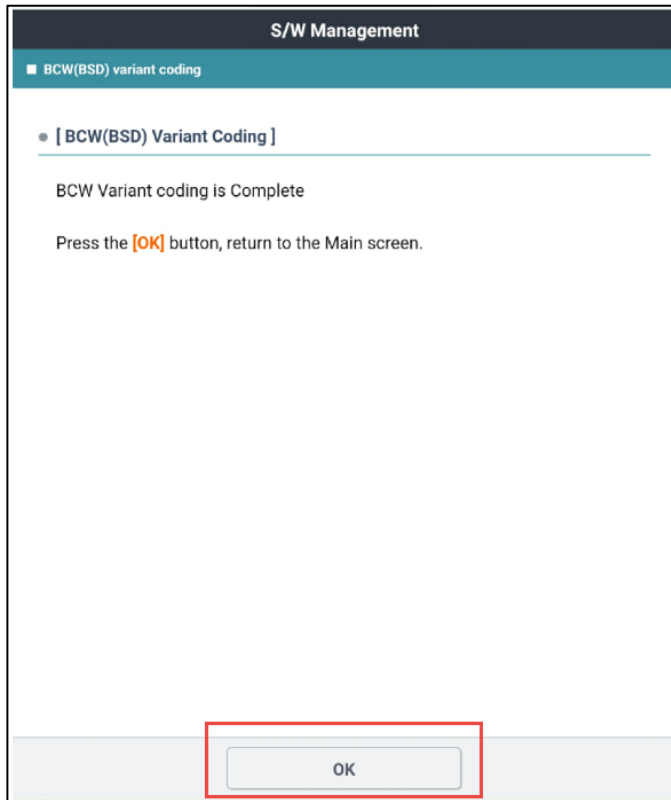
9. Select **OK**, and repeat the procedure for **Rear Corner Radar-Right**.

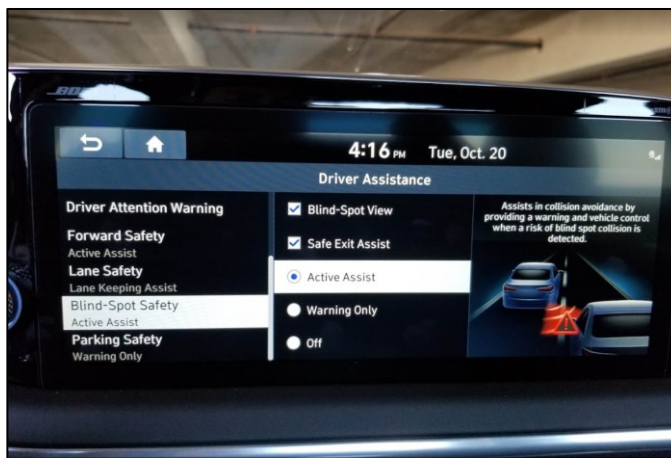
Vehicle equipped with AVN:

Restart the vehicle, then access the AVN Headunit.

Select **Set-up**, then choose the vehicle icon. Select **Driver Assistance** then **Blind Spot Safety**. A check mark should be placed at **Safe Exit Assist**.

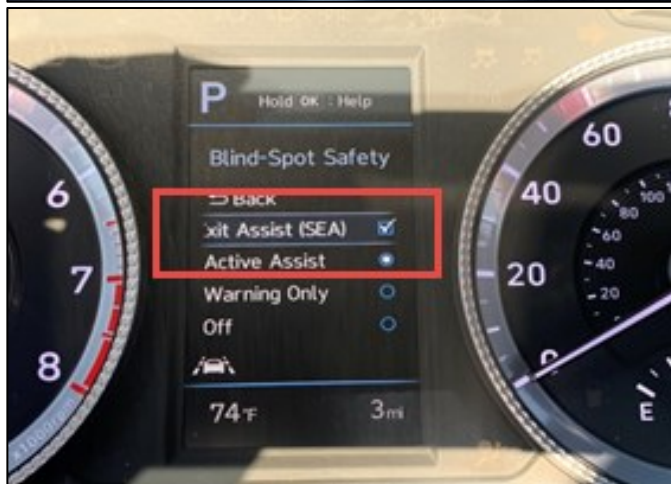
Vehicle equipped with D-Audio:

Restart the vehicle, then select the mode button on the steering wheel to access the cluster menu.

Select **User Settings** then **Driver Assistance**. Select **Blind Spot Safety** from the drop down menu. A check mark should be placed at **Safe Exist Assist**.
