# Technical Service Bulletin

SUBJECT:			No: <b>TSB-20-55-001</b>
<b>REDUCED CABIN HEATER PERFORMANCE DURING IDLE AND LOW VEHICLE SPEED</b>			DATE: <b>December 2020</b>
			MODEL: <b>2018-2020 Eclipse Cross</b>
<b>CIRCULATE TO:</b>	<input type="checkbox"/> GENERAL MANAGER	<input checked="" type="checkbox"/> PARTS MANAGER	<input checked="" type="checkbox"/> TECHNICIAN
<input checked="" type="checkbox"/> SERVICE ADVISOR	<input checked="" type="checkbox"/> SERVICE MANAGER	<input checked="" type="checkbox"/> WARRANTY PROCESSOR	<input type="checkbox"/> SALES MANAGER

Customers may notice a reduction in heater output temperature while idling or during low vehicle speeds. When ambient temperatures are extremely low, the coolant temperature may remain low, affecting heater performance. Both issues may be caused by improper programming of the ECU.

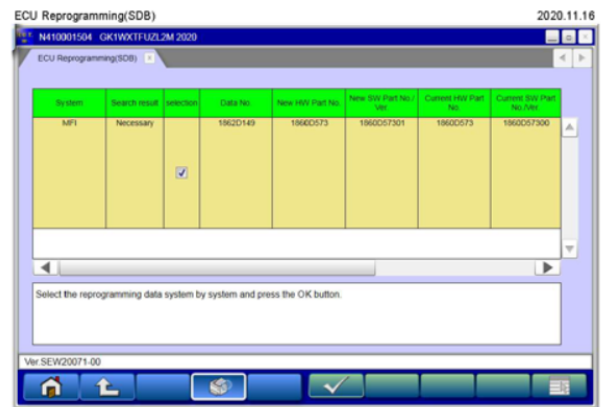
c. Click "SDB Data List, select the reprogramming data system and press the OK button"

d. Confirm that the database number displayed in the upper right above the chart is **N201001 or higher**

- If the database number displayed on your MUT3-SE is **N201001** or greater, continue to the next section.
- If the reprogramming database number displayed on your MUT3-SE is **lower** than **N201001**, then the MUT3-SE database needs to be updated.

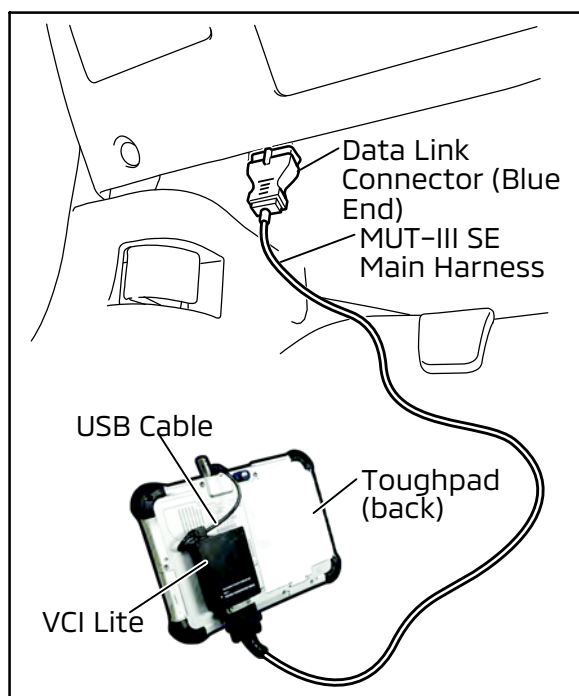
1. Connect the equipment as follows:

**NOTE:** VCI Lite and MEDIC 4.0 Toughpad shown for illustration purposes only.

- Turn the MEDIC PC/tablet on. If the battery indicator in the lower right hand corner of the screen does not show a full charge, it is recommended that either the battery be charged prior to beginning, or be used with the A/C power adaptor connected.
- Connect the USB cable to the VCI/VCI Lite. When the laptop/tablet displays the MUT-III SE main screen, connect the USB cable to the device.
- Connect the MUT-III SE main harness with the blue DLC connection to the VCI/VCI Lite. Connect the blue connection of the MUT-III SE main harness to the vehicle's data link connector.
- For VCI only (p/n MB991824): Turn the VCI power switch ON. Verify that the indicator lamp in the upper right corner of the screen is green.

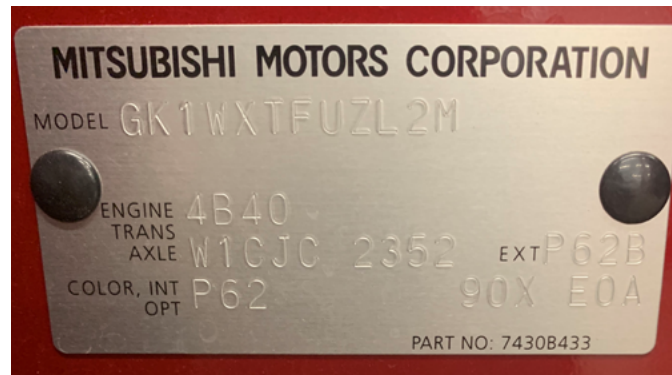
- The System Select screen opens and populates with some basic information from the vehicle. Look at the label on the passenger side B pillar to identify the appropriate class. (See B pillar label below; class is labeled as "model"). If necessary, select the correct class from the drop-down list.

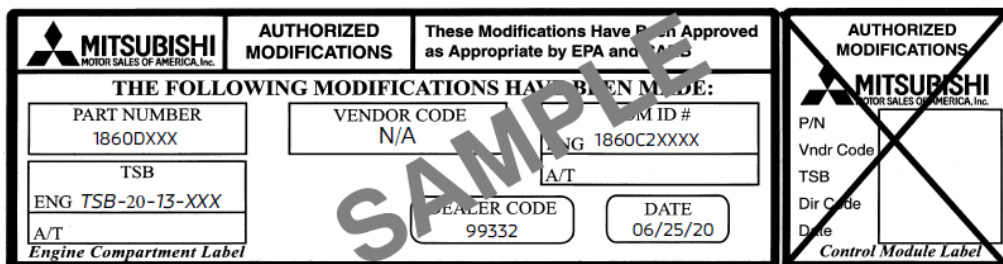
- 12. Using a ball-point pen, enter the appropriate ECU part number, Software Part Number (ROM ID#), this Technical Service Bulletin number, your dealer code, and the current date on the Engine Compartment/Control Module Label (p/n MSSF024G00). The Vendor Code is not applicable. The label is available from your facing PDC.
