# Audio Head Unit Software Update (Panasonic)

**Service Category** Audio/Visual/Telematics

**Section** Navigation/Multi Info Display

## Introduction

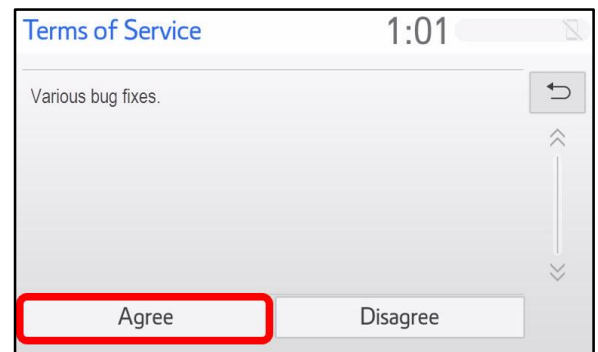
**Figure 8.**

11. Select Agree on the Terms of Service screen.
