# Poor Heater Performance When Ambient Temperature is Below -4°F (-20°C)

**Service Category** Vehicle Interior

**Section** Heating/Air Conditioning

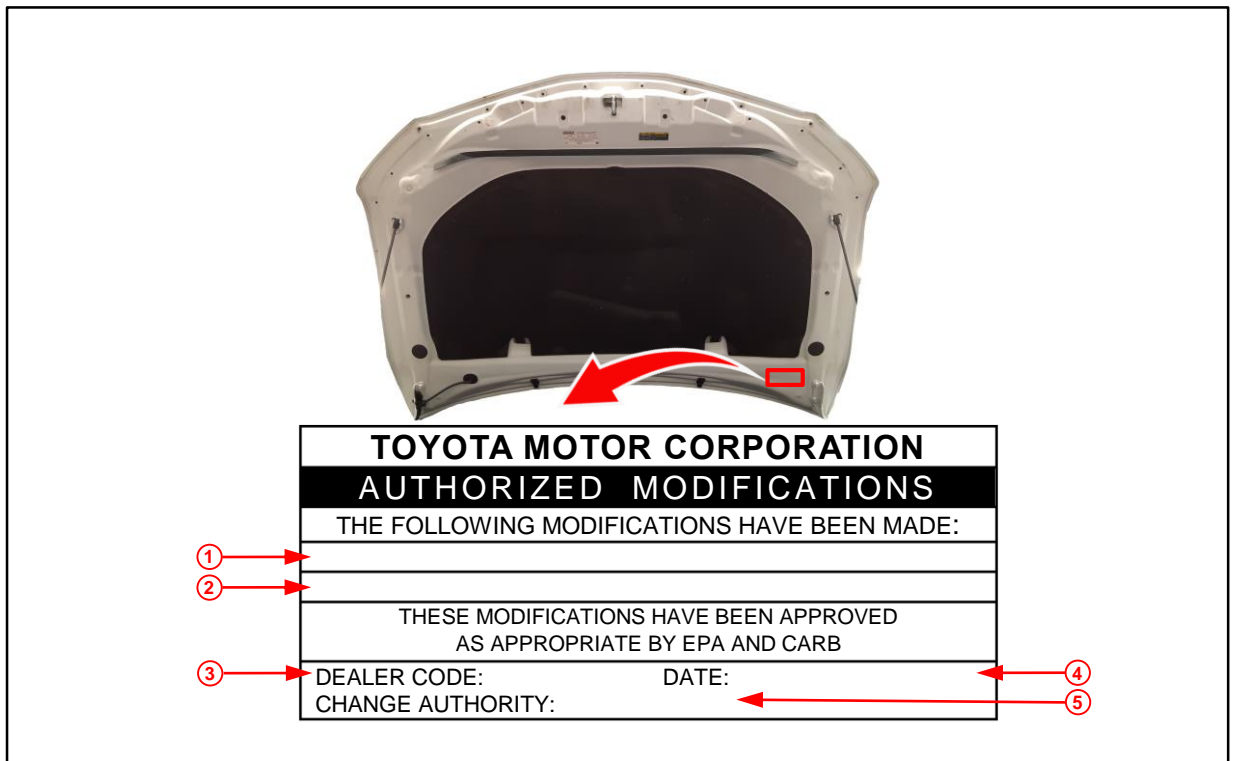
**Figure 1. Location of Authorized Modifications Label on 2019 – 2020 Camry**

| 1 | Replacement ECM (PCM) Part Number<br>e.g., 89661-0X585 |
| 2 | New Calibration ID e.g., 8966306Q4300 |

- Prepare and install the Authorized Modifications Label.
  - Using a permanent marker, enter the following information on the label:
    - ECM (PCM) part number [*Refer to the **Parts Information** section for the **NEW PART NUMBER**.*]
    - Calibration ID(s) [*Refer to the **Calibration Information** section for the **NEW CALIBRATION ID**.*]
    - Dealer Code.
    - Repair Date.
    - Change Authority [***This bulletin number**.*]
  - Install the Authorized Modifications Label onto the vehicle at the location shown in Figure 1. The Authorized Modifications Label is available through the MDC, P/N 00451-00001-LBL.
- Test-drive the vehicle to confirm proper heater performance, especially if the ambient temperatures are below -4°F (-20°C) and coolant temperature is 158°F (70°C) – 172°F (78°C).
