# Navigation System Software Update (Panasonic)

**Service Category** Audio/Visual/Telematics

**Section** Navigation/Multi Info Display

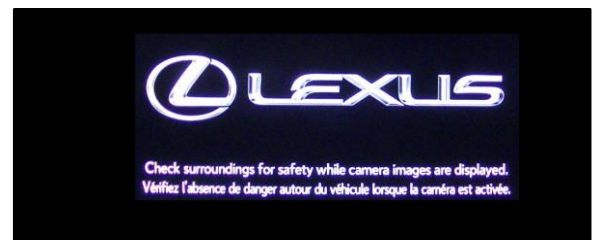
Figure 1.

1. Confirm the software version.
  - A. Start the engine. The Lexus emblem will display on the navigation screen.

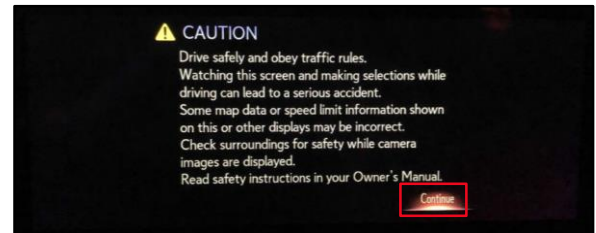
**Figure 2.**

- B. Wait for the display to switch to the Caution screen, then select Continue.

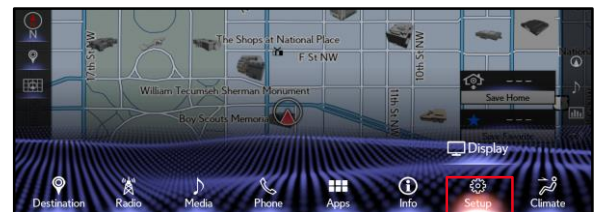
**Figure 3.**

- C. Connect the USB drive to the USB port.

- D. From the navigation menu, select Setup.

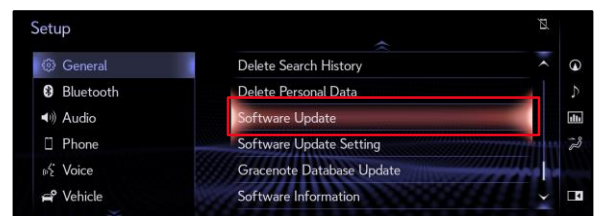
**Figure 4.**

- E. In the General menu, scroll to and select Software Update.

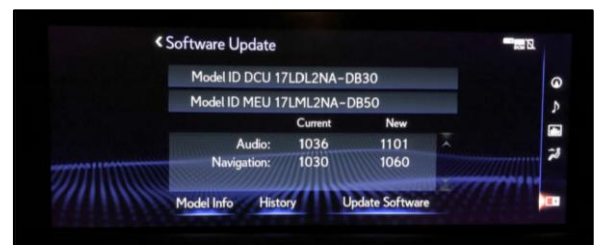
**Figure 5.**

- F. Is the Current Audio version 1101 or above, and Navigation Version 1060 or above?
- **YES** — This bulletin does NOT apply. Continue diagnosis using the applicable Repair Manual.
  - **NO** — Continue to step 2.

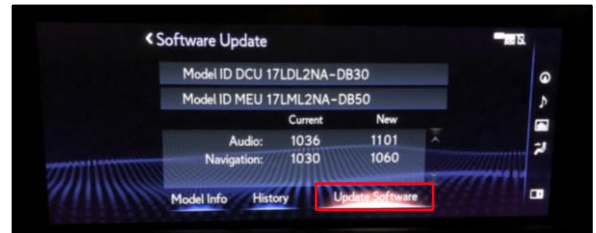
Figure 6.

2. Update the software version.
  - A. Select Update Software.

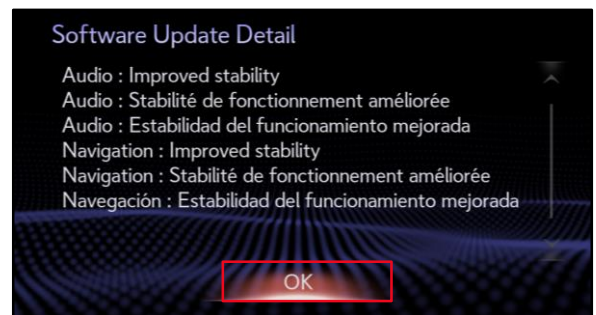
Figure 7.

- B. Review the Software Update Detail and select OK.

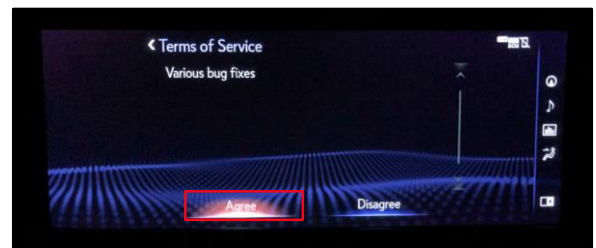
Figure 8.

- C. Confirm the Terms of Service and select Agree.

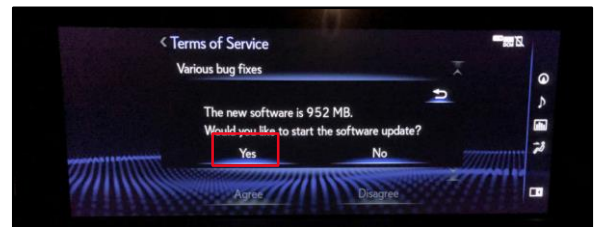
Figure 9.

- D. Select Yes.

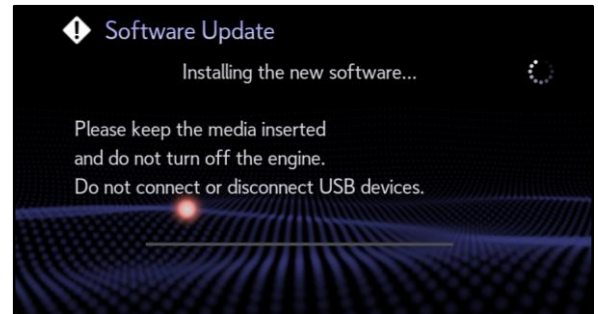
**Figure 10.**

- E. While installing the NEW software, do NOT turn off the engine.
- F. When prompted, turn the engine OFF and ON to complete the update.
- G. Confirm the current software version has been updated on the Software Update screen.
